RECONNAISSANCE LEVEL SURVEY
OF HISTORIC RESOURCES

VILLAGE OF HAMBURG

Erie County, New York

Bero Architecture PC
32 Winthrop Street
Rochester, New York 14607

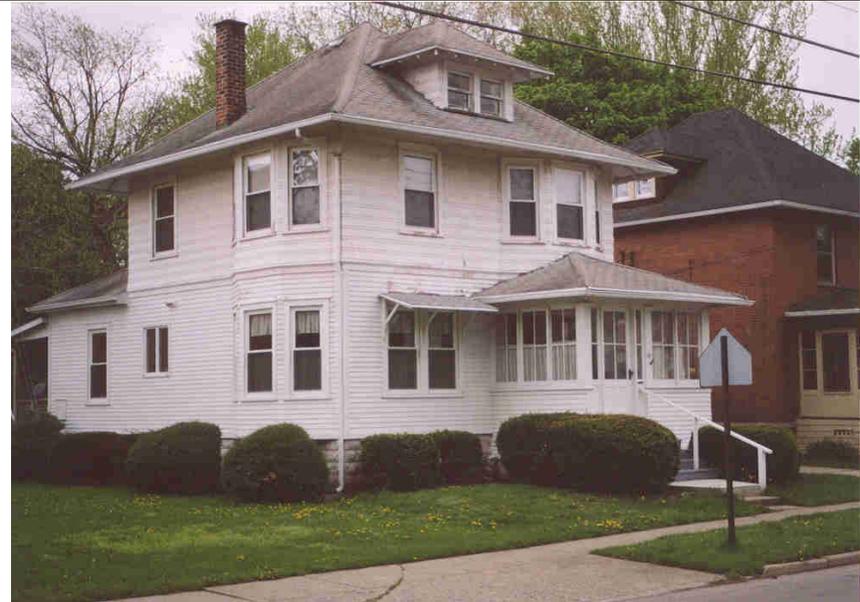
<p>ADDRESS: 98 Center Street</p>	<p>DATE OF CONSTRUCTION: ca. 1910</p>	<p>SIGNIFICANCE: C – Domestic architecture</p>

<p>DESCRIPTION: 2-1/2-story, hip-roof, wood-frame, Four-square house incorporating hip-roof dormer, flared eaves with exposed rafter tails, two-story bay, contrasting cladding between first and second floor and two-bay hip-roof porch with closed handrail.</p>

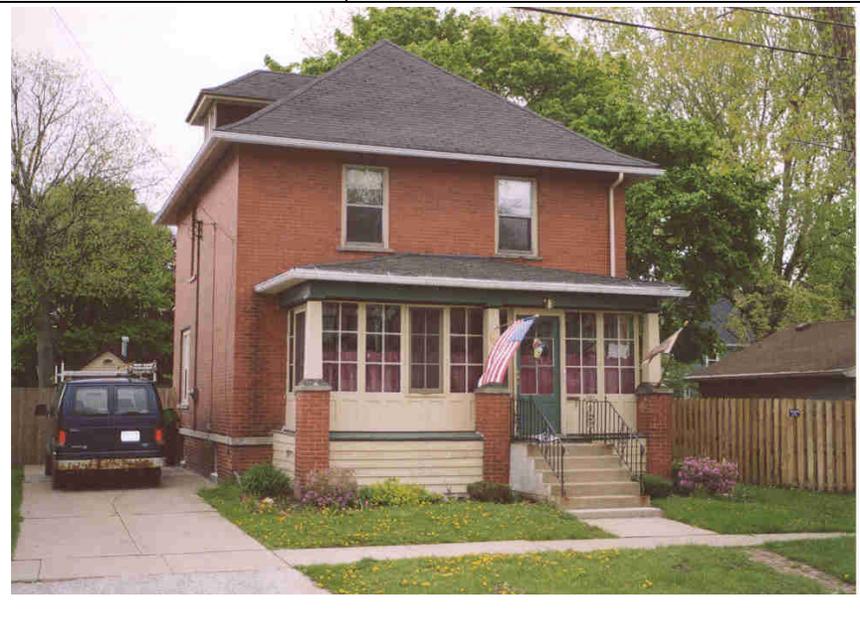
<p>ADDRESS: 102 Center Street</p>	<p>DATE OF CONSTRUCTION: ca. 1910</p>	<p>SIGNIFICANCE: C – Domestic architecture</p>

<p>DESCRIPTION: 2-1/2-story, hip-roof, brick, Four-square house incorporating hip-roof dormer, flared eaves with exposed rafter tails, two-story bay, two-bay hip-roof porch with closed handrail and 3/4-height battered posts set on brick piers.</p>

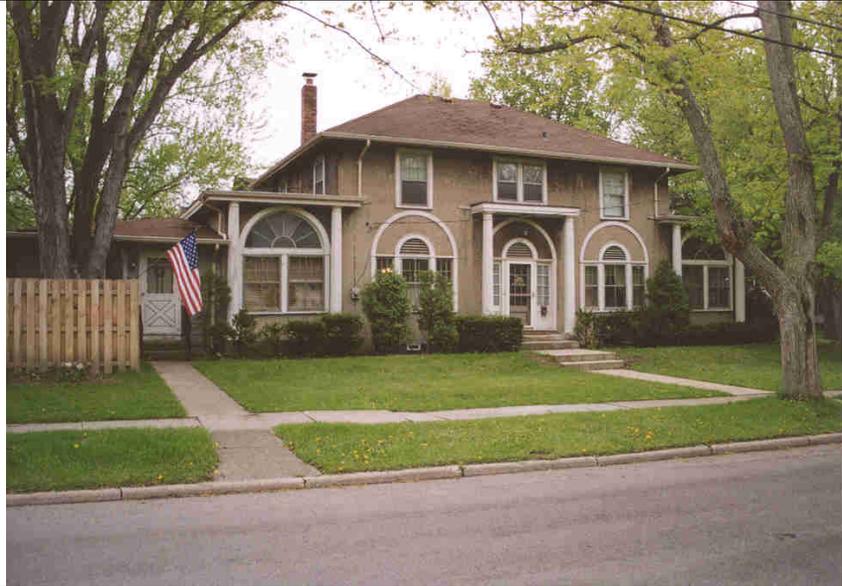
<p>ADDRESS: 114 Center Street</p>	<p>DATE OF CONSTRUCTION: ca. 1920</p>	<p>SIGNIFICANCE: C – Domestic architecture</p>

<p>DESCRIPTION: 2-1/2-story, hip-roof, stucco, symmetrical, three-bay, center entrance Italian Renaissance Revival house incorporating repeating half-round motif, broadly projecting eaves and Palladian windows.</p>

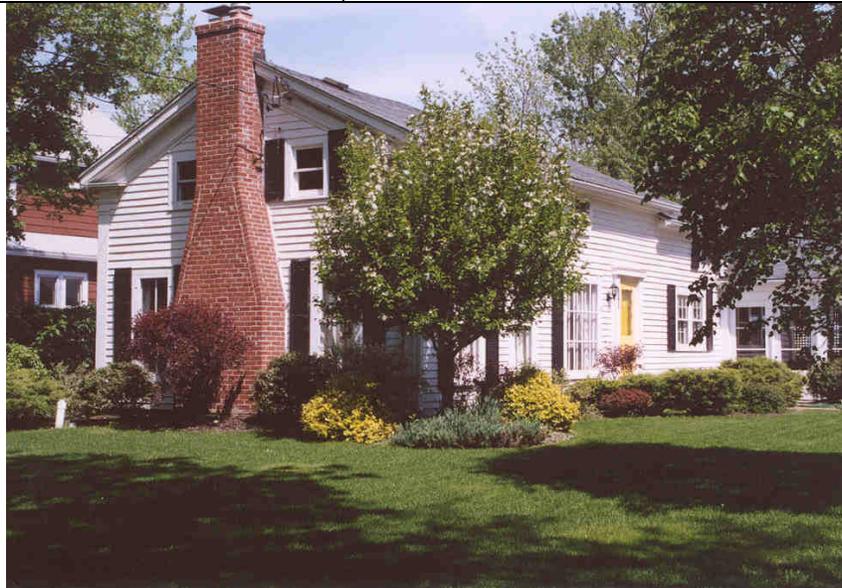
<p>ADDRESS: 117 Center Street</p>	<p>DATE OF CONSTRUCTION: ca. 1840</p>	<p>SIGNIFICANCE: C – Domestic architecture</p>

<p>DESCRIPTION: 1-1/2-story side-gable Greek Revival house with cornice returns and corner pilasters. Altered by additions, fenestration changes and twentieth-century gable-end chimney.</p>

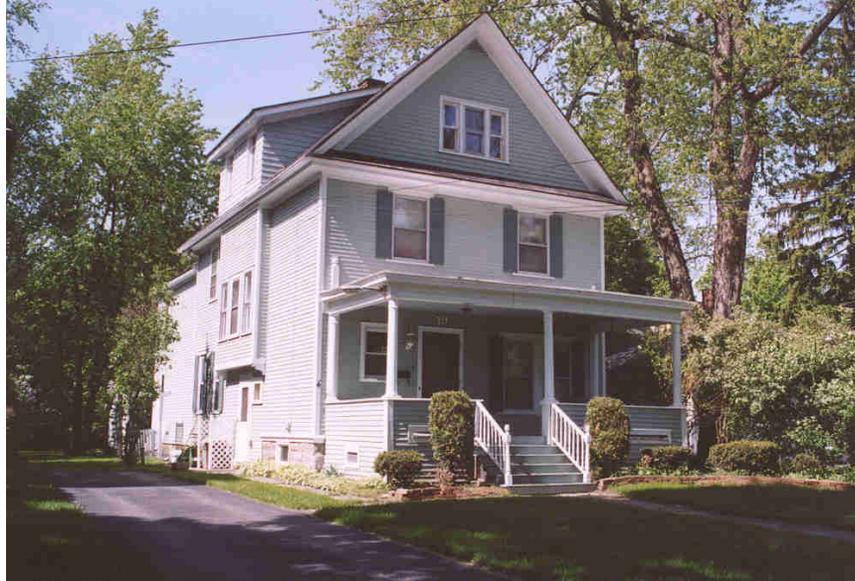
<p>ADDRESS: 19 Central Avenue</p>	<p>DATE OF CONSTRUCTION: ca. 1905</p>	<p>SIGNIFICANCE: C – Domestic architecture</p>

<p>DESCRIPTION: 2-1/2-story, front-gable Four-square house with closed gable roof at 45 degree pitch. Grade-level driveway door and rock-face concrete block foundation. Full façade porch supported by ¾ height Tuscan columns set on a closed handrail.</p>

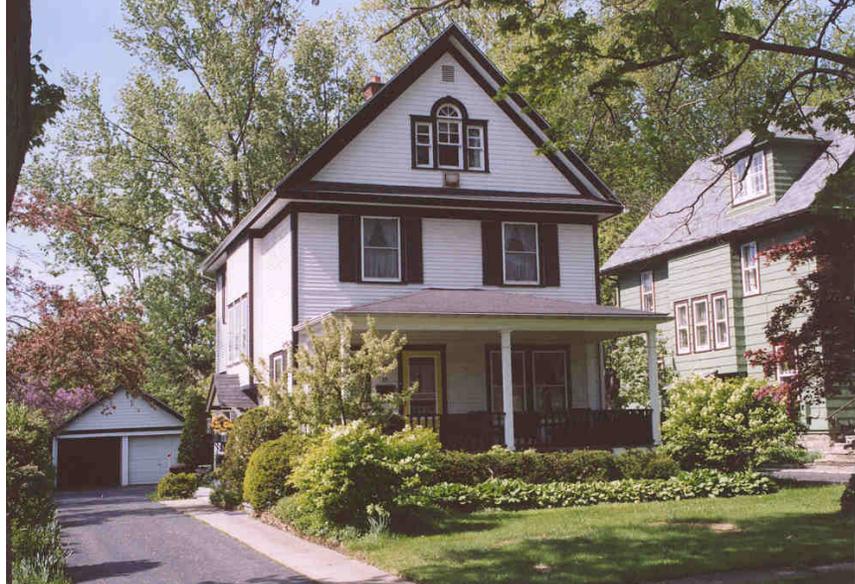
<p>ADDRESS: 35 Central Avenue</p>	<p>DATE OF CONSTRUCTION: ca. 1905</p>	<p>SIGNIFICANCE: C – Domestic architecture</p>

<p>DESCRIPTION: : 2-1/2-story, front-gable Four-square house with closed gable roof at 45 degree pitch, Palladian gable window. Grade level driveway door and rock-face concrete block foundation. Full façade porch supported by ¾ height Tuscan columns set on a closed handrail. Detached mid 20th century garage.</p>

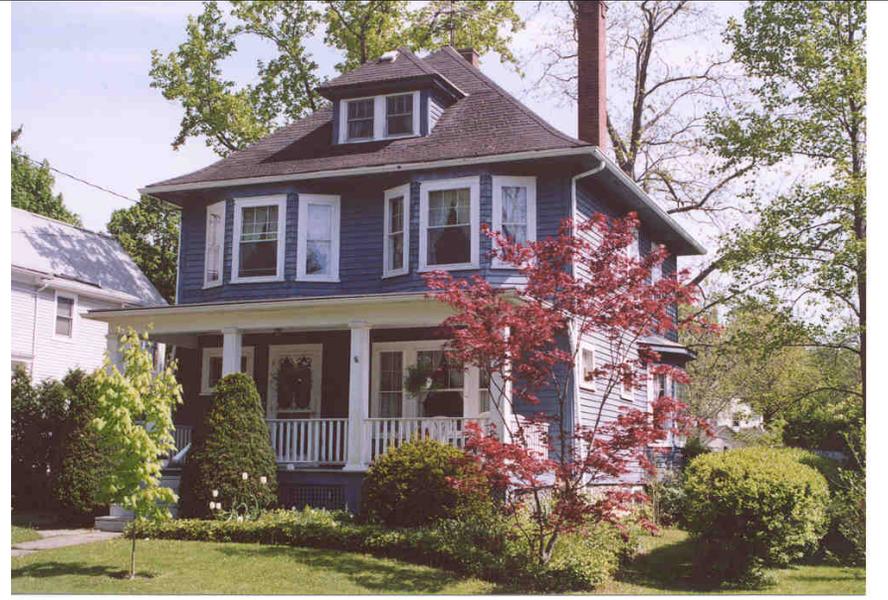
<p>DESCRIPTION: : 2-1/2-story, hip roof, Four-square house with 45 degree roof pitch. Grade level driveway door and rock-face concrete block foundation. Flared eaves, twin second-story three-sided bays, hip roof dormer, full façade, three-bay porch supported by battered square posts.</p>

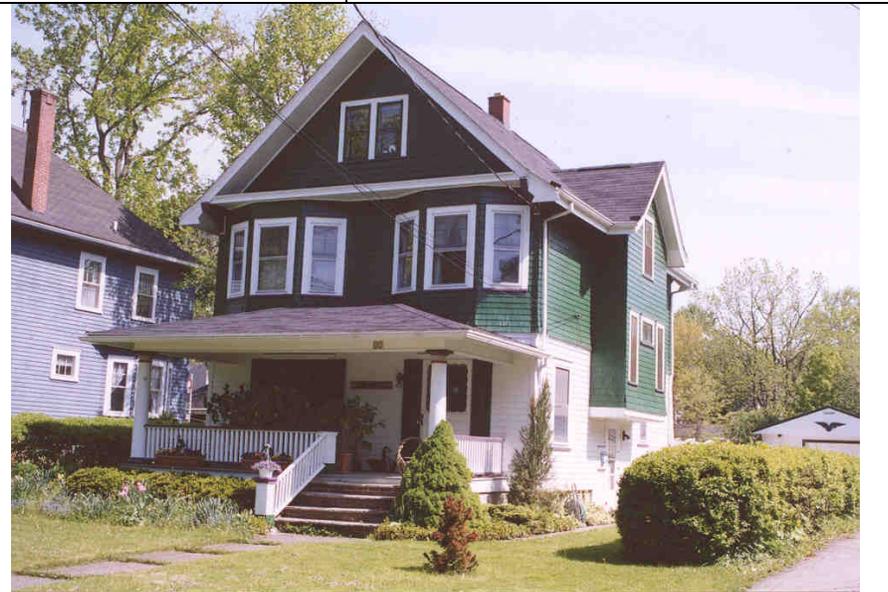
<p>DESCRIPTION: 2-1/2-story, front-gable Craftsman house with closed gable, knee braces supporting pent roof at base of closed gable, 45 degree roof pitch. Grade level driveway door, projecting stair gable and rock-face concrete block foundation. Flared eaves, twin second-story three-sided bays, full façade, single-bay porch supported by two massive Tuscan columns. The exterior of the house is clad with wood clapboard at the first-floor, while the second floor and gable ends are clad with wood shingles.</p>

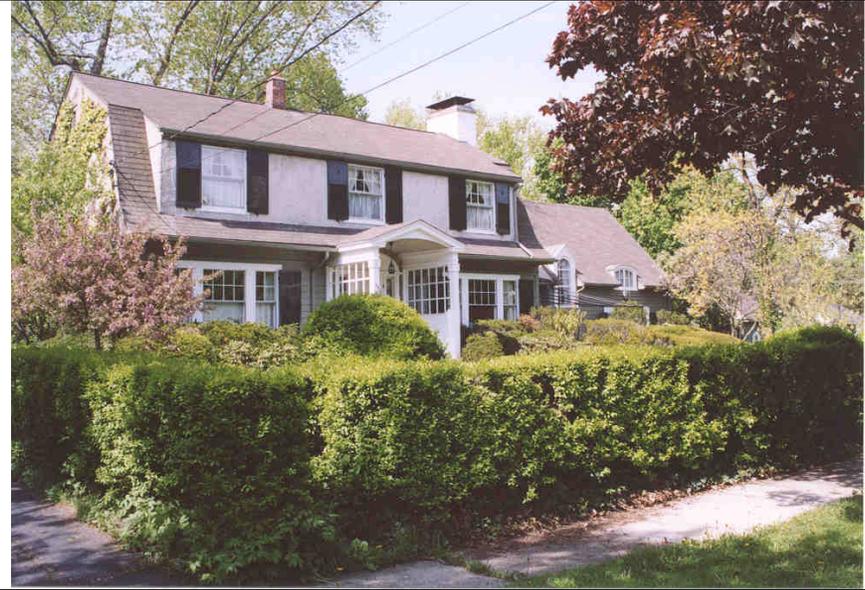
DESCRIPTION: 1-1/2-story, symmetrical gambrel roof Colonial Revival house with center entrance. The house incorporates stucco cladding, a full-façade shed dormer, cutout shutters, and a pedimented entry porch with lattice side panels.

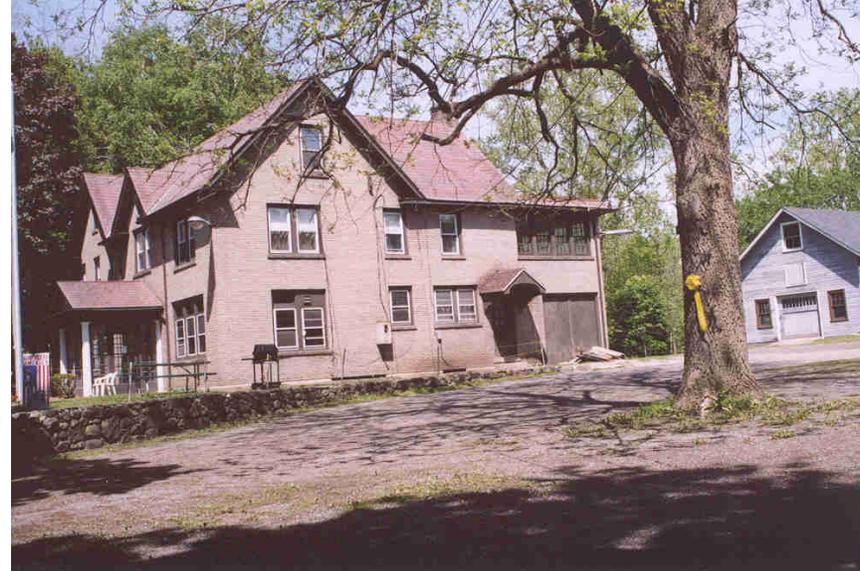
<p>ADDRESS: 65 Church Street (VFW Post)</p>	<p>DATE OF CONSTRUCTION: ca. 1915</p>	<p>SIGNIFICANCE: C – Domestic architecture</p>

<p>DESCRIPTION: Large 2-1/2-story, brick Craftsman house incorporating asymmetrical gables and pedimented entrance porch. Property retains 1-1/2-story carriage barn. Large gravel parking area is located on east side of house.</p>

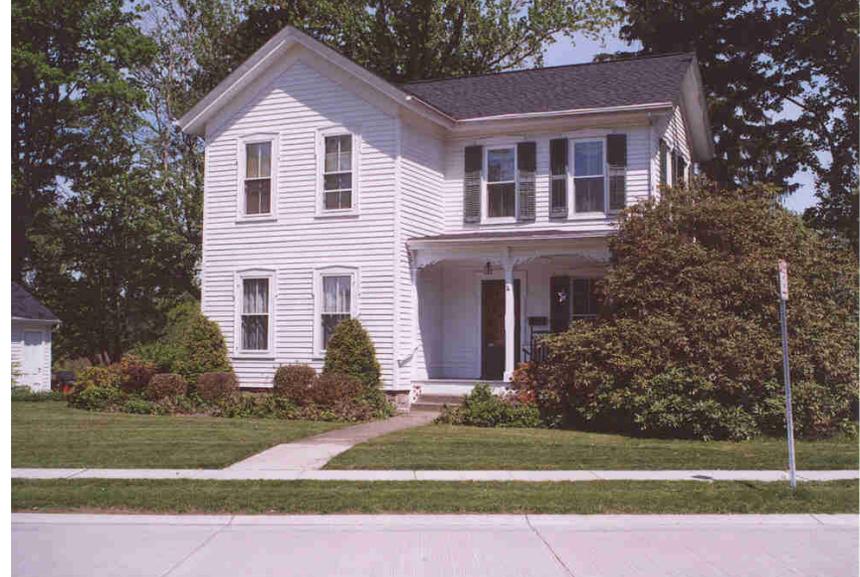
<p>ADDRESS: 97 Church Street</p>	<p>DATE OF CONSTRUCTION: ca. 1875</p>	<p>SIGNIFICANCE: S – Domestic architecture</p>

<p>DESCRIPTION: 2-1/2-story gable and wing Italianate house with drip-molded window surrounds, broadly projecting eaves and two-bay entry porch supported by square chamfered posts. Porch is embellished with scroll brackets. Property contains freestanding early 20th century garage.</p>

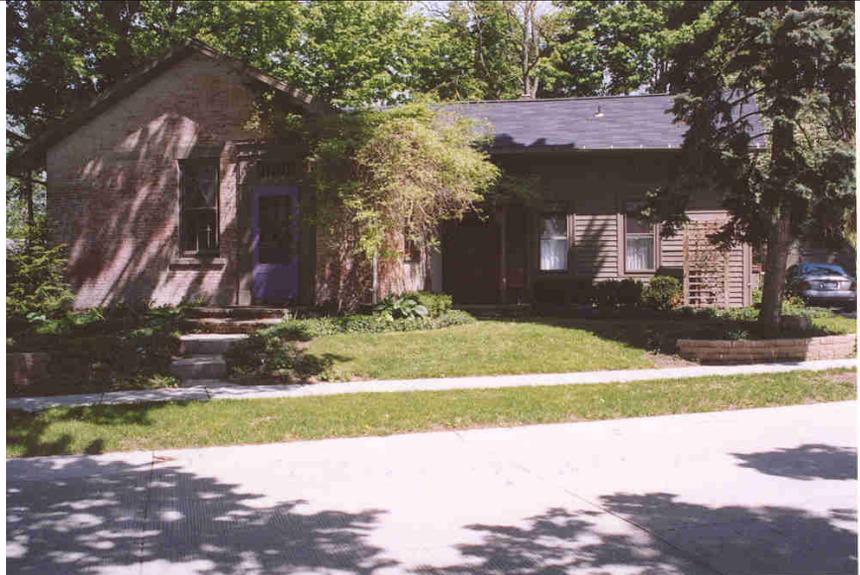
<p>ADDRESS: 99 Church Street</p>	<p>DATE OF CONSTRUCTION: ca. 1855</p>	<p>SIGNIFICANCE: S – Domestic architecture</p>

<p>DESCRIPTION: 1 story, wood and brick vernacular building. Brick section is a former Hamburg District School.</p>

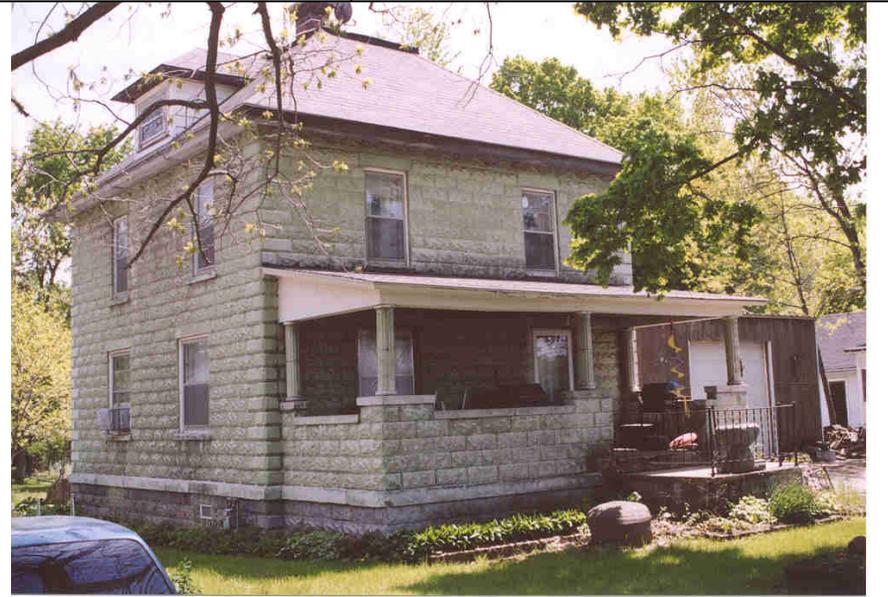
<p>DESCRIPTION: 2-1/2-story, hip-roof, Four-square rock-face concrete block house with 45 degree roof pitch. Hip-roof shingled dormer, full-façade, two-bay porch supported by fluted ½-height Tuscan columns set on a closed handrail. A smooth concrete watertable occurs at the top of the foundation.</p>

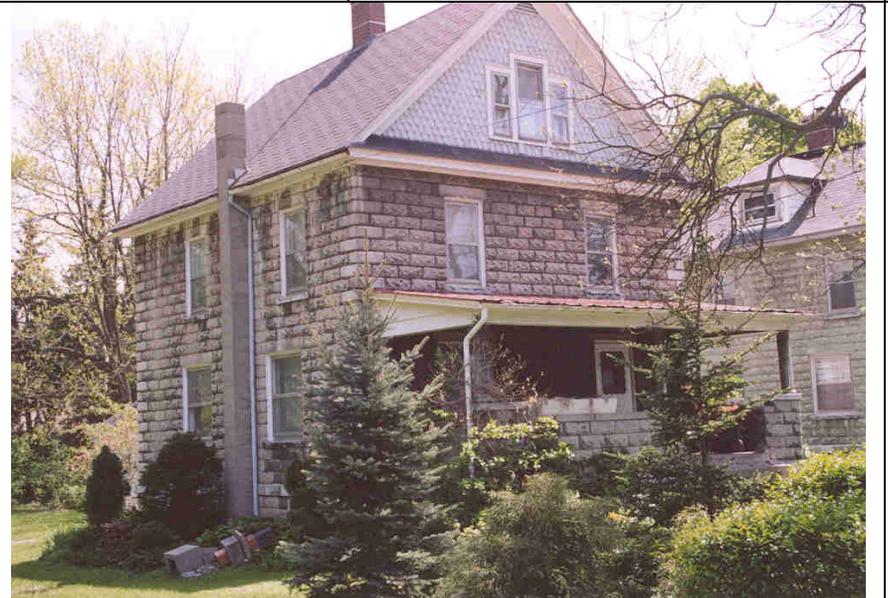
<p>DESCRIPTION: 2-1/2-story, front-gable Four-square rock-face concrete block house with 45 degree roof pitch. Fish scale-shingle closed gable, full-façade, two-bay porch supported by fluted Tuscan columns with closed handrail.</p>

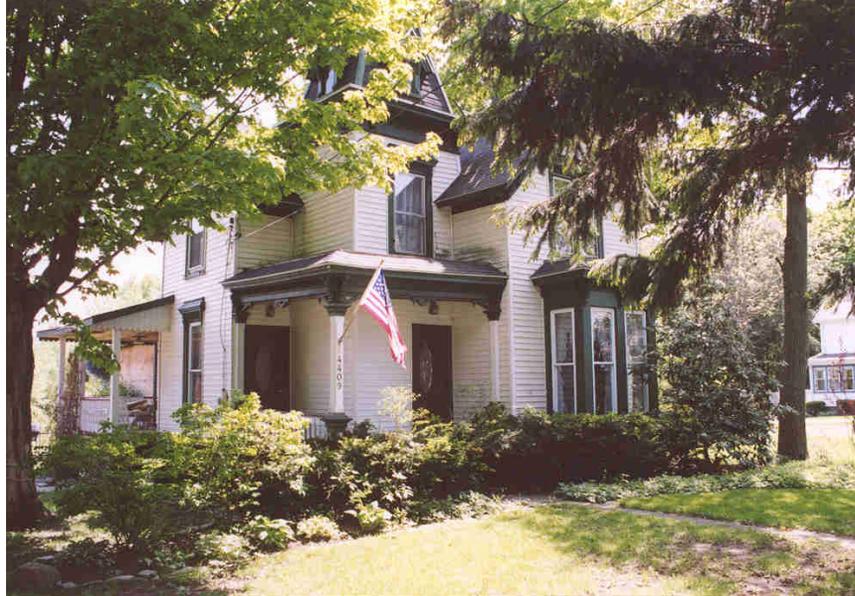
<p>ADDRESS: 4409 Clark Street</p>	<p>DATE OF CONSTRUCTION: ca. 1870</p>	<p>SIGNIFICANCE: S – Domestic architecture</p>

<p>DESCRIPTION: 2-1/2-story gable and wing Italianate house incorporating Mansard-roof tower. House features pent-roof window hoods, steeply pitched roofs, four-window bay, and entrance porch supported by chamfered square posts.</p>

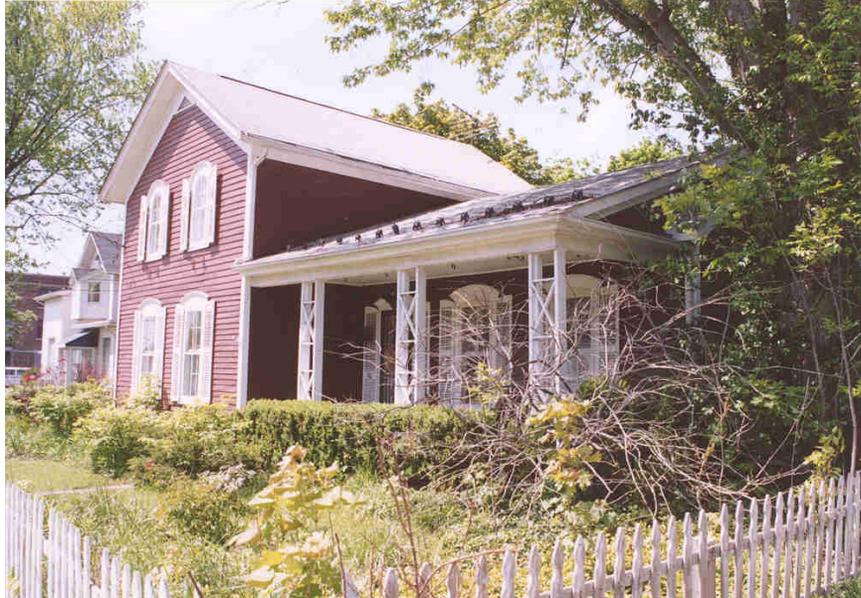
<p>ADDRESS: 110 East Main Street</p>	<p>DATE OF CONSTRUCTION: ca. 1860</p>	<p>SIGNIFICANCE: C – Domestic architecture</p>

<p>DESCRIPTION: 2-1/2-story gable and wing house with broadly projecting eaves, segmental window hoods and a three-bay entry porch supported by lattice posts.</p>

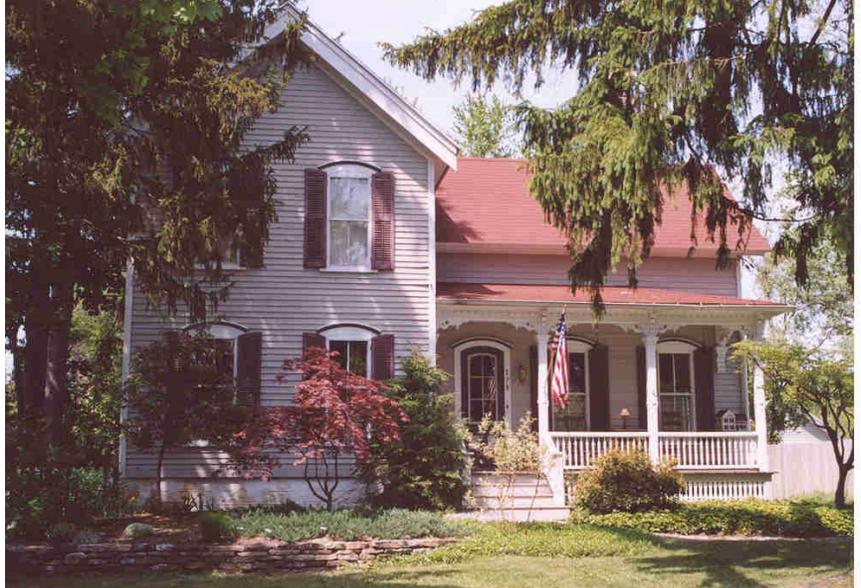
<p>ADDRESS: 178 East Main Street</p>	<p>DATE OF CONSTRUCTION: ca. 1870</p>	<p>SIGNIFICANCE: S – Domestic architecture</p>

<p>DESCRIPTION: 2-1/2-story gable and wing Italianate house with drip-molded window surrounds, broadly projecting eaves and three-bay entry porch supported by square chamfered posts. Porch is embellished with scroll brackets.</p>

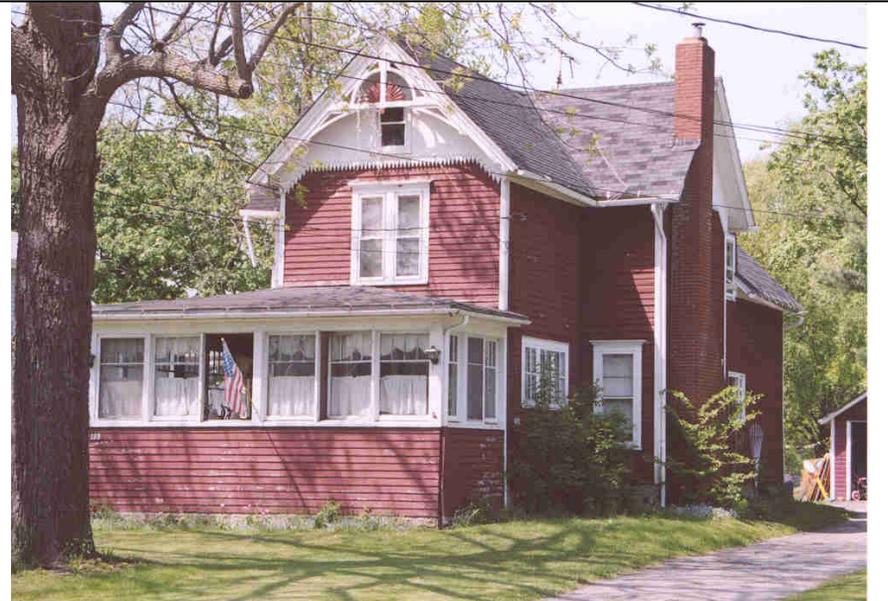
<p>ADDRESS: 188 East Main Street</p>	<p>DATE OF CONSTRUCTION: ca. 1880</p>	<p>SIGNIFICANCE: C – Domestic architecture</p>

<p>DESCRIPTION: 2-1/2-story cross plan Queen Anne house with decorative gable-end bargeboard featuring decorative sun motif and flush-board gable cladding with a sawtooth edge treatment. The wraparound porch was enclosed early in the 20th century.</p>

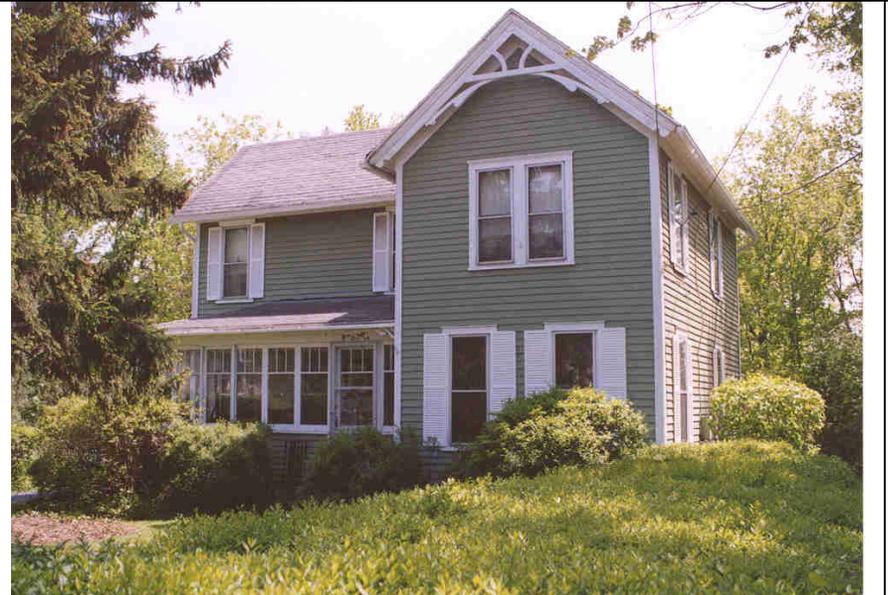
<p>ADDRESS: 193 East Main Street</p>	<p>DATE OF CONSTRUCTION: ca. 1880</p>	<p>SIGNIFICANCE: C – Domestic architecture</p>

<p>DESCRIPTION: 2-1/2-story gable and wing house incorporating a Queen Anne gable-end bargeboard and tall, narrow 1/1 double-hung windows. Side porch incorporates early 20th century storm panels.</p>

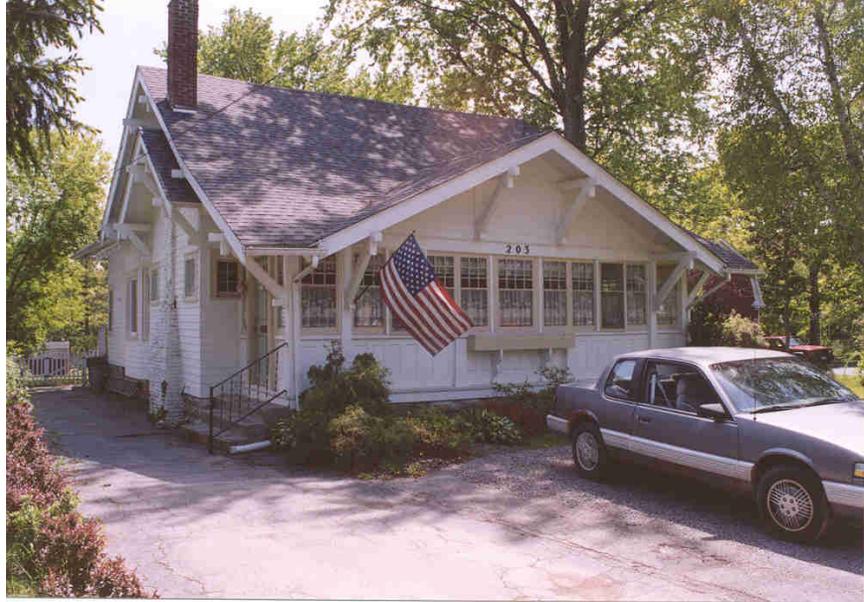
ADDRESS: 203 East Main Street	DATE OF CONSTRUCTION: ca. 1915	SIGNIFICANCE: S – Domestic architecture

DESCRIPTION: 1-1/2-story cross-gable Craftsman bungalow. Projecting roof with exposed rafter tails supported by triangular knee braces. Full façade enclosed porch.

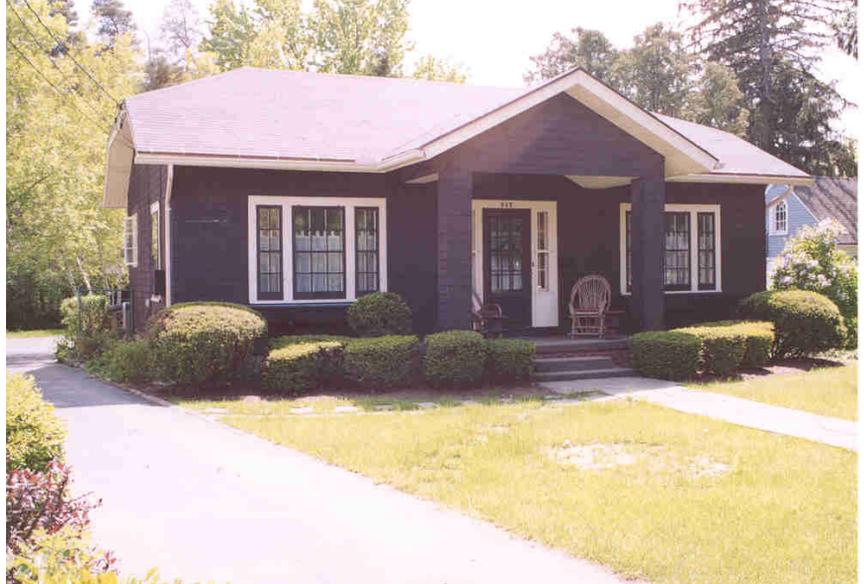
ADDRESS: 217 East Main Street	DATE OF CONSTRUCTION: ca. 1925	SIGNIFICANCE: C – Domestic architecture

DESCRIPTION: 1-1/2-story symmetrical jerkinhead-roof Colonial Revival house clad with stained wood shingles and front-gable entrance porch. This house was long associated with the Kronnenberg family who were prominent retail merchants in Hamburg from the mid nineteenth to mid twentieth centuries.

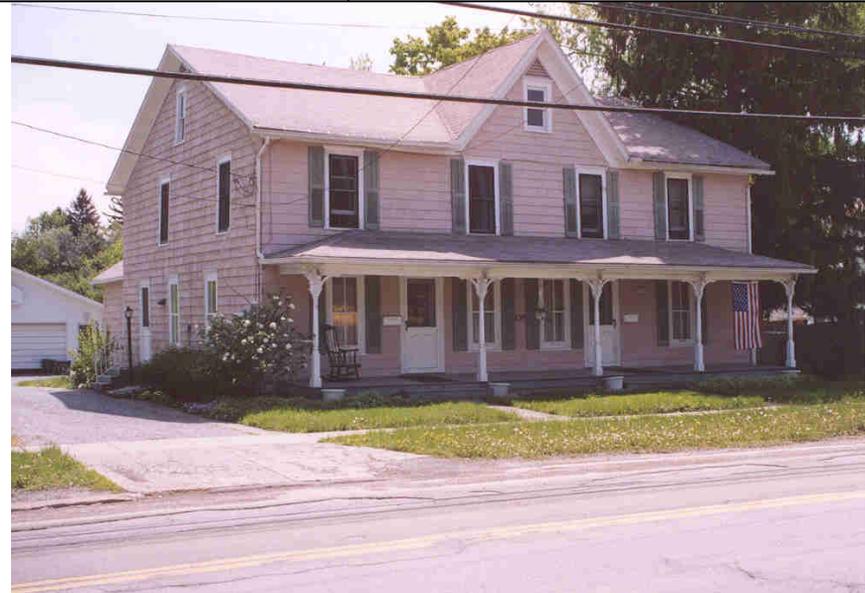
<p>DESCRIPTION: 2-1/2-story cross-gable Vernacular early nineteenth-century house remodeled and enlarged about 1870. The house has a steeply pitched cross gable, tall narrow windows and a four bay porch supported by turned posts. Altered by early 20th century wood shingle cladding.</p>

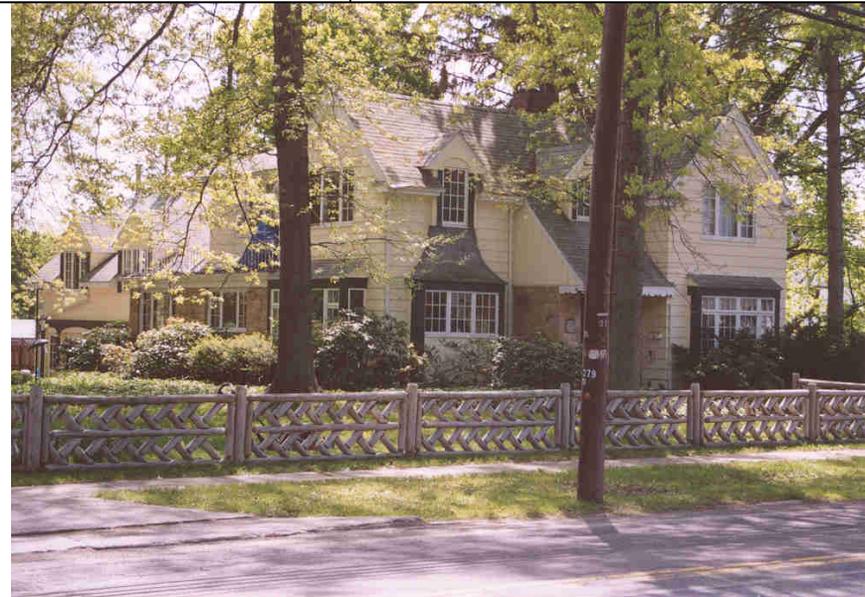
<p>ADDRESS: 279 East Main Street</p>	<p>DATE OF CONSTRUCTION: ca. 1930</p>	<p>SIGNIFICANCE: C – Domestic architecture</p>

<p>DESCRIPTION: Large rambling 2-1/2-story asymmetrical Tudor Revival house incorporated varied bays, dormers, steeply pitched roofs, and a mixture of brick and wood clapboard cladding.</p>

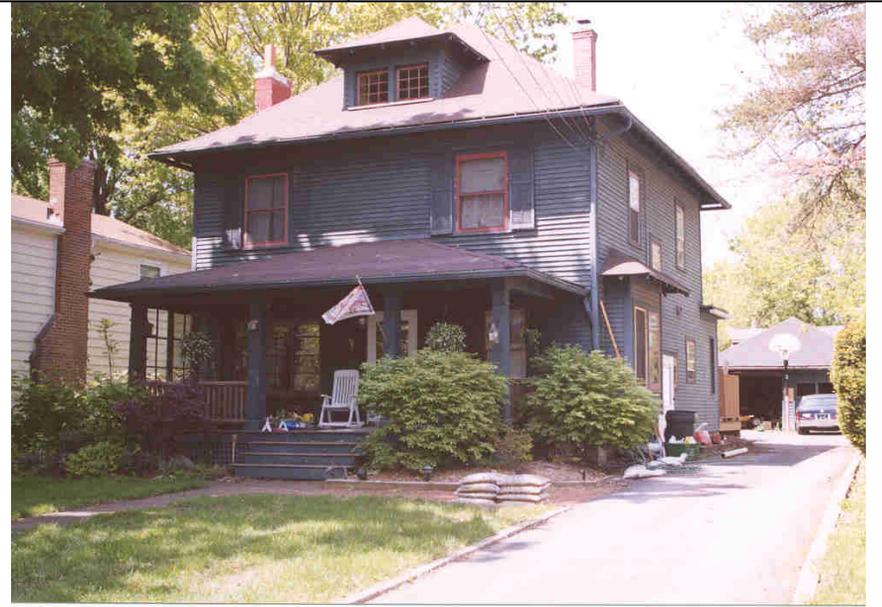
<p>DESCRIPTION: 2-1/2-story, hip roof Four-square house incorporating hip roof dormer. Flared roof with exposed rafter tails. Grade-level driveway door, rock-face concrete block foundation. Three-bay full-width porch supported by battered square posts.</p>

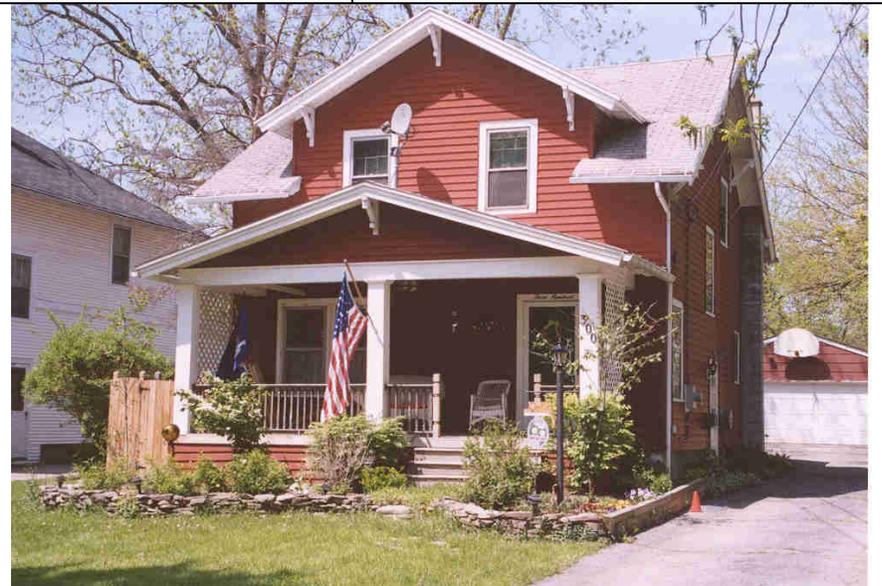
<p>DESCRIPTION: 1-1/2-story Craftsman house with side gable featuring large front gable dormer, gable end triangular knee braces and a front-gable two-bay full façade porch supported by square posts.</p>

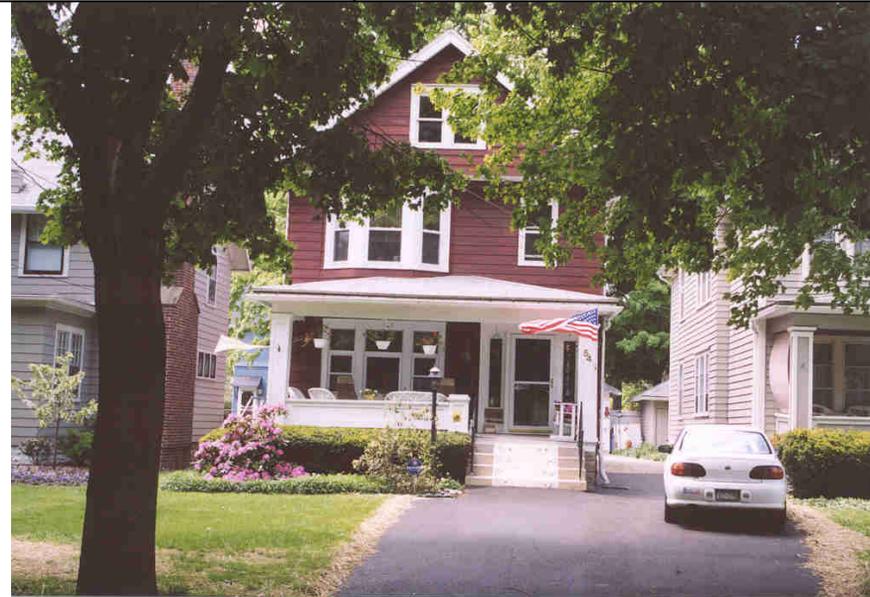
<p>DESCRIPTION: 2-1/2-story front-gable Four-square house with 45 degree roof slope and closed gable. Grade level driveway entrance, rock face concrete block foundation and three-sided projecting bay. One-bay full-façade porch supported by massive full height square posts.</p>

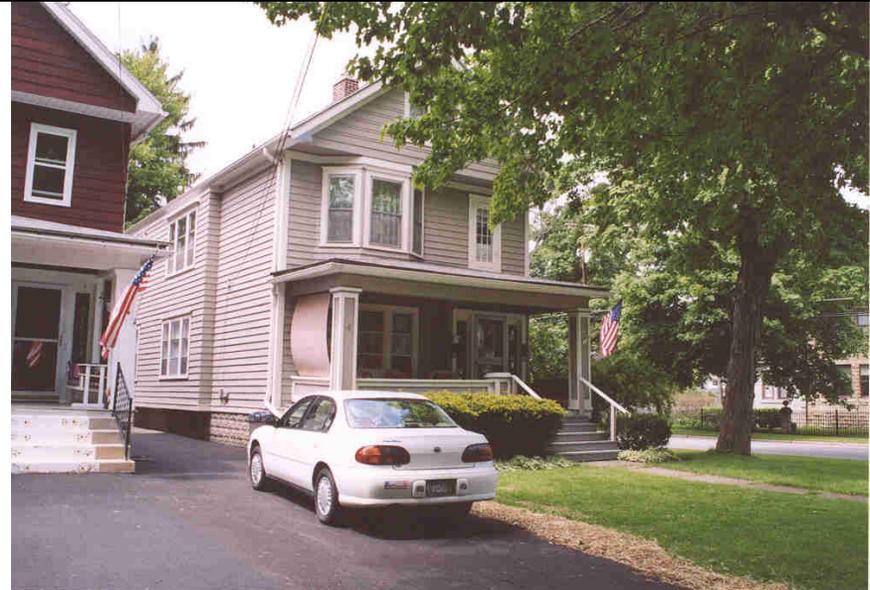
<p>DESCRIPTION: : 2-1/2-story front-gable Four-square house with 45 degree roof slope and closed gable, rock-face concrete block foundation, three-sided projecting bay, and single-bay full façade porch supported by massive full height square posts.</p>

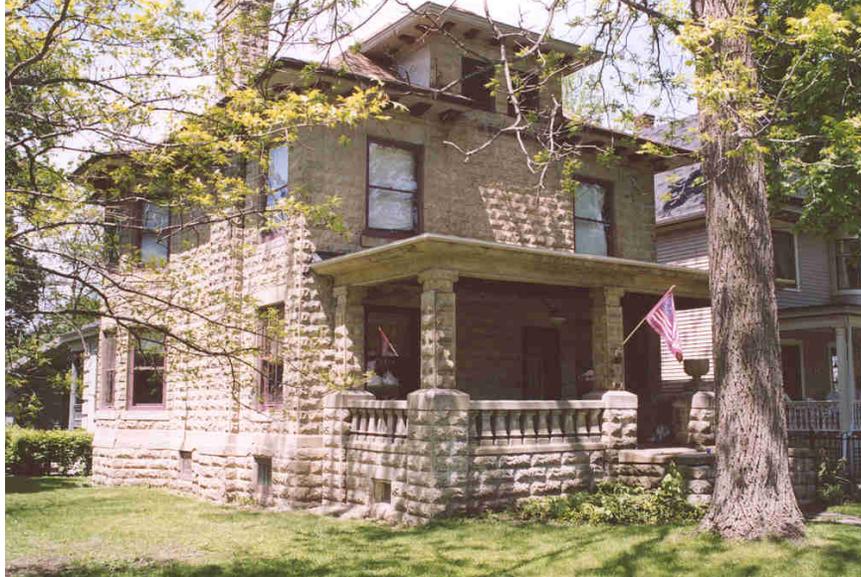
<p>ADDRESS: 70 Hawkins Avenue</p>	<p>DATE OF CONSTRUCTION: ca. 1905</p>	<p>SIGNIFICANCE: S – Domestic architecture</p>

<p>DESCRIPTION: 2-1/2-story, hip roof rock-face concrete block, Four-square house with 45 degree roof pitch. Flared eaves and eaves brackets, two-story side bay and hip roof dormer on the front façade. The first floor level of the house is marked on the exterior facades by a smooth textured water table. Full façade, two-bay porch supported by ¾ height square posts set on piers. The foundation piers and posts are all constructed of rock faced concrete block. The precast concrete handrail incorporates decoratively shaped balusters.</p>

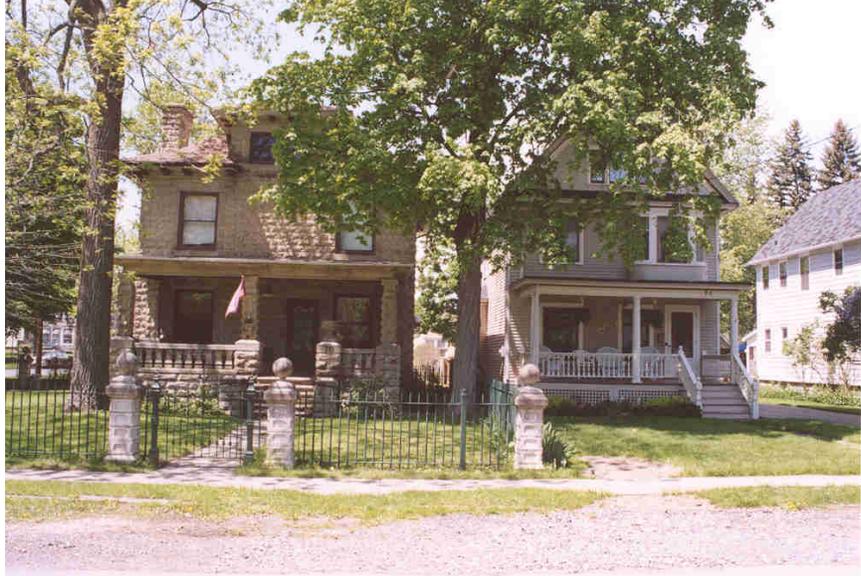
<p>ADDRESS: 74 Hawkins Avenue</p>	<p>DATE OF CONSTRUCTION: ca. 1905</p>	<p>C – Domestic architecture</p>

<p>DESCRIPTION: 2-1/2-story, front-gable Four-square house with closed gable roof at 45 degree pitch. Second-story rounded projecting bay and full façade two-bay porch supported by full height Tuscan columns.</p>

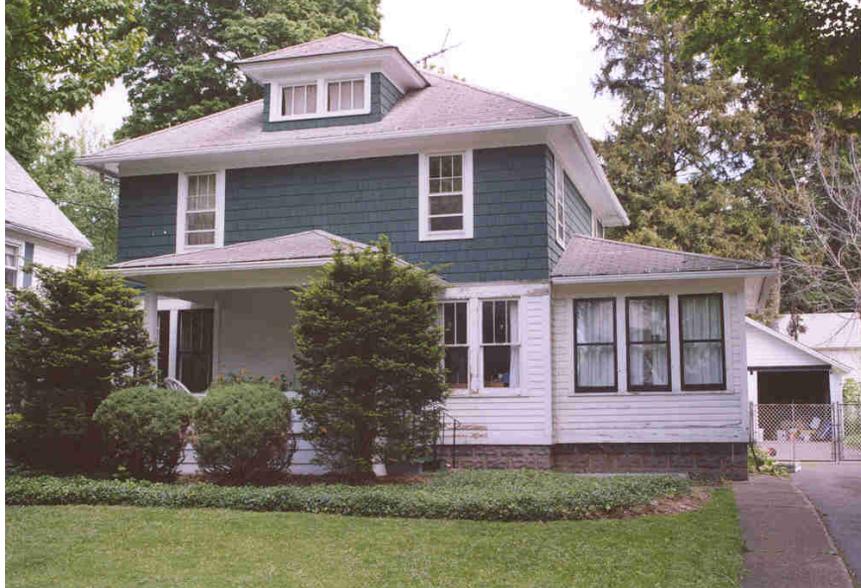
<p>ADDRESS: 85 Hawkins Avenue</p>	<p>DATE OF CONSTRUCTION: ca. 1910</p>	<p>SIGNIFICANCE: C – Domestic architecture</p>

<p>DESCRIPTION: 2-1/2-story, hip roof Four-square house incorporating a hip roof dormer. Side one-story hip roof enclosed porch, rock-face concrete block foundation. One-bay partial-width porch supported by two battered square posts with a closed handrail. Clapboard/wood shingle cladding.</p>

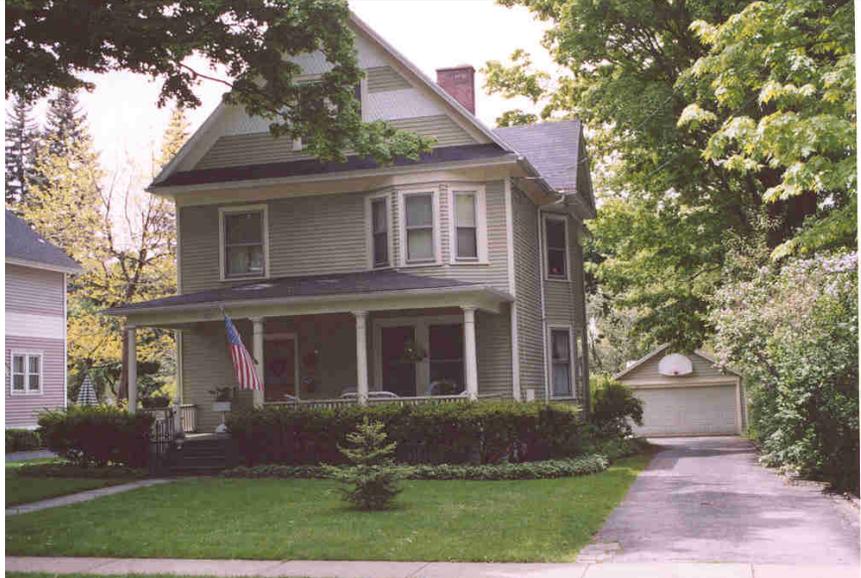
<p>ADDRESS: 92 Hawkins Avenue</p>	<p>DATE OF CONSTRUCTION: ca. 1900</p>	<p>SIGNIFICANCE: C – Domestic architecture</p>

<p>DESCRIPTION: 2-1/2-story, front-gable late Queen Anne house with 45 degree roof pitch. House incorporates closed gable ends, a rock-face concrete block foundation, single second-story three-sided bay, full façade, three-bay porch supported by full height Tuscan columns. Gables are clad with alternating bands of decoratively cut shingles.</p>

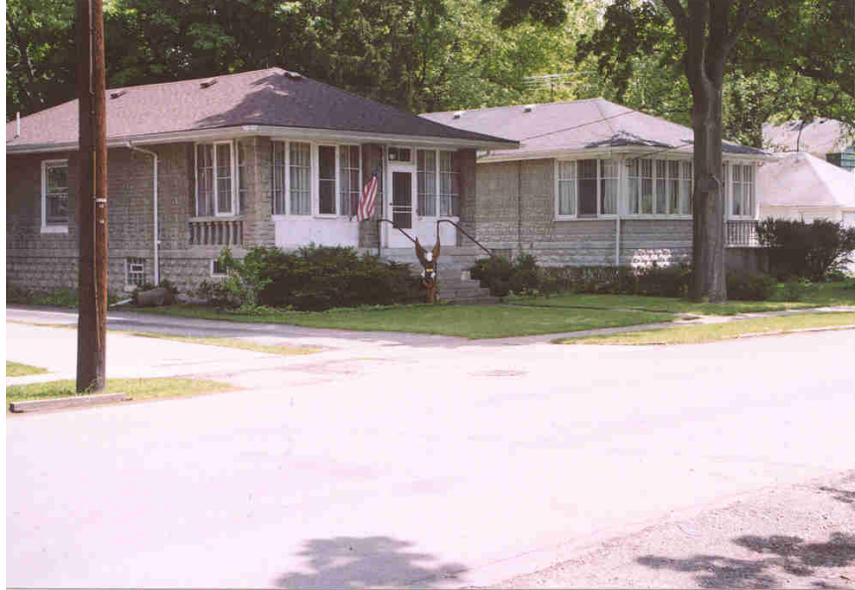
<p>ADDRESS: 131 & 135 Hawkins Ave.</p>	<p>DATE OF CONSTRUCTION: ca. 1910</p>	<p>SIGNIFICANCE: S – Domestic architecture</p>

<p>DESCRIPTION: Pair of similar 1-1/2-story, hip-roof, rock-face concrete block houses with enclosed full façade porches.</p>

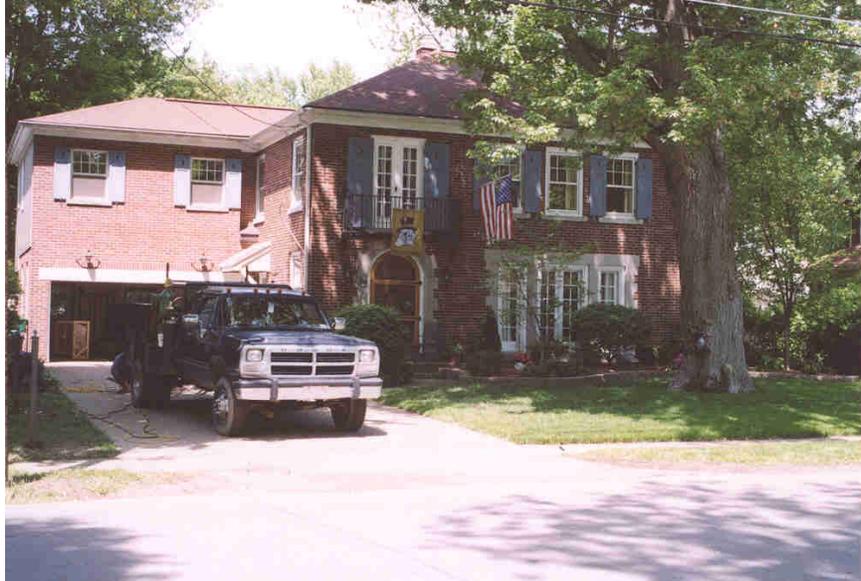
ADDRESS: 199 Highland Avenue	DATE OF CONSTRUCTION: ca. 1930	SIGNIFICANCE: C – Domestic architecture

DESCRIPTION: 2-1/2-story brick-clad, hip-roof, French Eclectic house featuring French doors and a half-round entrance opening with a quoined surround. The second story has a wrought metal balcony. The side wing incorporates an attached garage at grade.

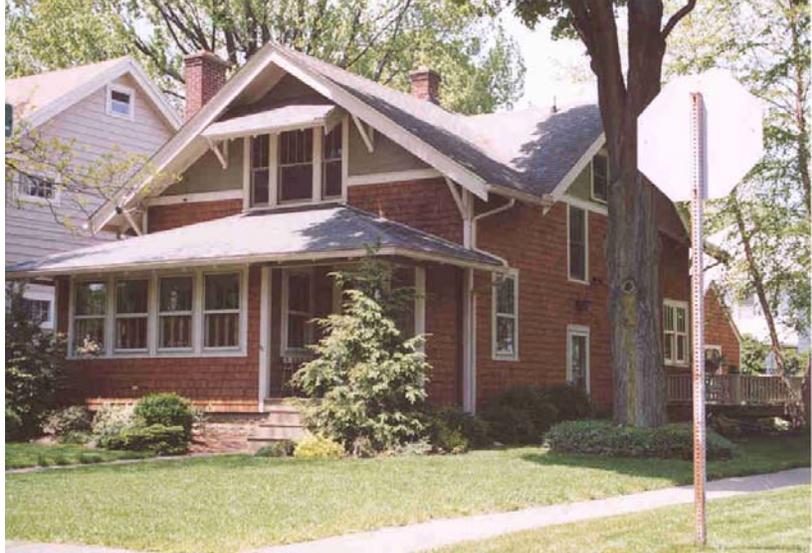
ADDRESS: 291 Highland Avenue	DATE OF CONSTRUCTION: ca. 1915	SIGNIFICANCE: C – Domestic architecture

DESCRIPTION: 1-1/2-story front-gable Craftsman house. Projecting eaves with exposed rafter tails supported by triangular knee braces. Rock-face concrete block foundation, shed awning above bay of upper register supported by triangular knee braces, contrasting cladding between upper and lower story with stained wood shingles below and painted wood shingles above. Enclosed hip roof porch.

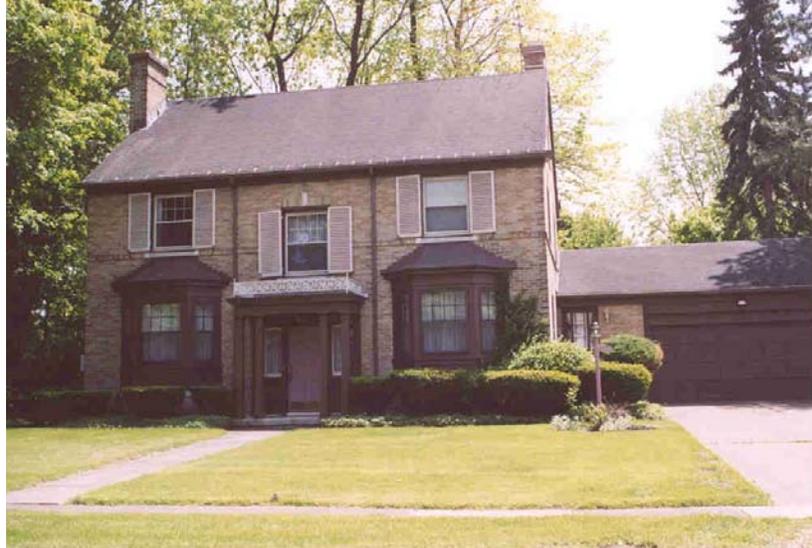
<p>ADDRESS: 296 Highland Avenue</p>	<p>DATE OF CONSTRUCTION: ca. 1930</p>	<p>SIGNIFICANCE: C – Domestic architecture</p>

<p>DESCRIPTION: 2-1/2-story side-gable center-entrance brick Colonial Revival house. Three-bay symmetrical façade, twin three-sided projecting bays on lower story flanking central portico, molded courses at cornice, header string course located at second floor sill level. Partial-façade one-story flat roof entry porch supported by paired square posts. Central door framed by sidelights.</p>

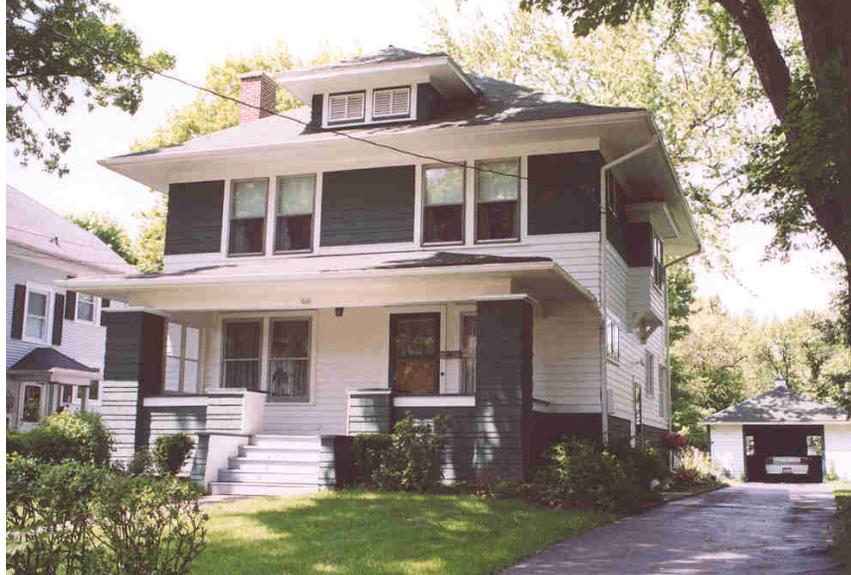
<p>ADDRESS: 313 Highland Avenue</p>	<p>DATE OF CONSTRUCTION: ca. 1910</p>	<p>SIGNIFICANCE: S – Domestic architecture</p>

<p>DESCRIPTION: 2-1/2-story, hip roof, Four-square Prairie house. The house incorporates flared broadly projecting eaves, a hip roof dormer, grade level driveway door and full façade, single-bay porch supported by massive shingle-clad square piers extending to the ground. A second-floor sill-level string course separates clapboard below from stained wood shingles above.</p>

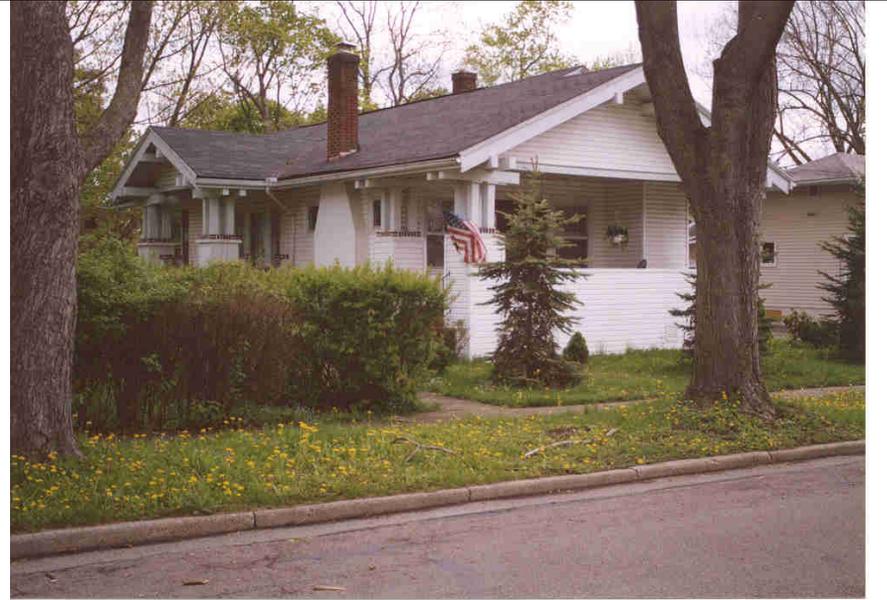
<p>DESCRIPTION: 1-1/2-story, front-gable wood-frame Craftsman house. Projecting eaves with exposed rafter tails and supported by decorative wood beams. Single-bay full-façade porch supported by ½ height grouped square posts with closed handrail. Decorative brickwork between square posts and supporting piers.</p>

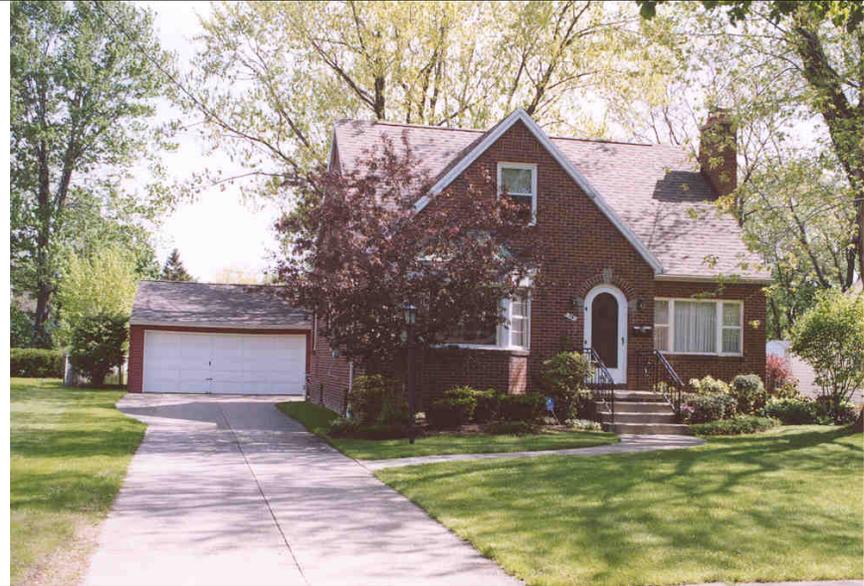
<p>ADDRESS: 78 Idlewood Avenue</p>	<p>DATE OF CONSTRUCTION: ca. 1940</p>	<p>SIGNIFICANCE: C – Domestic architecture</p>

<p>DESCRIPTION: 1-1/2-story cross-gable brick Minimal Traditional house featuring a three-sided bay, picture window and half-round entrance opening surrounded by a brick arch.</p>
