RECONNAISSANCE LEVEL SURVEY
OF HISTORIC RESOURCES

VILLAGE OF HAMBURG

Erie County, New York

Bero Architecture PC
32 Winthrop Street
Rochester, New York 14607

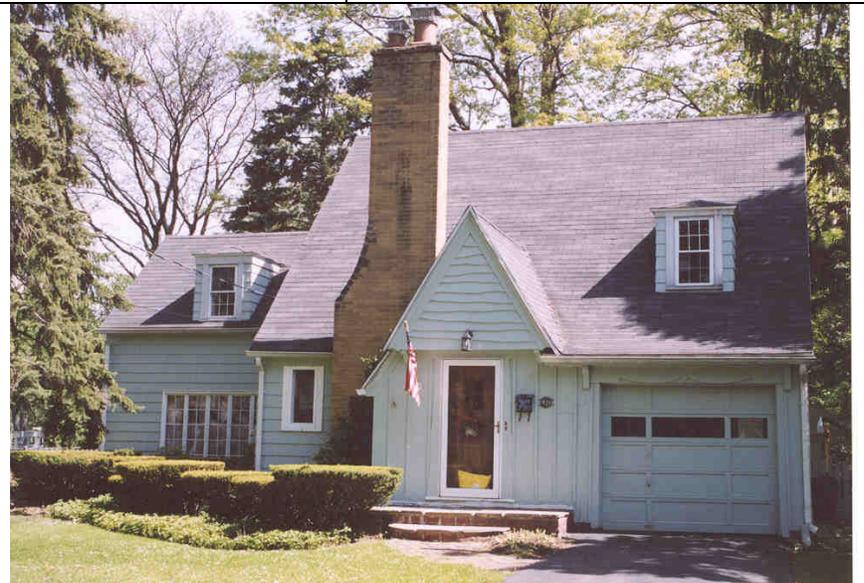
<p>ADDRESS: 92 Idlewood Avenue</p>	<p>DATE OF CONSTRUCTION: ca. 1940</p>	<p>SIGNIFICANCE: C – Domestic architecture</p>

<p>DESCRIPTION: 1-1/2-story side-gable Tudor Revival house. The house incorporates steeply pitched roof incorporating hip roof dormers, massive exterior brick chimney, imitation rough sawn clapboard at front gable, and twin wood brackets supporting main gable. The single-car garage is incorporated into the main mass of the house.</p>

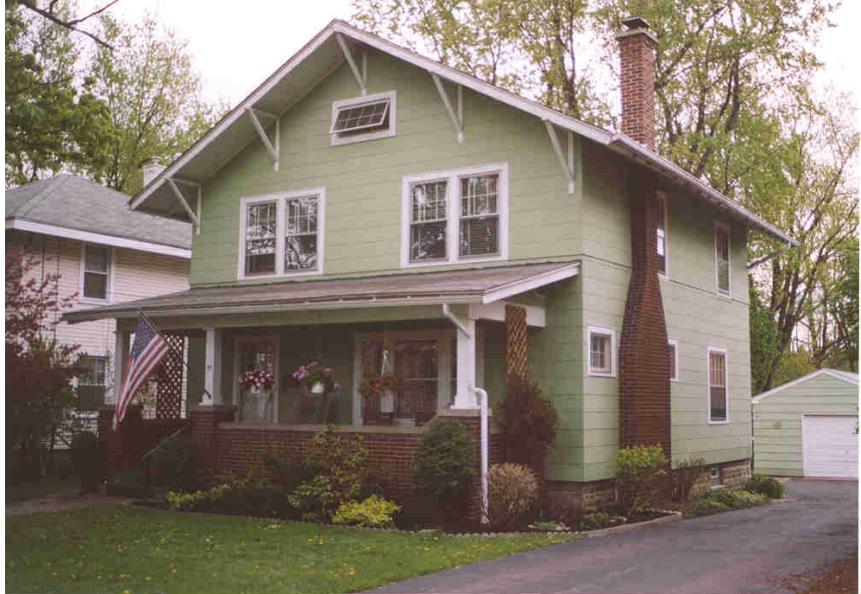
<p>DESCRIPTION: 2-1/2-story, front gable wood frame Craftsman house with brick exterior chimney, rock-face concrete block foundation and projecting roof with exposed rafter tails supported by triangular knee braces. Full façade, two-bay porch supported by square posts with closed handrail. Mid twentieth-century asbestos shingle cladding.</p>

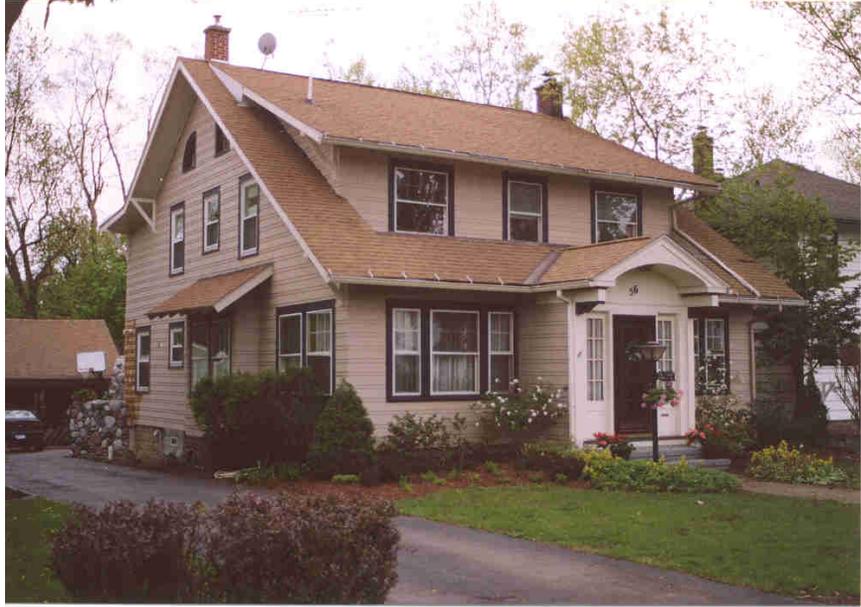
<p>DESCRIPTION: 1-1/2 story, side-gable roof, wood frame Craftsman house. Projecting eaves with exposed rafter tails supported by triangular knee brackets. Rock-face concrete block foundation, full-façade shed dormer and pedimented entry porch.</p>

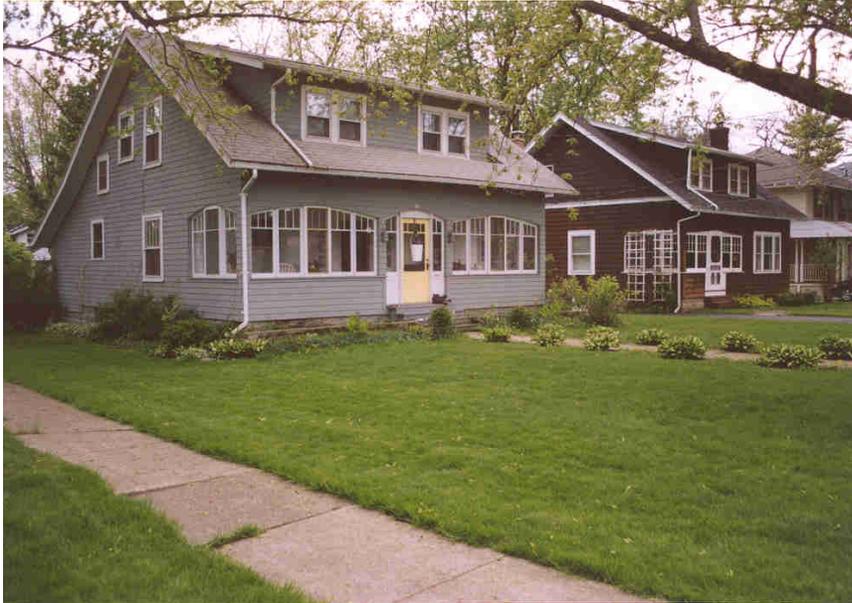
<p>DESCRIPTION: Both 1-1/2-story, side-gable Craftsman bungalow houses featuring full-façade shed dormers and enclosed porches.</p>

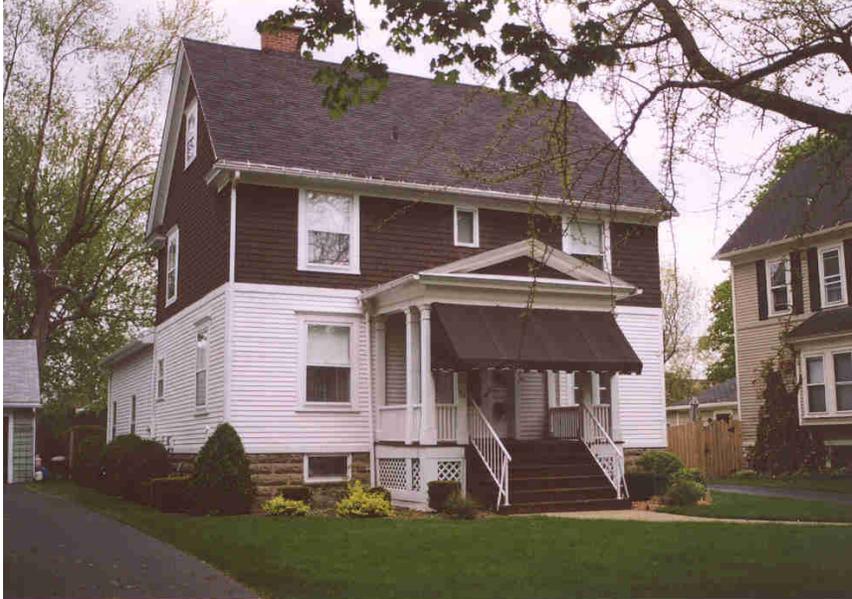
<p>DESCRIPTION: 2-1/2-story, side-gable Colonial Revival house with rock faced concrete block foundation, contrasting cladding between stories and a pedimented entry porch supported by grouped square Tuscan columns.</p>

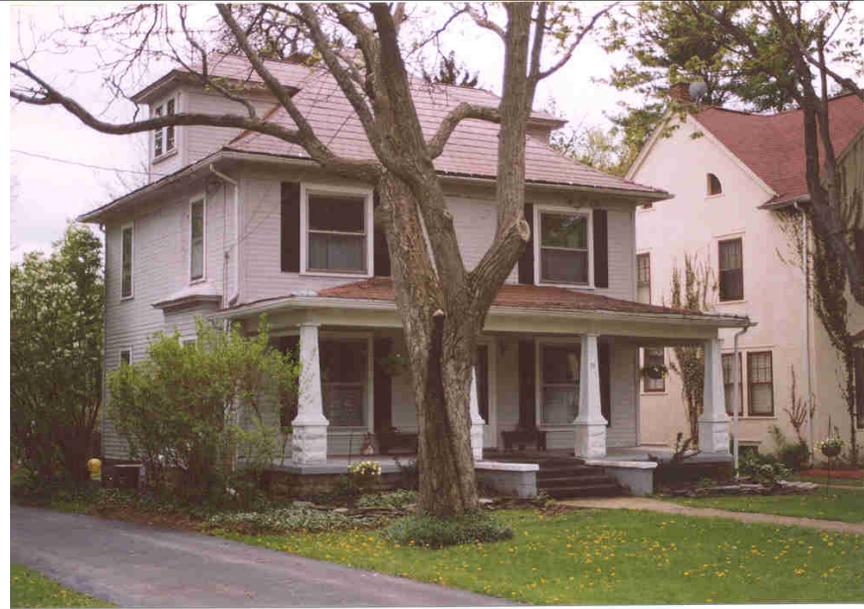
<p>DESCRIPTION: 2-1/2-story, hip-roof Four-square house incorporating hip-roof dormers, flared eaves with exposed rafter tails, two-story bay with three-bay hip-roof porch supported by battered square posts set on rock-face concrete block piers.</p>

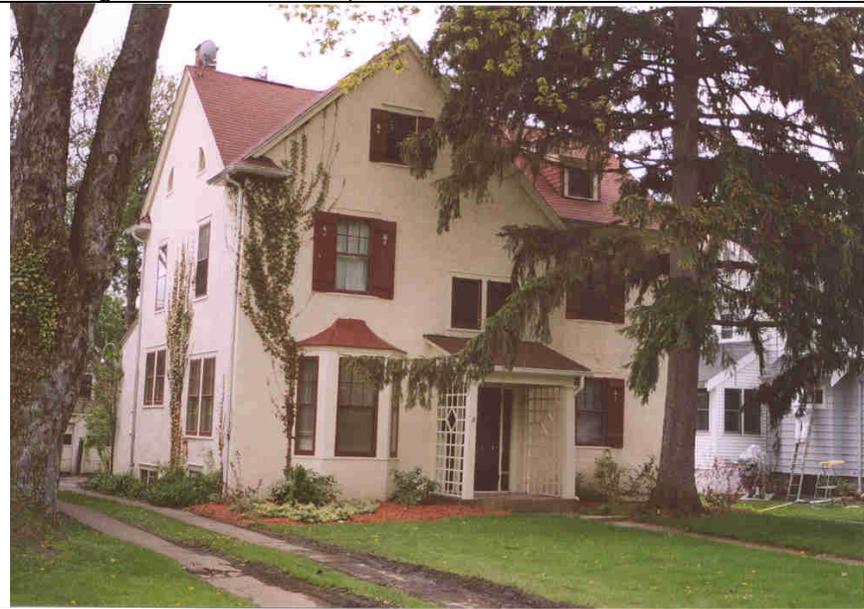
<p>ADDRESS: 100 Long Avenue</p>	<p>DATE OF CONSTRUCTION: ca. 1925</p>	<p>SIGNIFICANCE: C – Domestic architecture</p>

<p>DESCRIPTION: 2-1/2-story, asymmetrical side-gable stucco Colonial Revival house featuring a flared roof, cut-out shutters and stucco cladding. Partial-façade shed roof entrance portico supported by full-height Tuscan columns and enclosed by lattice panels on the sides.</p>

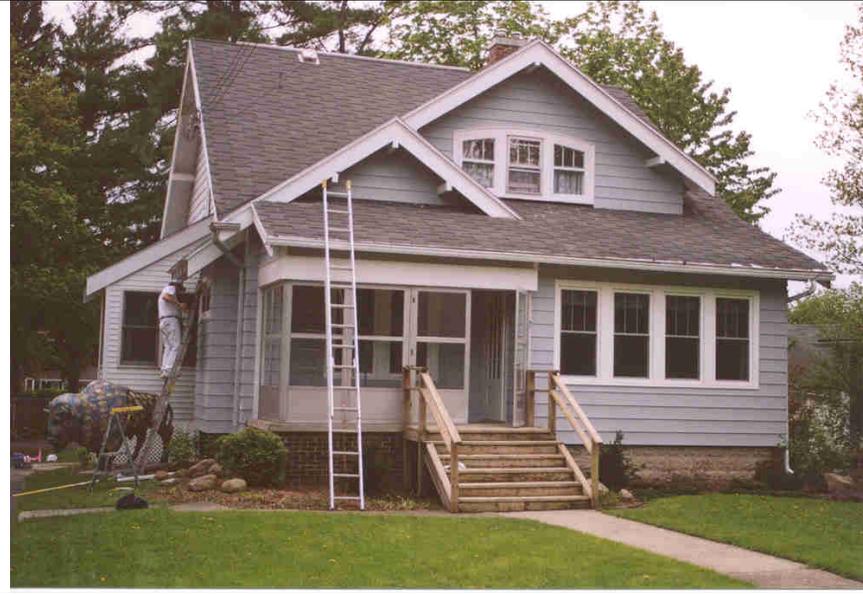
<p>ADDRESS: 104 Long Avenue</p>	<p>DATE OF CONSTRUCTION: ca. 1915</p>	<p>SIGNIFICANCE: C – Domestic architecture</p>

<p>DESCRIPTION: 1-1/2-story, side-gable Craftsman bungalow. Flared eaves with exposed rafter tails supported by false beams at gable ends, partially enclosed porch, wood shingle siding and a tripartite double hung window with segmental arch.</p>

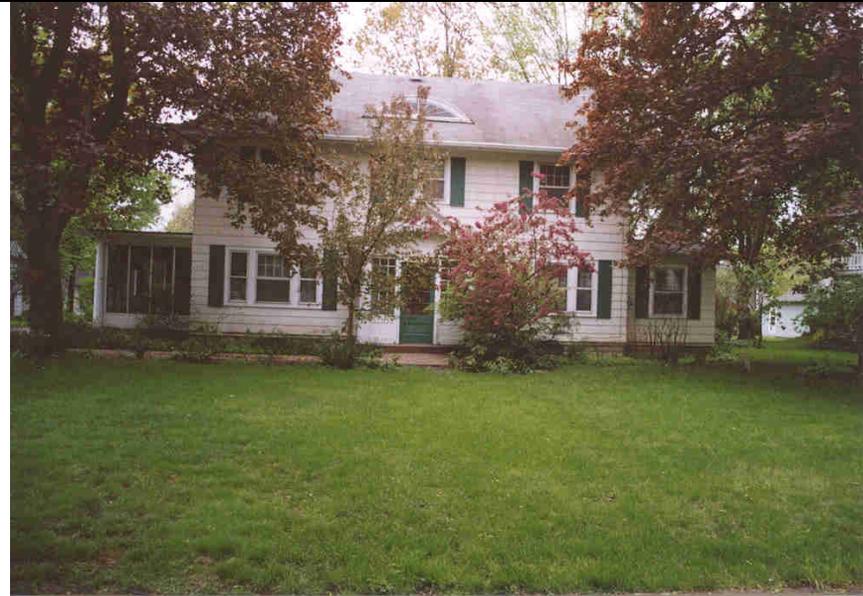
<p>ADDRESS: 112 Long Avenue</p>	<p>DATE OF CONSTRUCTION: ca. 1920</p>	<p>SIGNIFICANCE: C – Domestic architecture</p>

<p>DESCRIPTION: 2-1/2-story, side-gable three-bay center-entrance Colonial Revival house featuring an eyebrow window. Sun porch on one end of the house.</p>

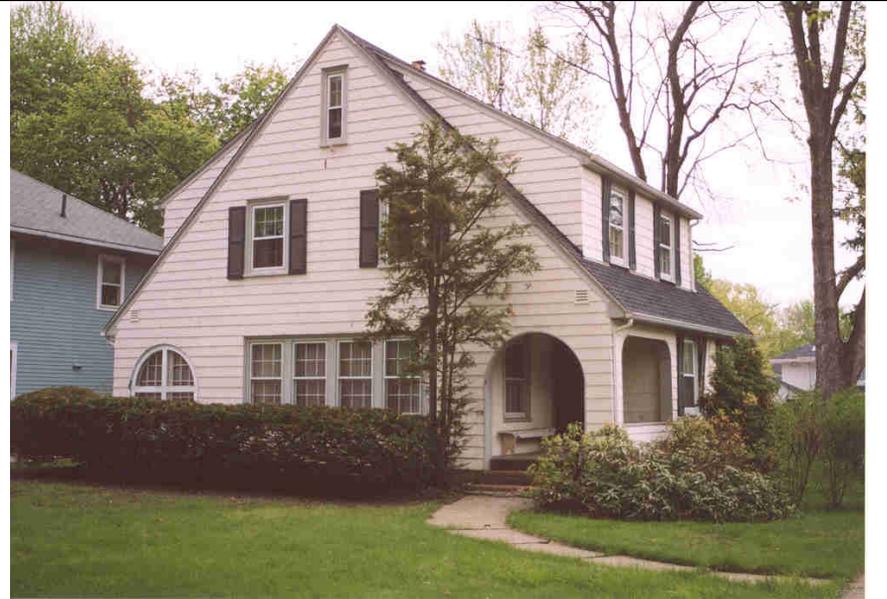
<p>DESCRIPTION: 2-1/2-story, front-gable wood frame symmetrical Tudor house with flush eaves. Rock faced concrete block foundation, twin full length shed dormers on each side of the main roof and recessed corner entrance porch with half-round opening. Also featuring wood shingle cladding, a central grouped window and a tall narrow attic window at the gable.</p>

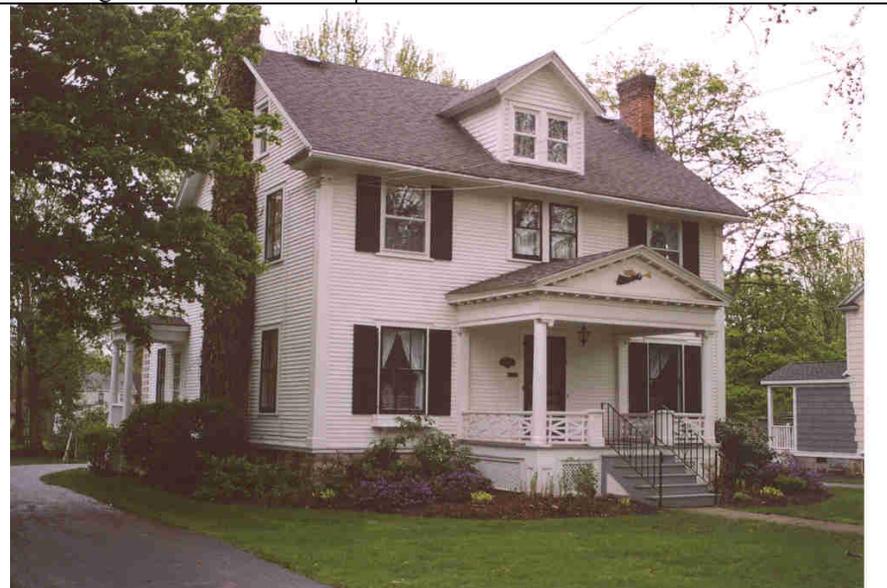
<p>DESCRIPTION: 2-1/2-story, side-gable roof, wood frame. symmetrical three-bay Colonial Revival house incorporating front-gable dormer, two-story bay with single-bay pedimented portico featuring Ionic columns, a modillioned cornice and Roman lattice balustrade.</p>

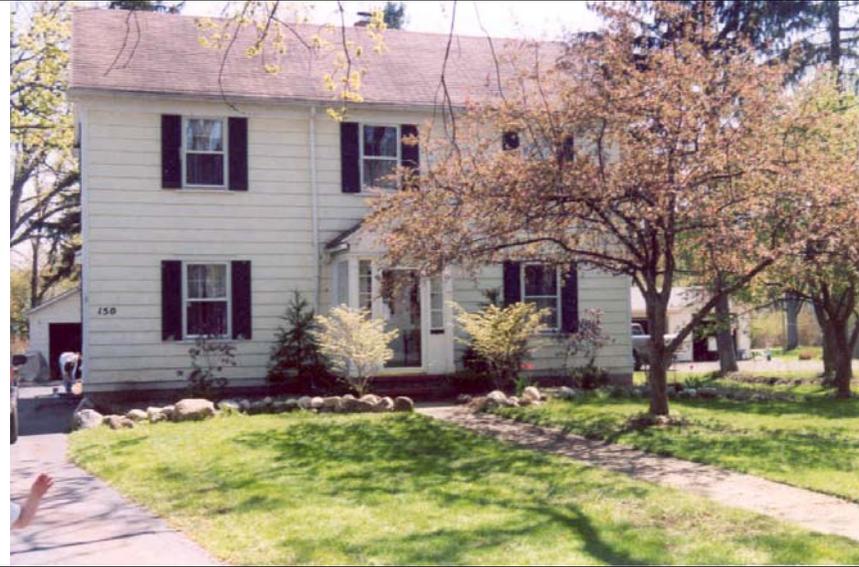
<p>ADDRESS: 150 Long Avenue</p>	<p>DATE OF CONSTRUCTION: ca. 1922</p>	<p>SIGNIFICANCE: S – Domestic architecture</p>

<p>DESCRIPTION: 2-1/2-story, side-gable roof, wood frame. symmetrical, three-bay Colonial Revival house incorporating cornice returns at the gable ends, six-over-one cottage sash, louvered shutters wide clapboard siding, a rear porch with roof balustrade, and an enclosed front-gable entrance porch with door and sidelights. A period detached front-gable, single-bay garage is located behind the house.</p>

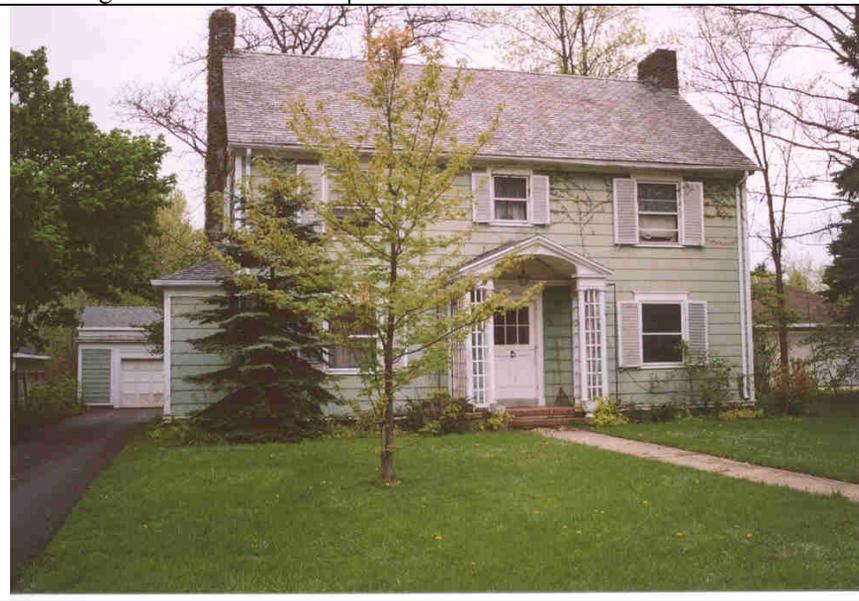
<p>ADDRESS: 196 Long Avenue</p>	<p>DATE OF CONSTRUCTION: ca. 1940</p>	<p>SIGNIFICANCE: C – Domestic architecture</p>

<p>DESCRIPTION: 2-1/2-story, side-gable, three-bay symmetrical, center entrance Colonial Revival house with a slate roof and a front-gable portico featuring lattice panels and an elliptical barrel-vaulted ceiling.</p>

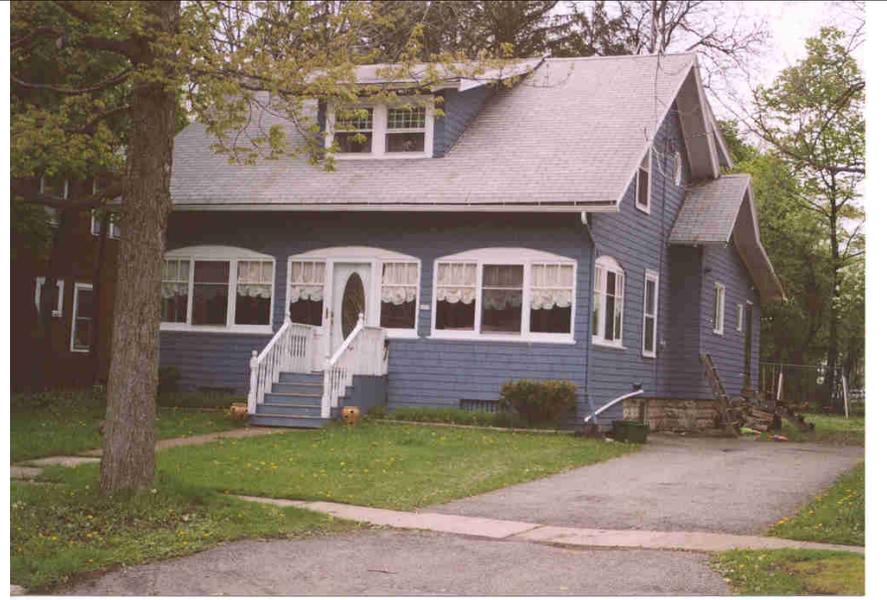
<p>DESCRIPTION: 1-1/2-story side-gable roof, wood frame. Craftsman house featuring a rock faced concrete block foundation, a partial-façade shed dormer and a recessed front porch.</p>

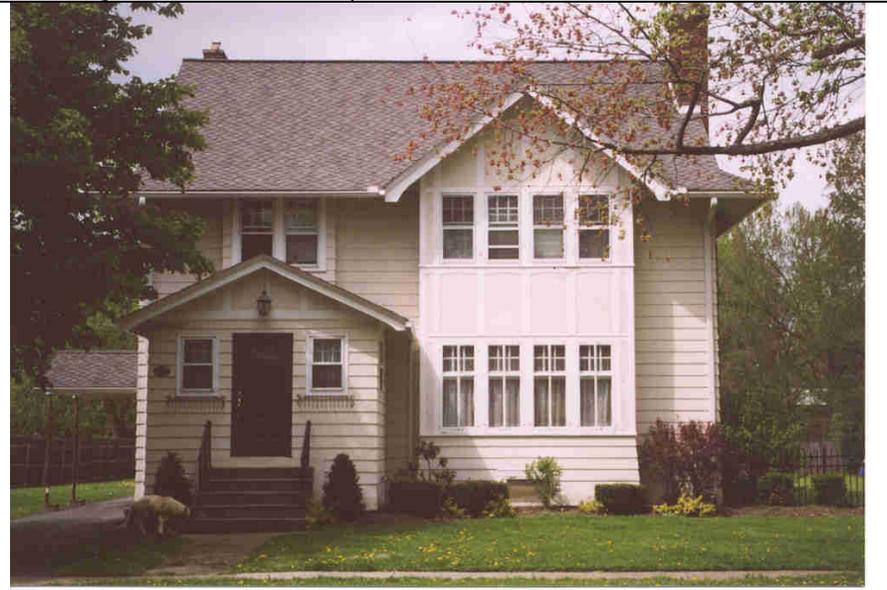
<p>DESCRIPTION: 2-1/2-story, side - gable, wood frame. asymmetrical Craftsman house featuring a projected front-gable, half timbered, two-story bay, flared skirt, and a projecting one-story entrance vestibule.</p>

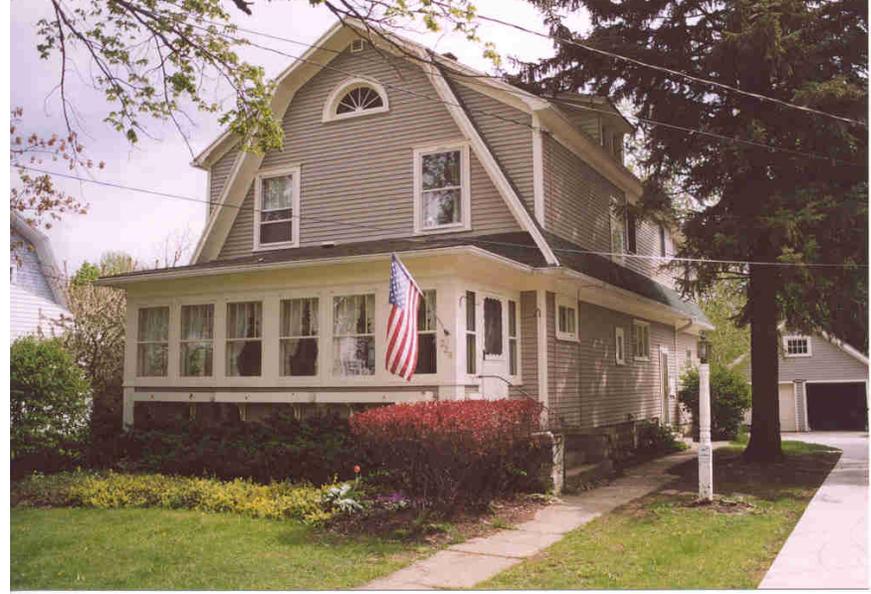
<p>ADDRESS: 228 Long Avenue</p>	<p>DATE OF CONSTRUCTION: ca. 1920</p>	<p>SIGNIFICANCE: C – Domestic architecture</p>

<p>DESCRIPTION: 2-1/2-story, front-Gambrel roof, wood frame, symmetrical Dutch Colonial house with twin full-length shed dormers, gable fan light, clapboard cladding and enclosed full-façade porch.</p>

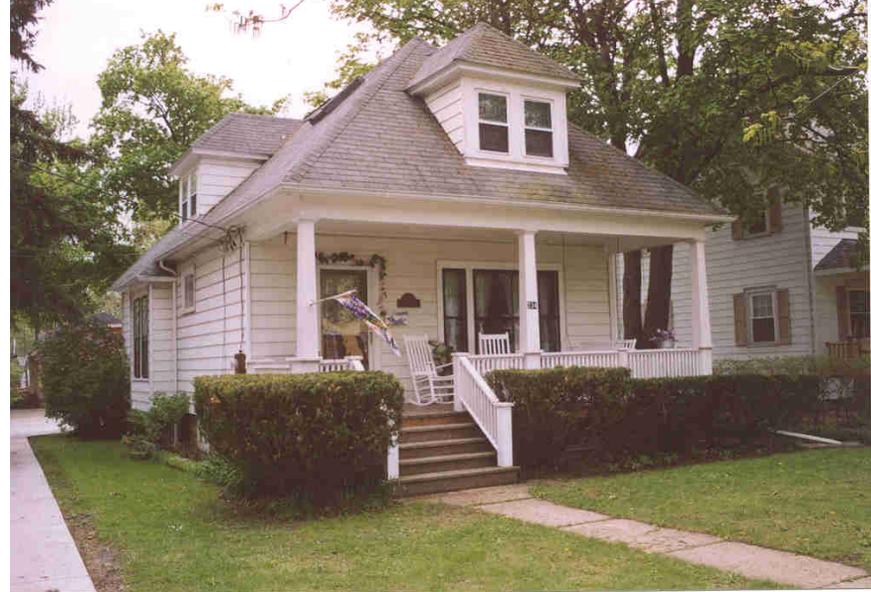
<p>ADDRESS: 234 Long Avenue</p>	<p>DATE OF CONSTRUCTION: ca. 1920</p>	<p>SIGNIFICANCE: C – Domestic architecture</p>

<p>DESCRIPTION: 1-1/2-story, hip-roof, wood frame Vernacular house incorporating multiple hip-roof dormers and a two-bay full-façade porch supported by ¾ height square battered posts set on piers.</p>

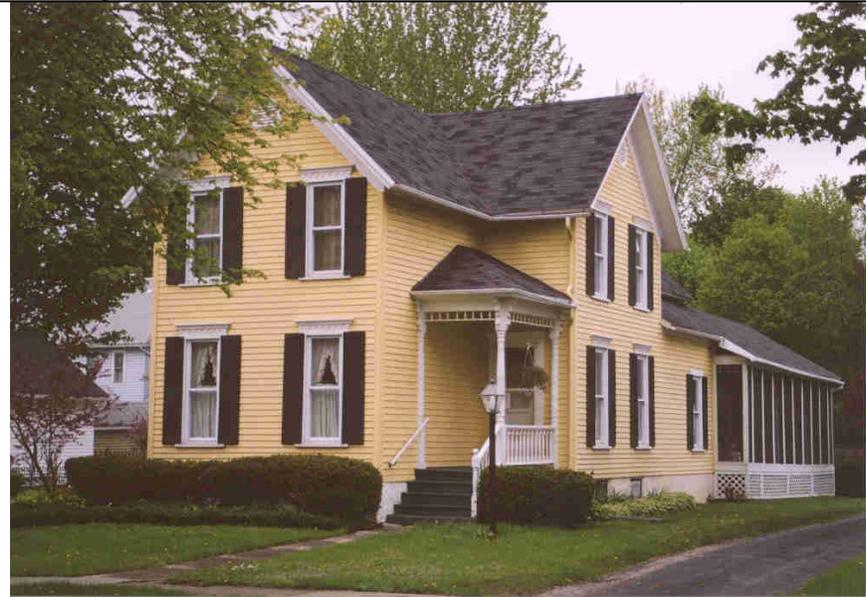
<p>ADDRESS: 237 Long Avenue</p>	<p>DATE OF CONSTRUCTION: ca. 1880</p>	<p>SIGNIFICANCE: C – Domestic architecture</p>

<p>DESCRIPTION: 2-1/2-story, L-plan tri-gable roof, wood-frame Vernacular house featuring steeply-pitched roofs, broadly-projecting eaves, regularly spaced tall, narrow 1/1 windows and a single-bay corner entry porch incorporating turn posts and a spindle frieze.</p>

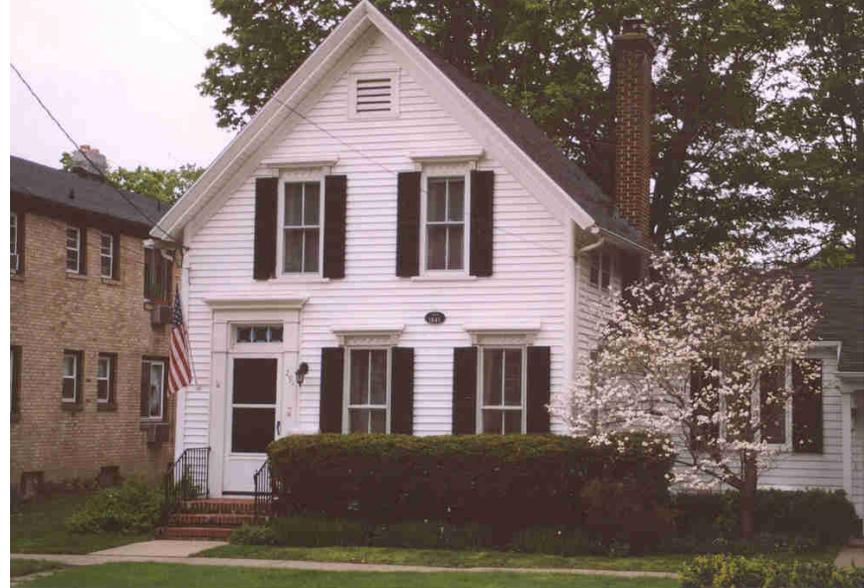
<p>ADDRESS: 291 Long Avenue</p>	<p>DATE OF CONSTRUCTION: 1845</p>	<p>SIGNIFICANCE: S – Domestic architecture</p>

<p>DESCRIPTION: 2-1/2-story, front-gable, wood frame Greek Revival house. The appearance of the house was modified by a ca. 1870 alteration which raised the roof and added the pent-roof window hoods. The side wing appears to be a mid twentieth-century addition.</p>

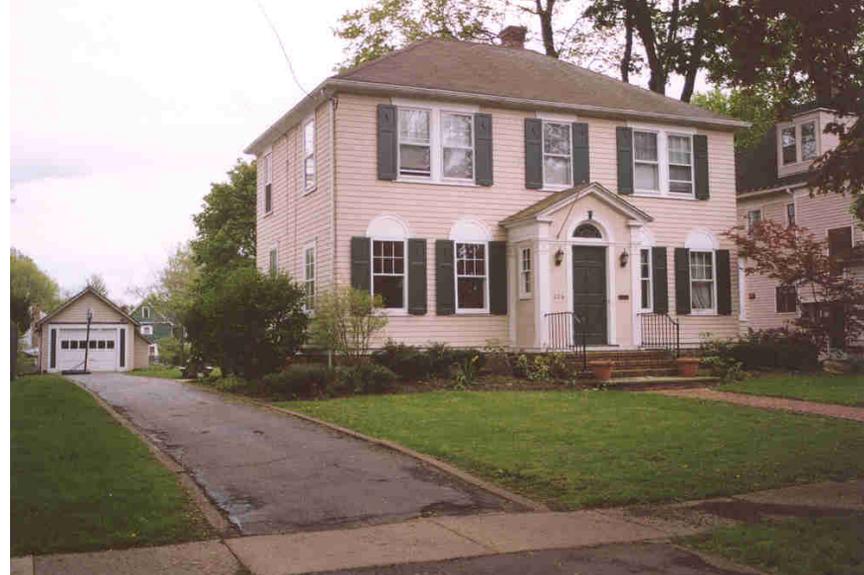
<p>ADDRESS: 294 Long Avenue</p>	<p>DATE OF CONSTRUCTION: ca. 1920</p>	<p>SIGNIFICANCE: C – Domestic architecture</p>

<p>DESCRIPTION: 2-1/2-story, hip roof, wood frame Colonial Revival house featuring rounded arch window surrounds on the lower story, cutout shutters and a front-gabled enclosed entry porch supported by Tuscan pilasters. Front door is topped by a fan light.</p>

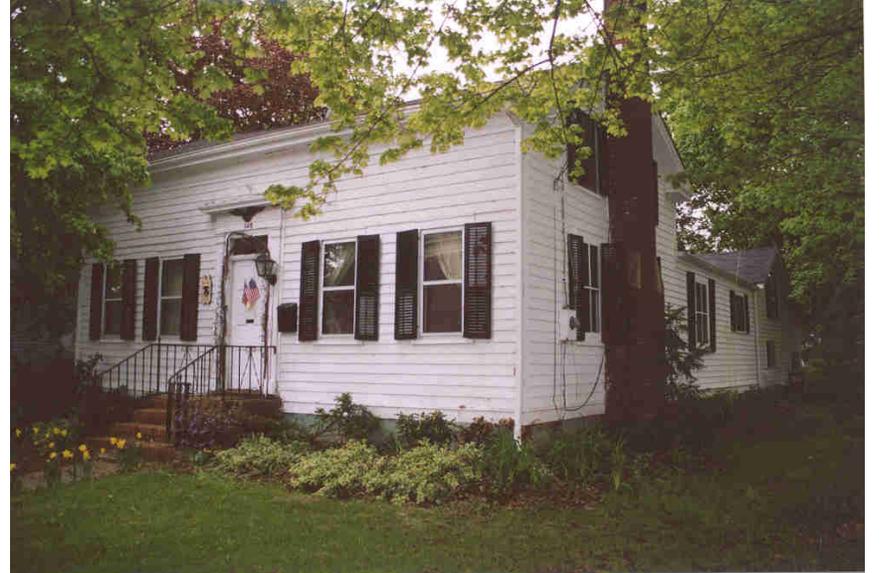
<p>ADDRESS: 146 Main Street</p>	<p>DATE OF CONSTRUCTION: ca. 1830</p>	<p>SIGNIFICANCE: S – Domestic architecture</p>

<p>DESCRIPTION: 1-1/2-story, side-gable, wood frame five-bay center-entrance symmetrical Federal house. Barn located at rear wing. One of the village’s oldest remaining buildings, this house retains an unusually high level of exterior architectural integrity. Home of Thomas White, an early nineteenth-century prominent businessman and town supervisor.</p>

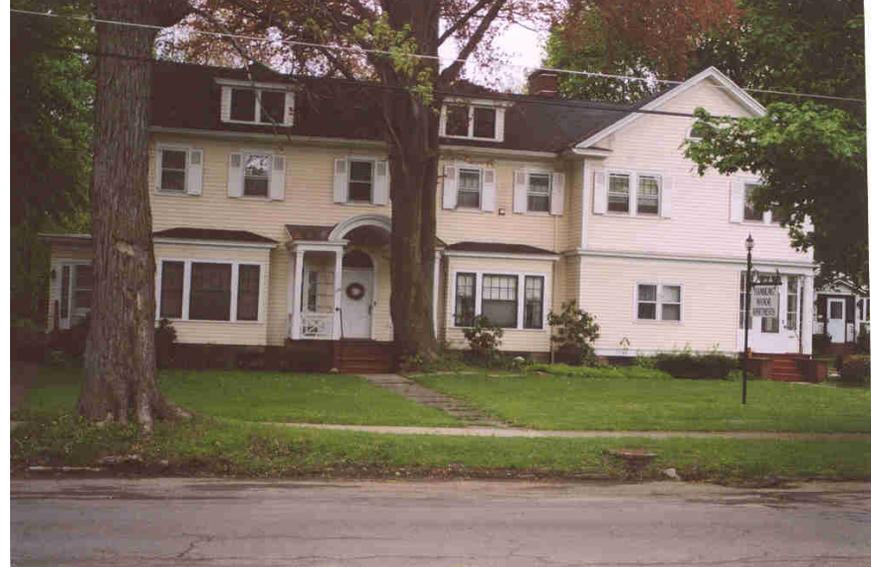
<p>ADDRESS: 154 Main Street</p>	<p>DATE OF CONSTRUCTION: ca. 1875/remodeled 1914</p>	<p>SIGNIFICANCE: S – Domestic architecture</p>

<p>DESCRIPTION: Large 2-1/2-story, wood frame center entrance Colonial Revival house featuring hip roof dormers, twin hip roof projecting bays on the lower story and a Palladian three-bay porch supported by full-height Tuscan columns. In 1914, to accommodate the widening of Main Street, the front wing of this house was and rotated 90 degrees and the house was remodeled in the Colonial revival style for John and Emma Kronenberg.</p>

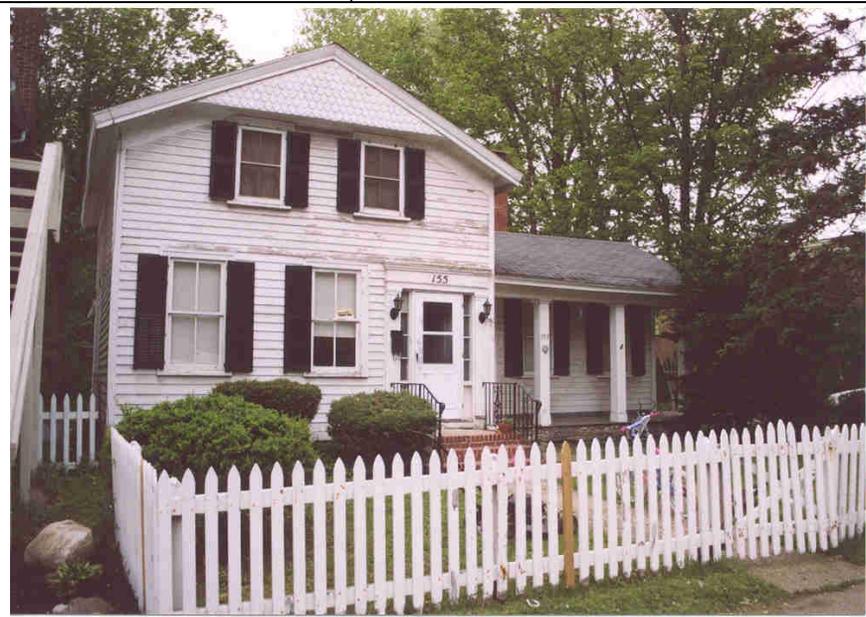
<p>ADDRESS: 155 Main Street</p>	<p>DATE OF CONSTRUCTION: ca. 1840</p>	<p>SIGNIFICANCE: S – Domestic architecture</p>

<p>DESCRIPTION: 2-1/2-story gable and wing Greek Revival house with broadly projecting eaves and three-bay entry porch supported by square chamfered posts. Property contains freestanding barn. The extended eaves and patterned shingles filling the gable date from the last decades of the nineteenth century.</p>

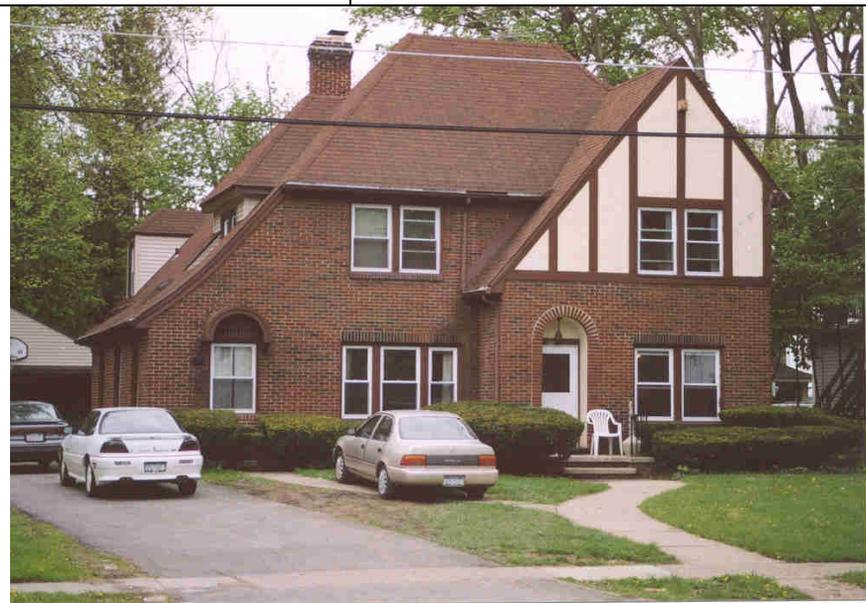
<p>ADDRESS: 168 Main Street</p>	<p>DATE OF CONSTRUCTION: ca. 1930</p>	<p>SIGNIFICANCE: C – Domestic architecture</p>

<p>DESCRIPTION: 2-1/2-story, hip-roof, brick and stucco Tudor house featuring steeply pitched roof, vertical half-timbering and a recessed doorway with a rounded arch surround.</p>

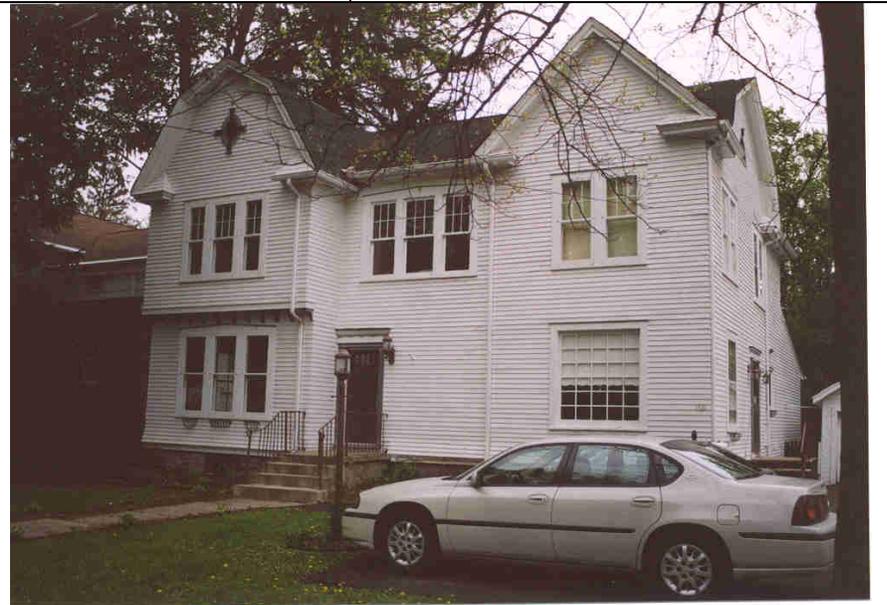
<p>ADDRESS: 169 Main Street</p>	<p>DATE OF CONSTRUCTION: ca. 1905</p>	<p>SIGNIFICANCE: C – Domestic architecture</p>

<p>DESCRIPTION: 2-1/2-story, wood frame, asymmetrical Colonial Revival house featuring cornice returns, bull's eye window, gambrel gable, and grouped windows. Porch has been removed.</p>

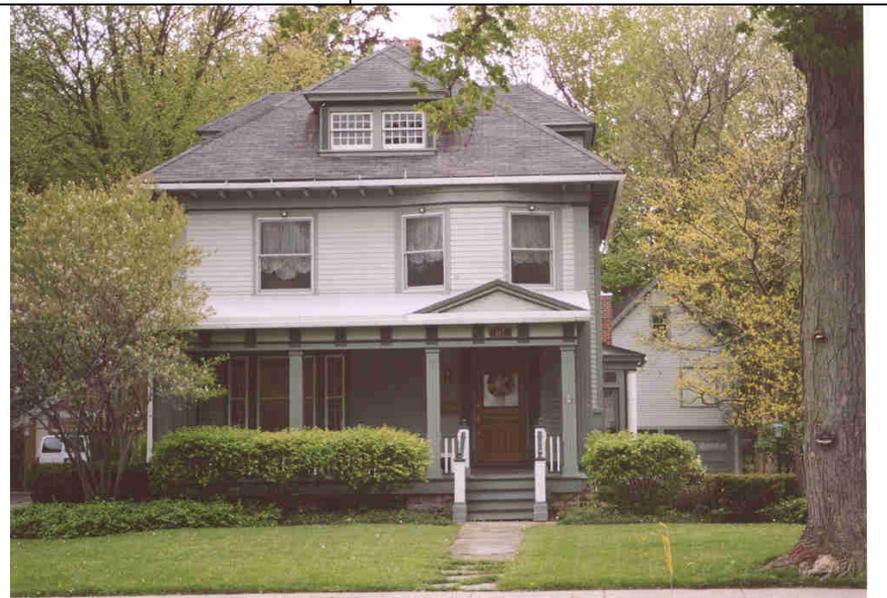
<p>DESCRIPTION: 2-1/2-story, hip-roof Four-square house incorporating a hip-roof dormer. Single three-sided projecting bay, rock face concrete block foundation and full width three-bay porch supported by square posts upholding a partial Doric entablature. Property includes a freestanding barn.</p>

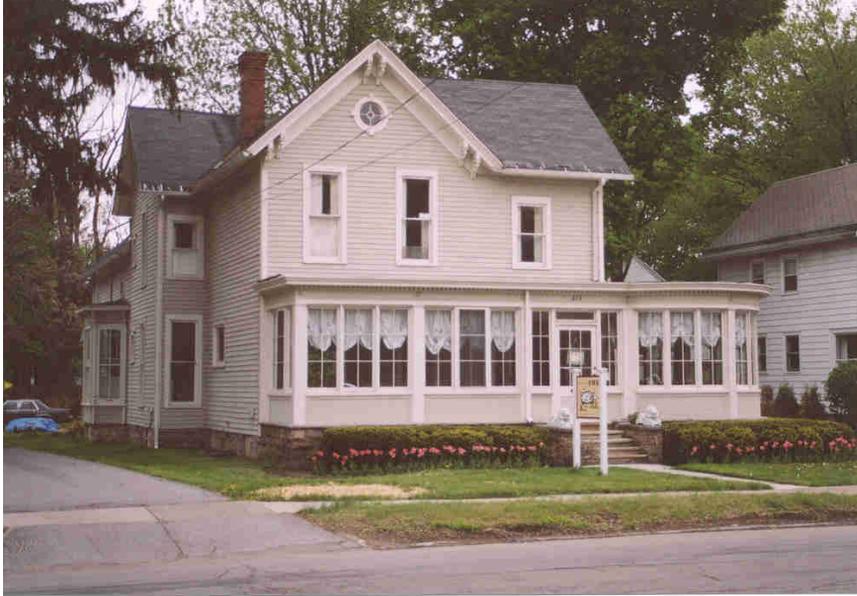
DESCRIPTION: 2-1/2-story, cross-gable roof, wood frame Italianate house. Tall, narrow windows, bulls eye gable window, paired eaves brackets and wraparound porch, which has been enclosed. Property also contains freestanding barn. Early twentieth-century porch is enclosed.

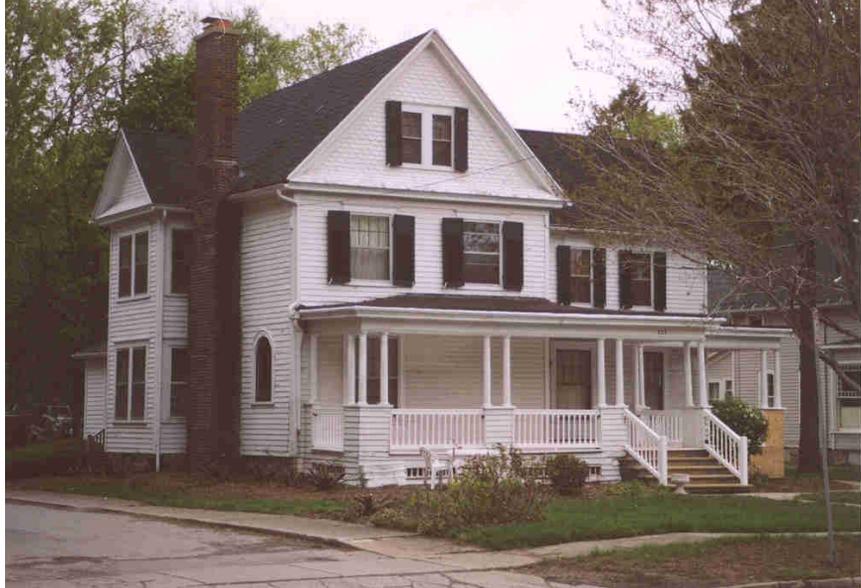
<p>ADDRESS: 223 Main Street</p>	<p>DATE OF CONSTRUCTION: ca. 1900</p>	<p>SIGNIFICANCE: S – Domestic architecture</p>

<p>DESCRIPTION: 2-1/2-story, gable and wing roof, wood frame Colonial Revival house with 45 degree roof slope and closed gable ends. Wraparound porch supported by slender grouped Tuscan columns set on clapboard-clad piers.</p>

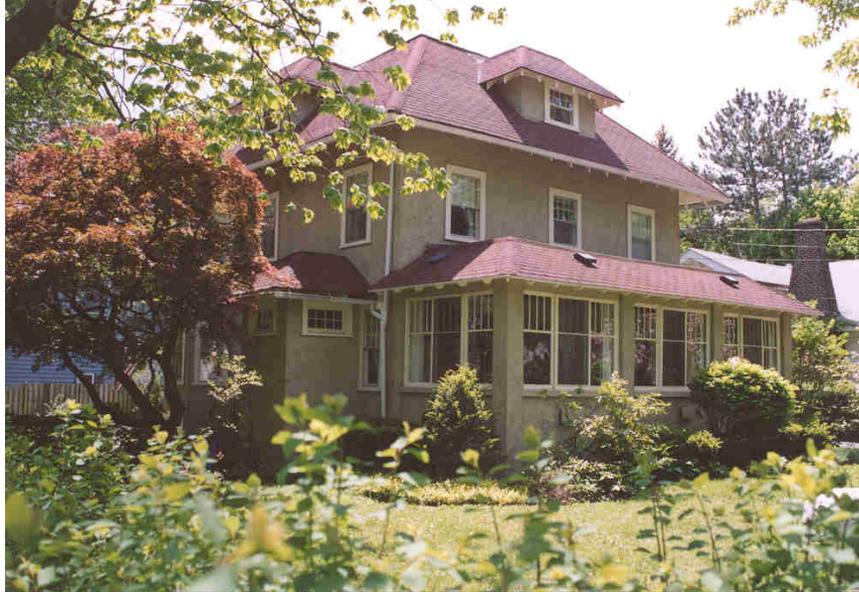
<p>ADDRESS: 34 Maple Avenue</p>	<p>DATE OF CONSTRUCTION: ca. 1920</p>	<p>SIGNIFICANCE: C – Domestic architecture</p>

<p>DESCRIPTION: 2-1/2-story, stucco hip-roof, symmetrical Craftsman house with stucco cladding, exposed rafter tails and an enclosed three-bay full-facade porch with cottage sash windows.</p>

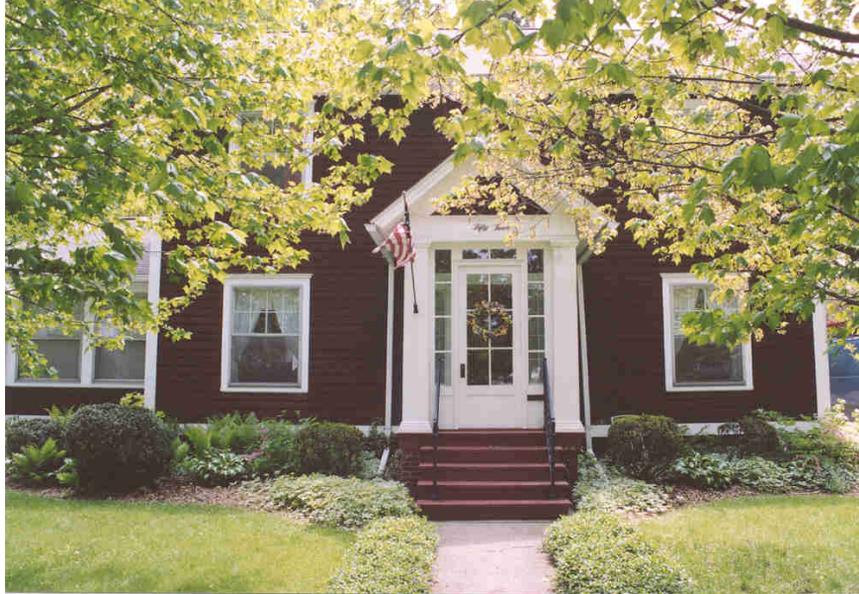
<p>DESCRIPTION: 2-1/2-story three bay, side-gable symmetrical Colonial Revival house with single-bay front-gable entrance porch supported by full-height Tuscan pilasters and stained wood shingles.</p>

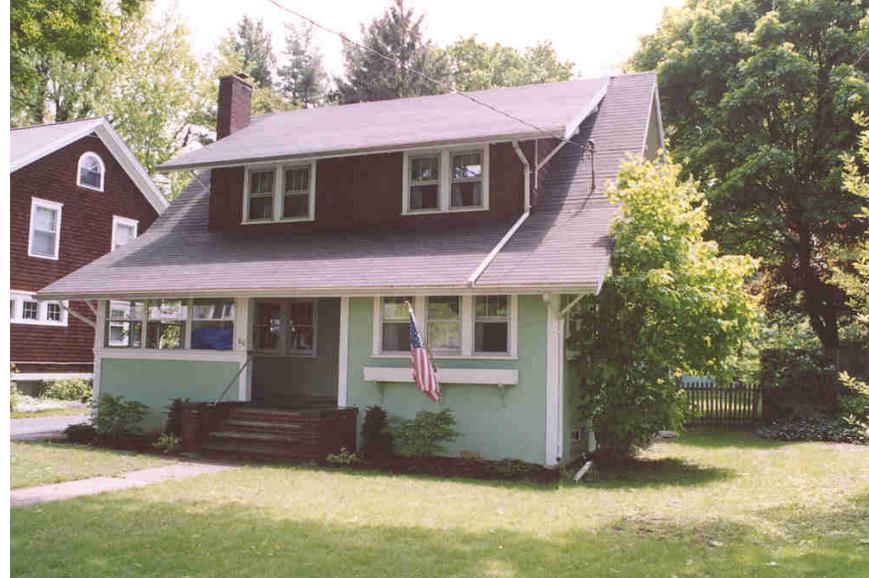
<p>ADDRESS: 60 Maple Avenue</p>	<p>DATE OF CONSTRUCTION: ca. 1920</p>	<p>SIGNIFICANCE: C – Domestic architecture</p>

<p>DESCRIPTION: 1-1/2-story side-gable wood frame Craftsman bungalow featuring full-façade shed dormer with stained wood shingles, broadly projecting eaves supported by knee braces, and a partially enclosed front porch.</p>

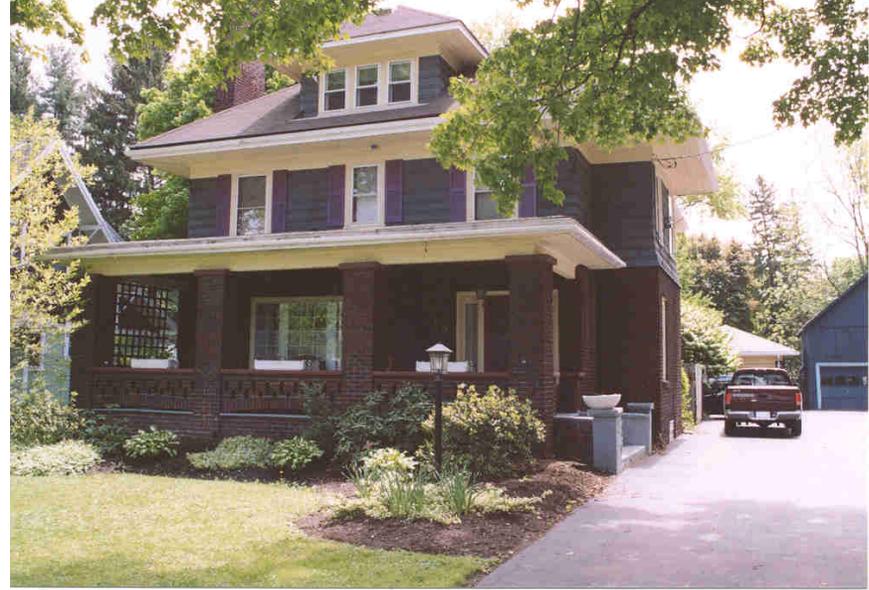
<p>DESCRIPTION: 2-1/2-story hip roof Prairie house featuring hip roof dormer, widely overhanging eaves and a one-story, full-façade three-bay porch supported by massive square brick piers and incorporating a brick balustrade. Brick cladding at the first-floor level of the house contrasts with wood shingle cladding located on the upper walls.</p>

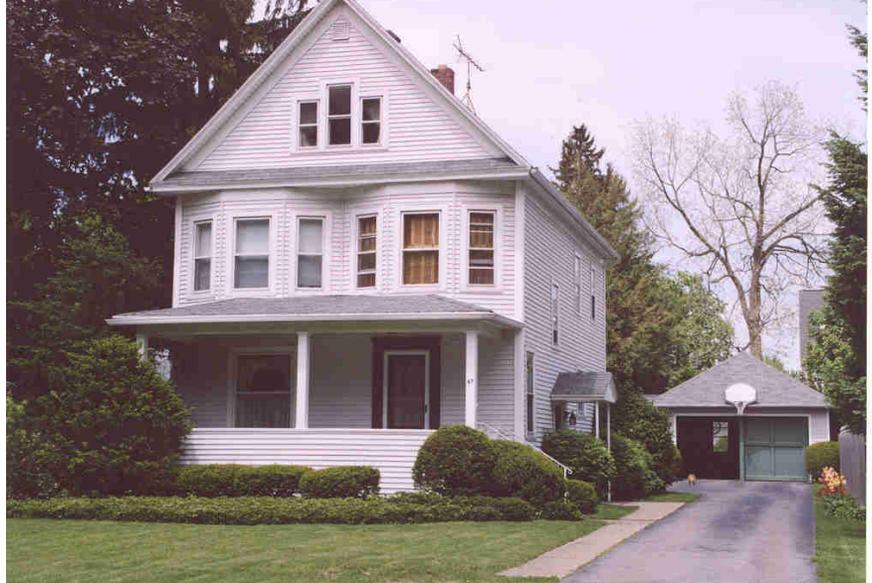
<p>ADDRESS: 67 Maple Avenue</p>	<p>DATE OF CONSTRUCTION: ca. 1900</p>	<p>SIGNIFICANCE: C – Domestic architecture</p>

<p>DESCRIPTION: 2-1/2-story, front-gable Four-square house with closed gable roof at 45 degree pitch. Twin second-story three-sided bays, grade level driveway door, two-bay full façade porch supported by ¾-height square posts set on a closed handrail.</p>

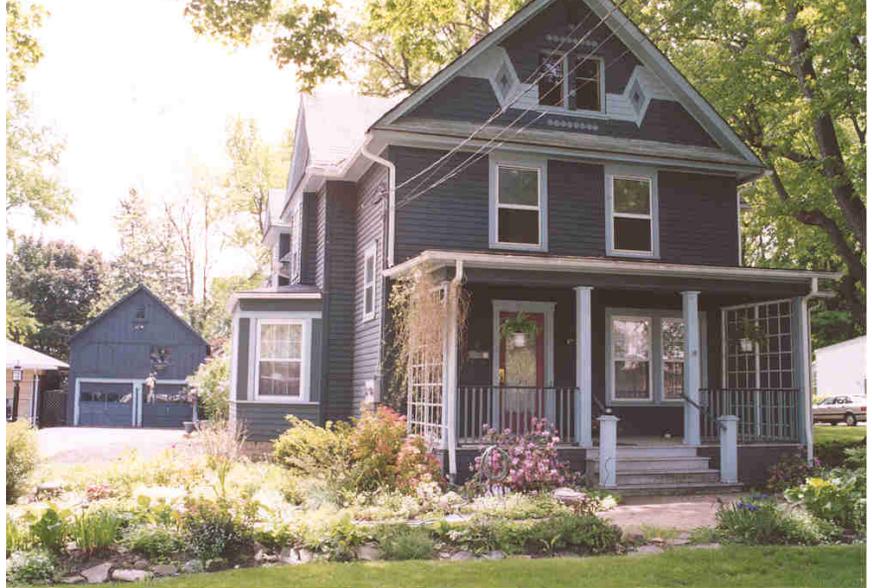
<p>DESCRIPTION: 2-1/2-story, front-gable late Queen Anne house with closed gable roof at 45 degree pitch, rock-face concrete block foundation, and three-bay full-façade porch supported by full height square posts. A carriage barn is located at the rear of the property.</p>

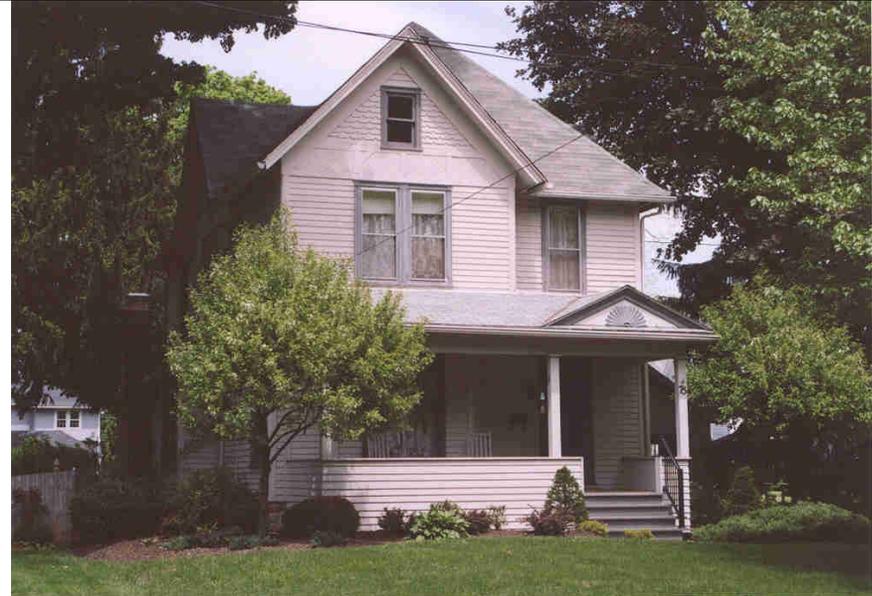
<p>DESCRIPTION: 2-1/2-story asymmetrical hip roof Queen Anne house with patterned wood shingles in gables and full-façade two-bay porch supported by ¾-height Tuscan columns set on a closed handrail.</p>

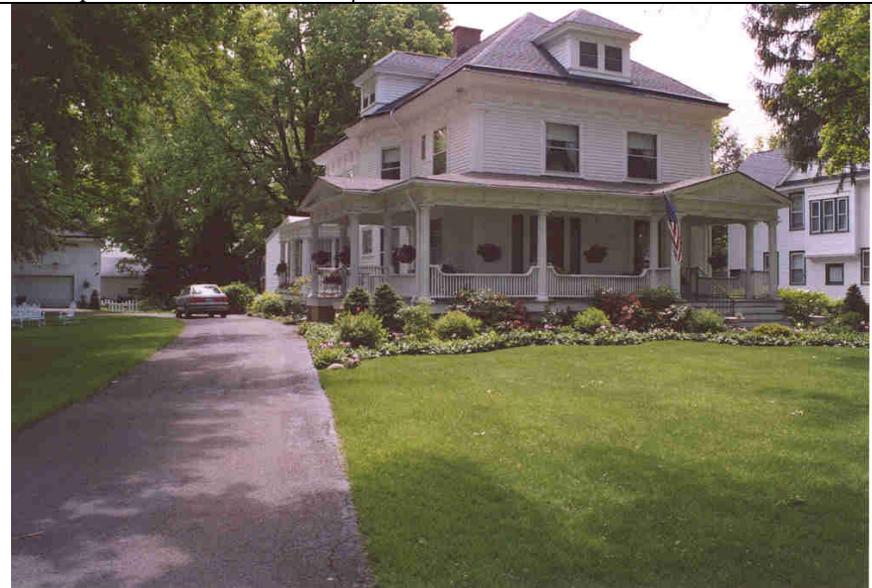
<p>ADDRESS: 82 Maple Avenue</p>	<p>DATE OF CONSTRUCTION: ca. 1905</p>	<p>SIGNIFICANCE: S – Domestic architecture</p>

<p>DESCRIPTION: 2-1/2-story hip roof Colonial Revival house with a 45 degree roof pitch, hip roof dormers, a classically-proportioned cornice at the main roof, corner pilasters, and a wraparound porch featuring pedimented gables at the porch entrances and Tuscan columns.</p>

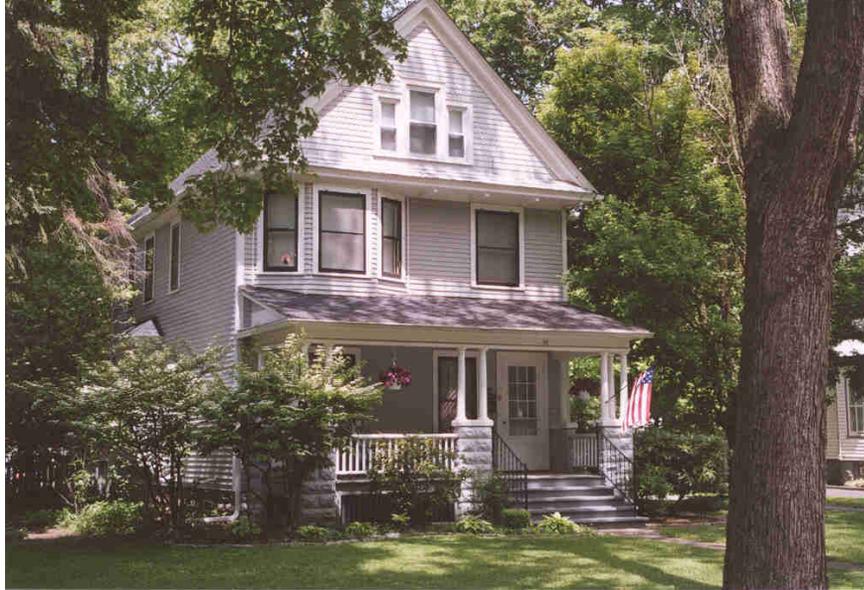
<p>DESCRIPTION: 2-1/2-story front-gable Four-square house with projecting closed gable with decorative beams, rock-face concrete block foundation and a three-sided projecting second-story bay. Full façade two-bay porch supported by paired ¾-height Tuscan columns.</p>

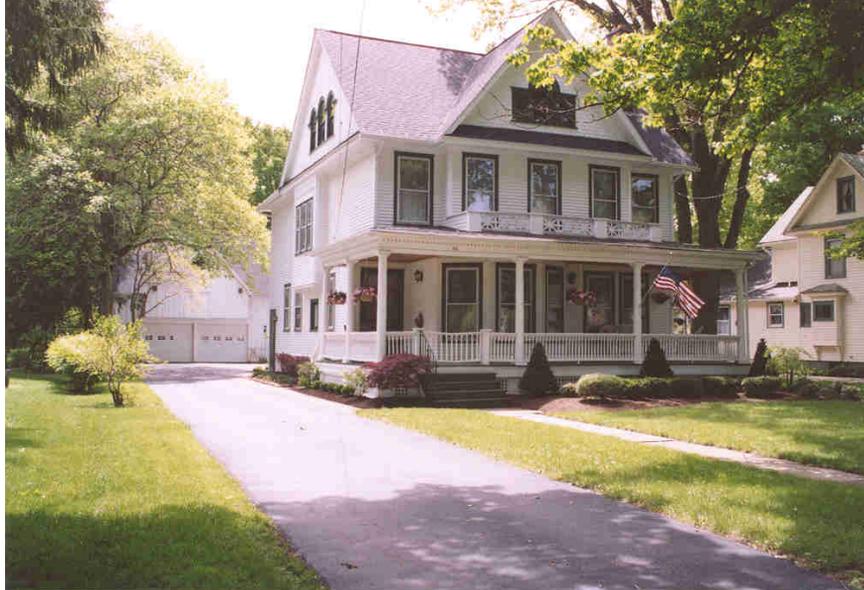
<p>DESCRIPTION: 2-1/2-story cross gable Queen Anne house with steeply-pitched roofs, projecting stair window, closed gable ends, Palladian gable window, three-sided bay and wraparound porch supported by Tuscan columns. Property contains a freestanding 1-1/2 story carriage barn located at the rear.</p>
