RECONNAISSANCE LEVEL SURVEY
OF HISTORIC RESOURCES

VILLAGE OF HAMBURG

Erie County, New York

Bero Architecture PC
32 Winthrop Street
Rochester, New York 14607

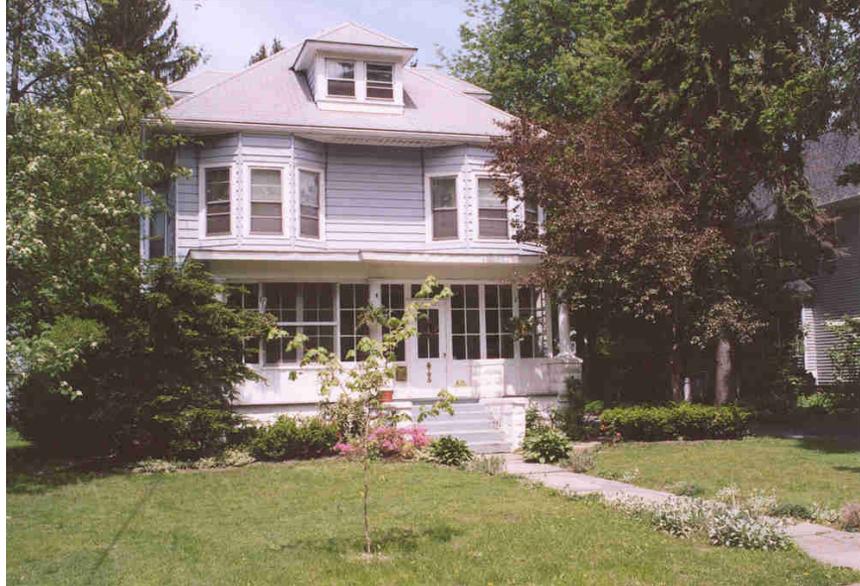
<p>ADDRESS: 95 Maple Avenue</p>	<p>DATE OF CONSTRUCTION: ca. 1905</p>	<p>SIGNIFICANCE: C – Domestic architecture</p>

<p>DESCRIPTION: : 2-1/2-story, hip roof Four-square house with 45 degree roof pitch. Rock-face concrete block foundation, twin second-story three-sided bays and full façade two-bay porch supported by ¾ Tuscan columns. Porch has been enclosed.</p>

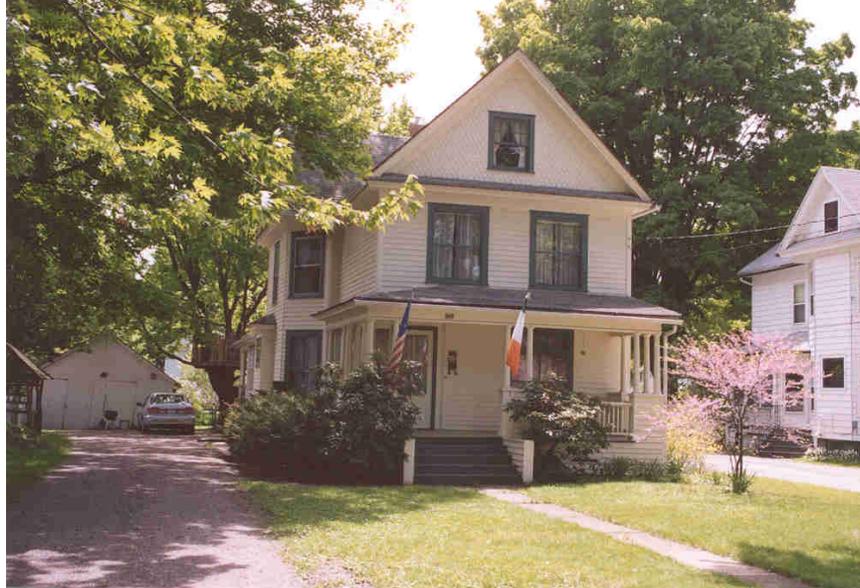
<p>DESCRIPTION: 2-1/2-story front-gable Queen Anne house with 45 degree roof pitch, closed gables, two-story bay and two bay porch supported by grouped slender Tuscan columns set on wood shingle clad piers.</p>

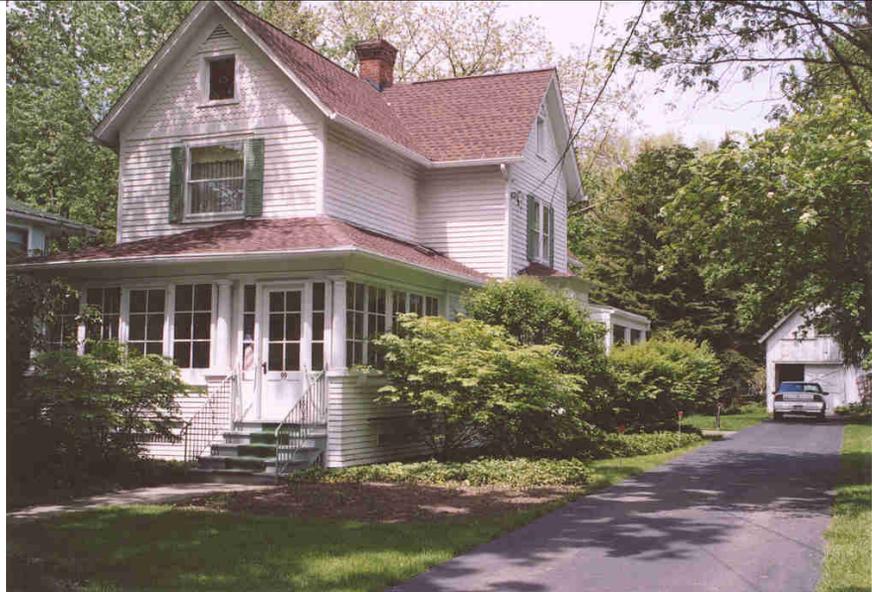
<p>ADDRESS: 99 Maple Avenue</p>	<p>DATE OF CONSTRUCTION: ca. 1895</p>	<p>SIGNIFICANCE: C – Domestic architecture</p>

<p>DESCRIPTION: 2-1/2-story cross plan Queen Anne house with three-sided bay, wraparound porch supported by ¾ height Tuscan columns set on wood clapboard clad closed handrail. Porch has been enclosed with early 20th century storm windows. Freestanding 1-1/2 story carriage barn.</p>

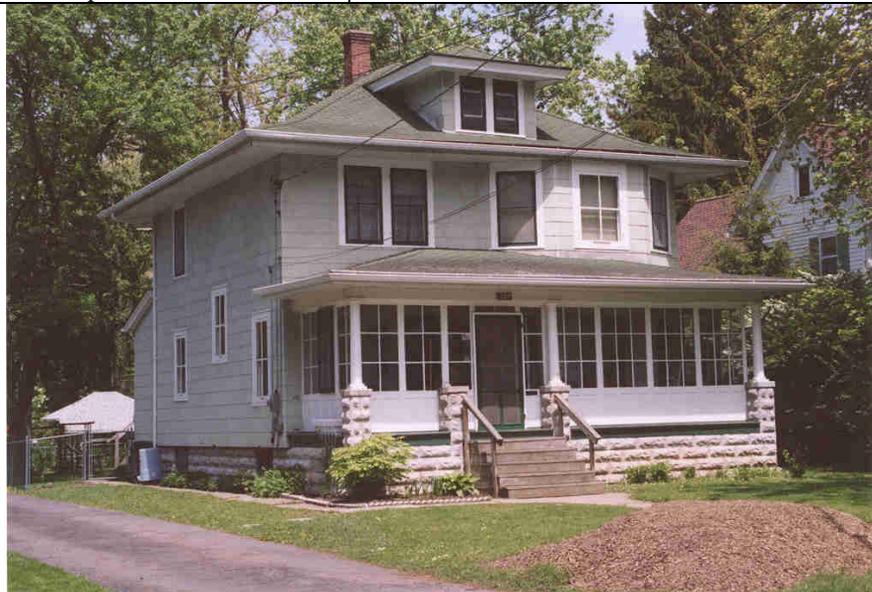
<p>ADDRESS: 107 Maple Avenue</p>	<p>DATE OF CONSTRUCTION: ca. 1910</p>	<p>SIGNIFICANCE: C – Domestic architecture</p>

<p>DESCRIPTION: 2-1/2-story hip roof Prairie house featuring hip roof dormer, flared eaves, projecting three-sided bay on second story and two-bay full-façade porch supported by ¾-height Tuscan columns sitting on rock faced concrete block piers. Porch has been enclosed.</p>

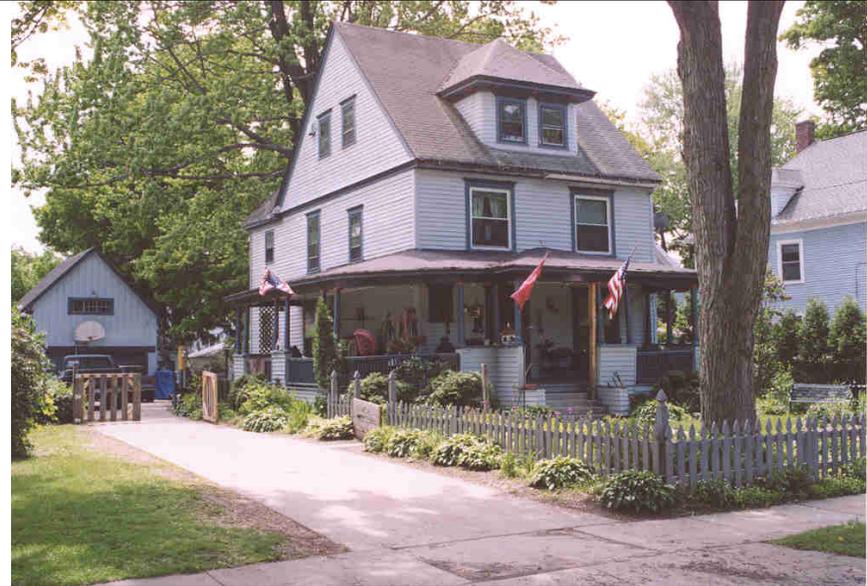
<p>ADDRESS: 108 Maple Avenue</p>	<p>DATE OF CONSTRUCTION: ca. 1900</p>	<p>SIGNIFICANCE: C – Domestic architecture</p>

<p>DESCRIPTION: 2-1/2-story side-gable Colonial Revival house with flush eaves, closed gables, hip-roof dormer, and a wraparound porch supported by ¾-height Tuscan columns. One-and-one-half-story carriage barn is located at the rear of the property.</p>

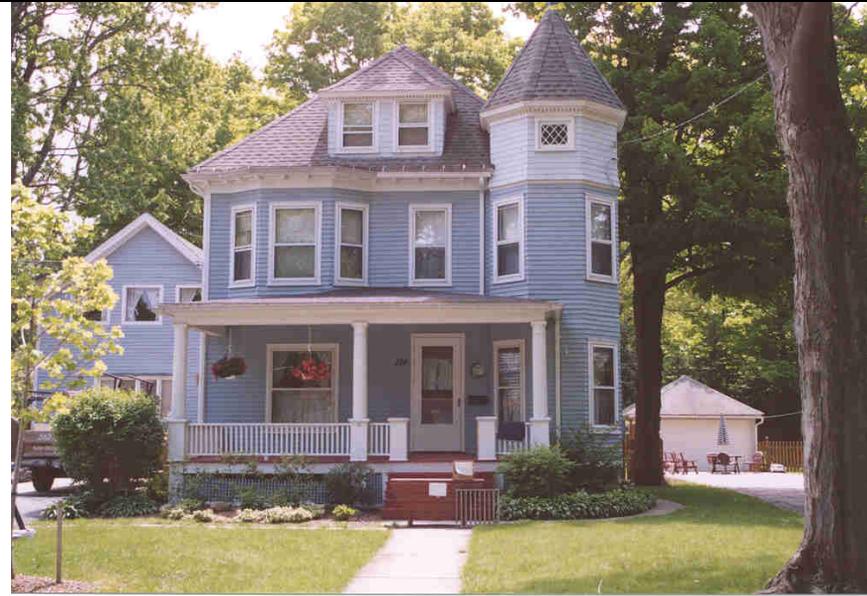
<p>ADDRESS: 114 Maple Avenue</p>	<p>DATE OF CONSTRUCTION: ca. 1900</p>	<p>SIGNIFICANCE: C – Domestic architecture</p>

<p>DESCRIPTION: 2-1/2-story hip roof asymmetrical Queen Anne house with octagonal corner tower featuring a faceted conical roof. Hip roof dormer, modillioned cornice and a two bay entrance porch supported by Tuscan columns set on wood piers.</p>

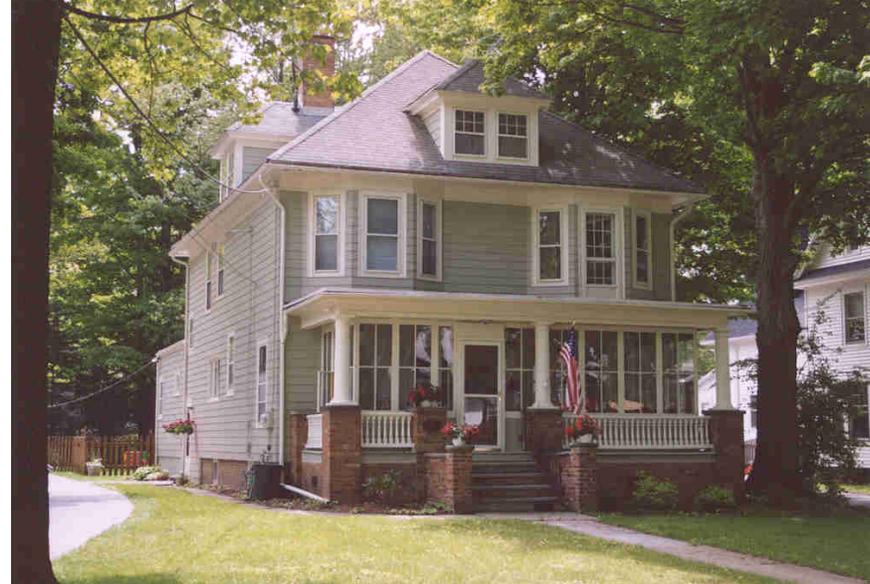
<p>DESCRIPTION: 2-1/2-story hip roof Four-square house incorporating hip roof dormers. Twin second-story three-sided projecting bays, grade level driveway door, brick-faced foundation, and full façade two-bay porch with ¾-height Tuscan columns.</p>

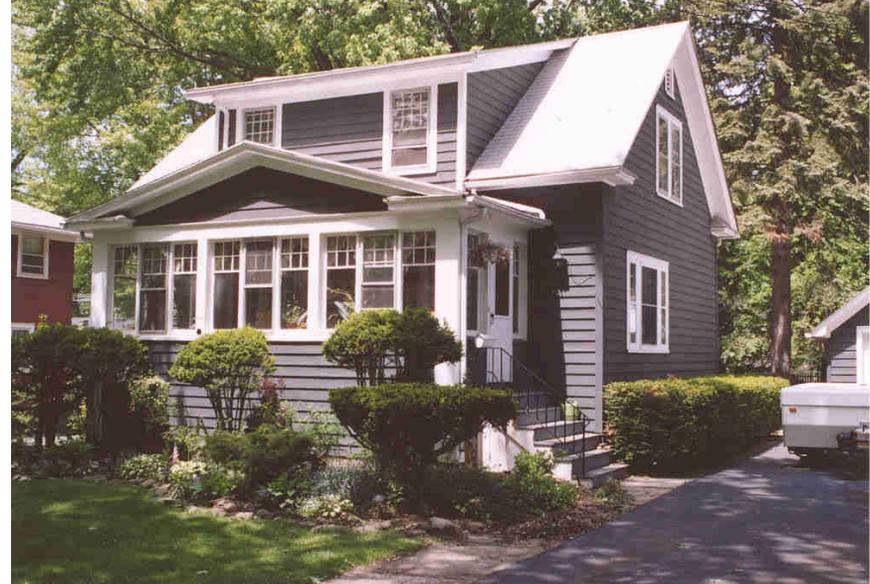
<p>DESCRIPTION: 1-1/2-story, side,-gable, symmetrical Vernacular house with cornice returns, cottage sash windows, and a front-gable full-façade enclosed porch.</p>

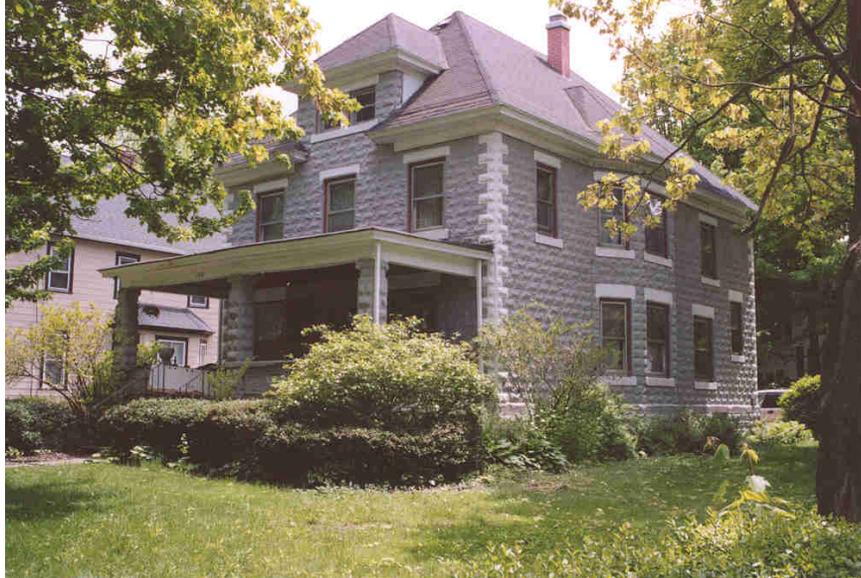
<p>ADDRESS: 140 Maple Avenue</p>	<p>DATE OF CONSTRUCTION: ca. 1905</p>	<p>SIGNIFICANCE: S – Domestic architecture</p>

<p>DESCRIPTION: 2-1/2-story, hip-roof, rock-face concrete block four-square house with 45 degree pitched roof, two-story bay, and two-bay full-façade porch supported by concrete block piers.</p>

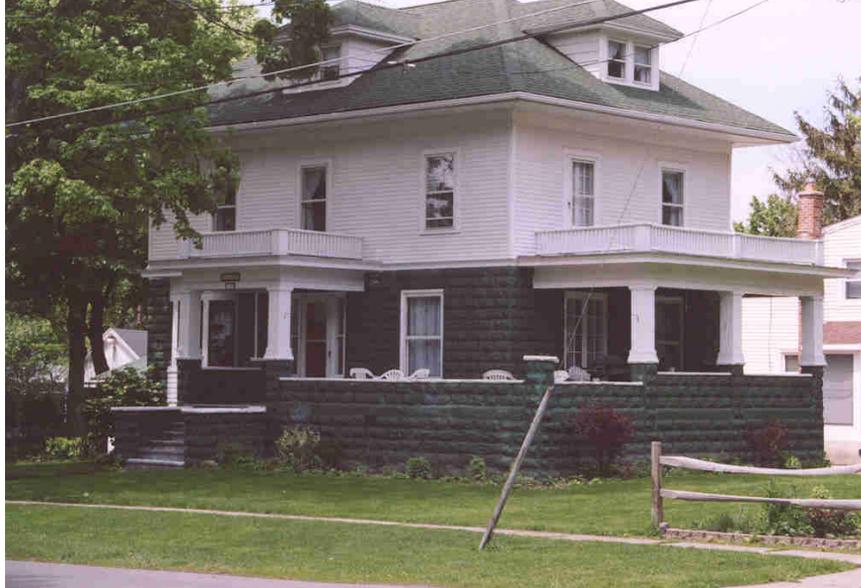
<p>ADDRESS: 157 Maple Avenue (116 Hawkins)</p>	<p>DATE OF CONSTRUCTION: ca. 1905</p>	<p>SIGNIFICANCE: S – Domestic architecture</p>

<p>DESCRIPTION: 2-1/2-story hip roof Prairie house featuring widely overhanging eaves, hip roof dormers, and contrasting first-floor and second-floor cladding. A wood string course, aligned with the porch eaves separates rock-face concrete block at the lower levels from the narrow clapboards covering the walls above. The single-bay center entrance porch and the two-bay side porch are both supported by 1/2-height thick square posts set on a closed handrail. The handrail and deck continue between the porches creating a wraparound terrace.</p>

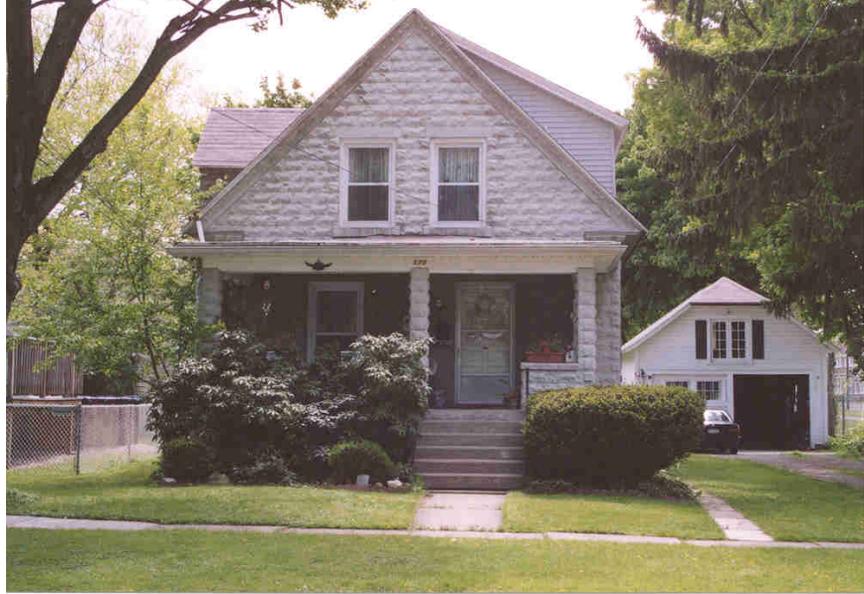
<p>ADDRESS: 170 Maple Avenue</p>	<p>DATE OF CONSTRUCTION: ca. 1910</p>	<p>SIGNIFICANCE: S – Domestic architecture</p>

<p>DESCRIPTION: 1-1/2-story front-gable, rock-face concrete block Vernacular house with cornice returns and two-bay full-façade porch supported by concrete block piers. A jerkinhead-foot garage is located behind the house.</p>

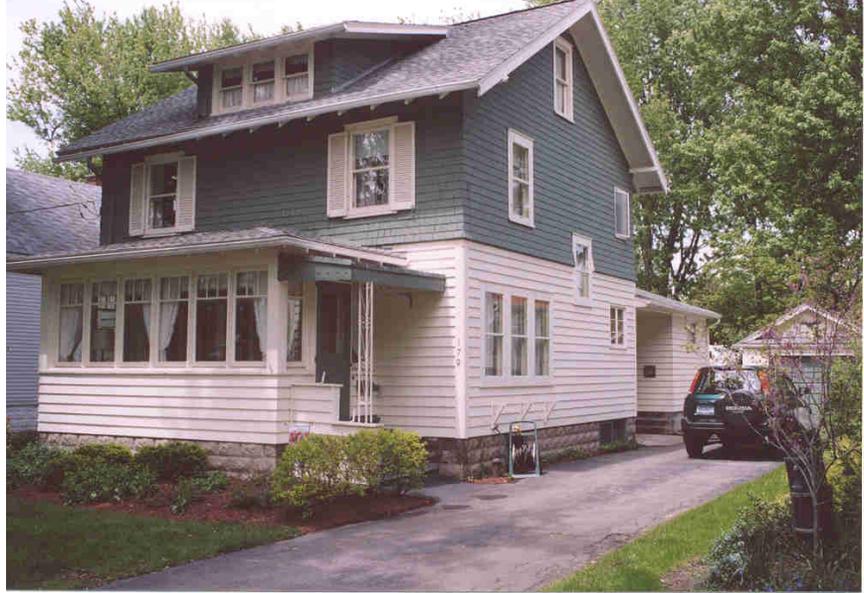
<p>DESCRIPTION: 2-1/2-story side-gable Craftsman house with projecting eaves and exposed rafter tails. Partial-façade shed roof dormer, contrasting first-floor/second-floor cladding, rock face concrete block foundation and enclosed hip roof porch.</p>

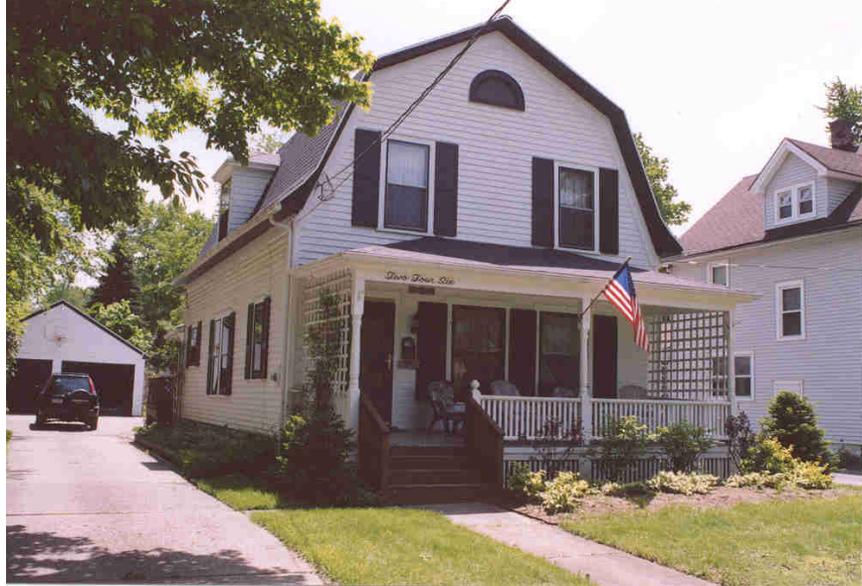
<p>ADDRESS: 246 Maple Avenue</p>	<p>DATE OF CONSTRUCTION: ca. 1910</p>	<p>SIGNIFICANCE: C – Domestic architecture</p>

<p>DESCRIPTION: 1-1/2-story gambrel roof Dutch Colonial house featuring flared eaves, front-gable dormers, fan light in gable and two-bay full-façade porch supported by turned posts.</p>

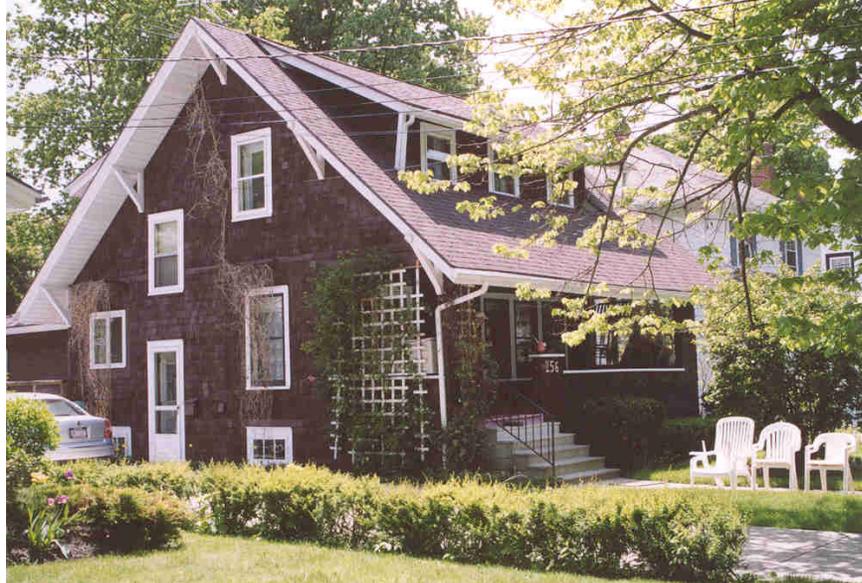
<p>ADDRESS: 256 Maple Avenue</p>	<p>DATE OF CONSTRUCTION: ca. 1915</p>	<p>SIGNIFICANCE: C – Domestic architecture</p>

<p>DESCRIPTION: 1-1/2-story side-gable Craftsman bungalow featuring projecting eaves supported by triangular knee braces. Full-façade shed roof dormer stained wood shingles and two-bay full-façade porch supported by thick piers and featuring a closed handrail.</p>

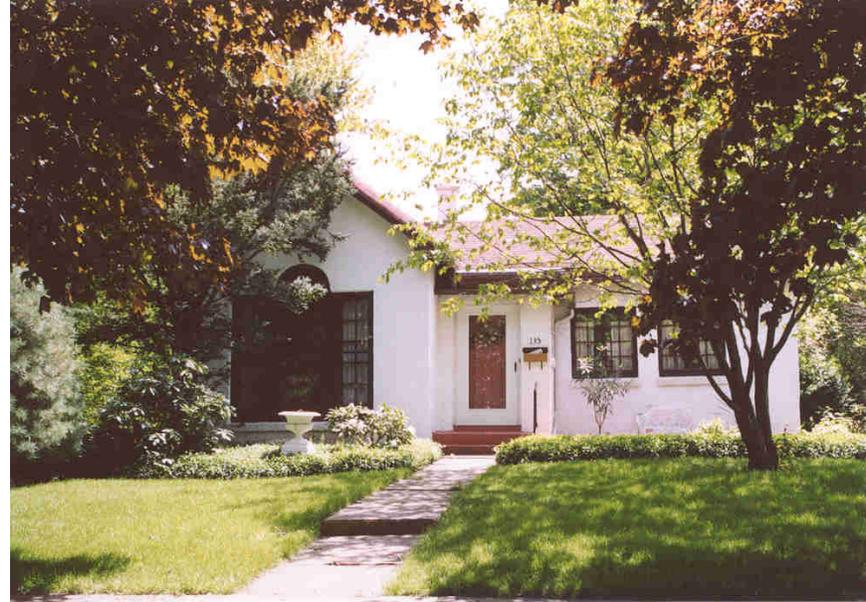
<p>DESCRIPTION: 1-1/2-story, stucco Spanish Eclectic house with Palladian window, tile roof and steel windows.</p>

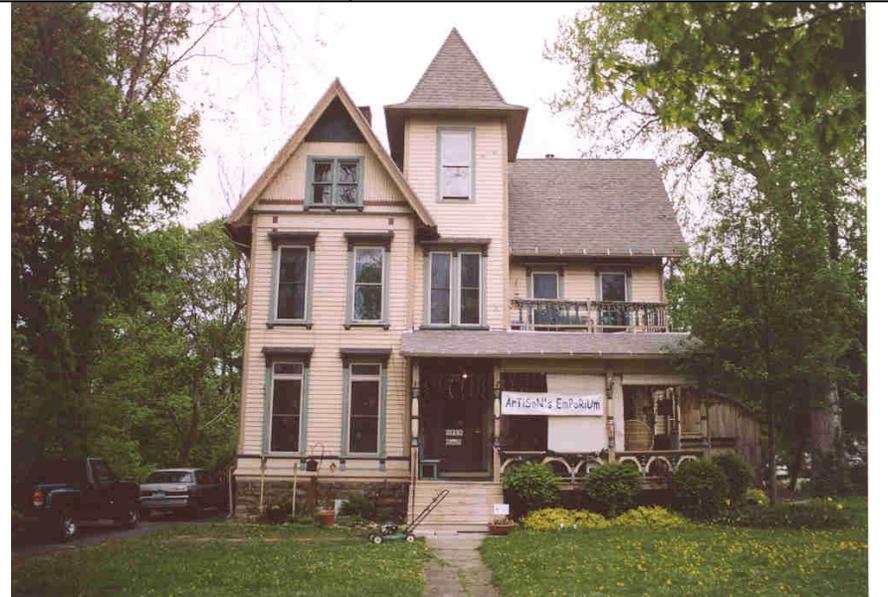
<p>DESCRIPTION: 2-1/2-story gable and wing asymmetrical Queen Anne house featuring steeply pitched roofs and tower with flared pyramidal roof. Rock-face ashlar foundation, pent-roof bracketed window hoods and wraparound porch supported by turned posts.</p>

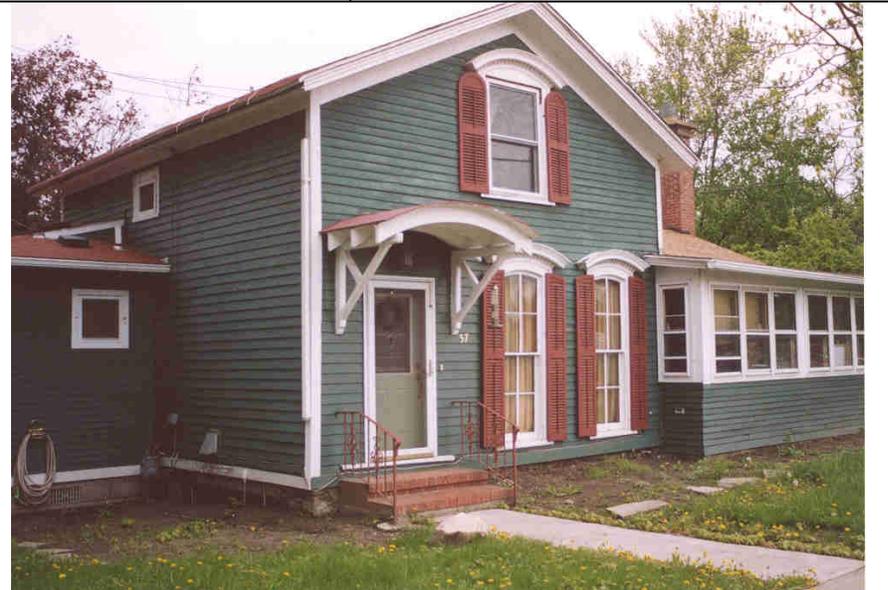
<p>DESCRIPTION: 2-1/2-story gable and wing, wood frame Italianate house with floor to ceiling windows, segmental arch window surrounds, entry porch with segmental arch overhang supported by triangular knee braces and enclosed porch.</p> <p>DESCRIPTION: 2-1/2-story gable and wing, wood frame Italianate house with floor to ceiling windows, segmental arch window surrounds, entry porch with segmental arch overhang supported by triangular knee braces and enclosed porch.</p>

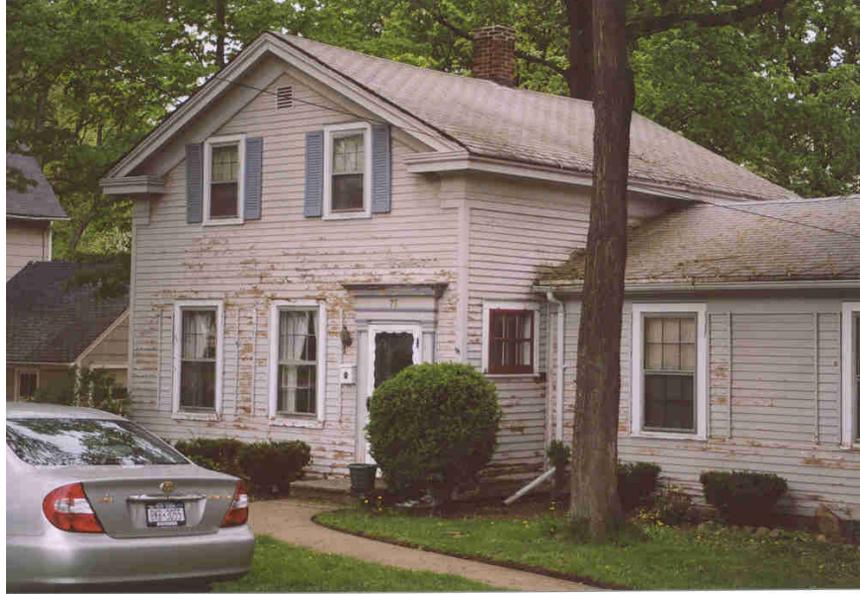
ADDRESS: 77 Pierce Avenue	DATE OF CONSTRUCTION: ca. 1840	SIGNIFICANCE: S – Domestic architecture

DESCRIPTION: 1-1/2-story, gable and wing, wood frame, Greek Revival house featuring low pitched roof, massive cornice with returns and trabeated entrance surround.

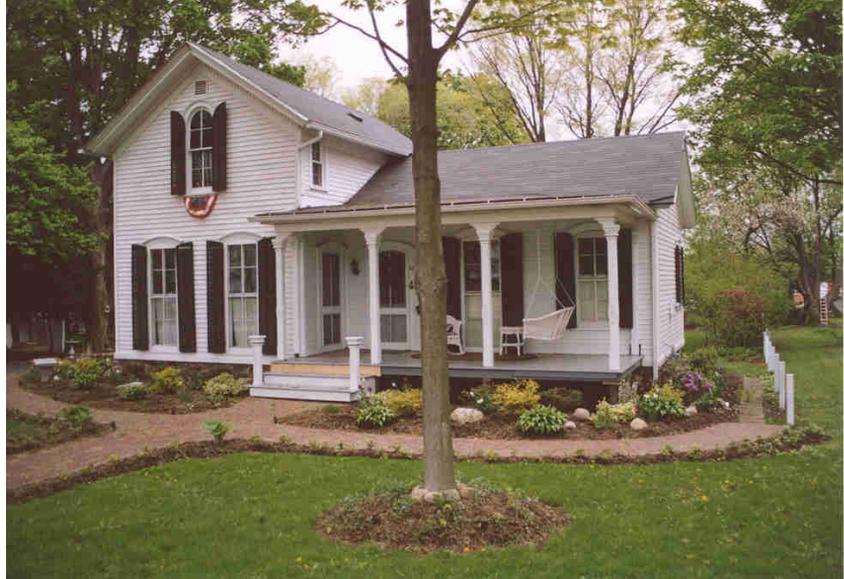
ADDRESS: 93 Pierce Avenue	DATE OF CONSTRUCTION: ca. 1855	SIGNIFICANCE: S – Domestic architecture

DESCRIPTION: 2-1/2-story, gable and wing Italianate house with tall, narrow windows, segmental window heads and a four bay porch supported by chamfered square posts.

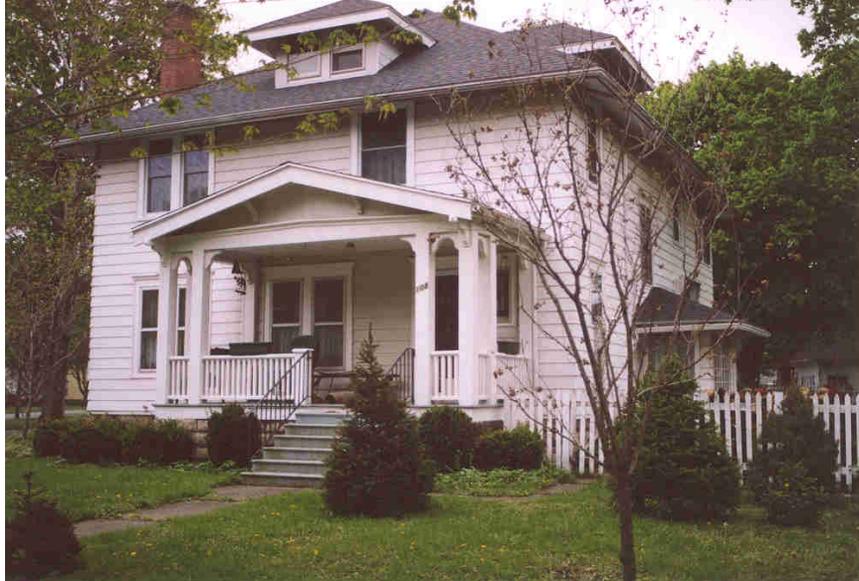
<p>ADDRESS: 108 Pierce Avenue</p>	<p>DATE OF CONSTRUCTION: ca. 1910</p>	<p>SIGNIFICANCE: C – Domestic architecture</p>

<p>DESCRIPTION: 2-1/2-story, hip-roof wood frame Craftsman house with aluminum siding featuring hip roof dormers, broadly projecting eaves and front-gabled partial-façade entry porch supported by grouped square posts.</p>

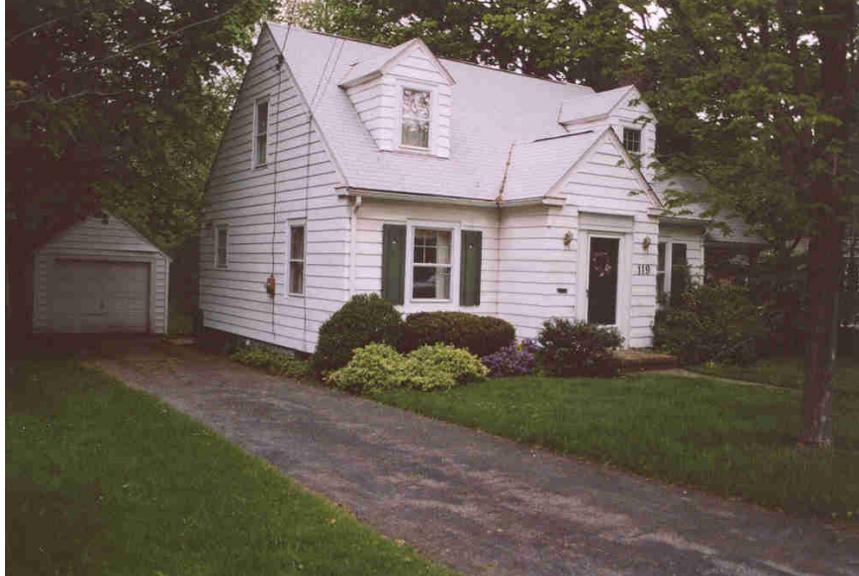
<p>ADDRESS: 119 Pierce Avenue</p>	<p>DATE OF CONSTRUCTION: ca. 1945</p>	<p>SIGNIFICANCE: C – Domestic architecture</p>

<p>DESCRIPTION: 1-1/2-story, side-gable wood frame Cape Cod house featuring front-gable dormers, cut-out shutters, rock-face concrete block foundation and front-gable entrance vestibule.</p>

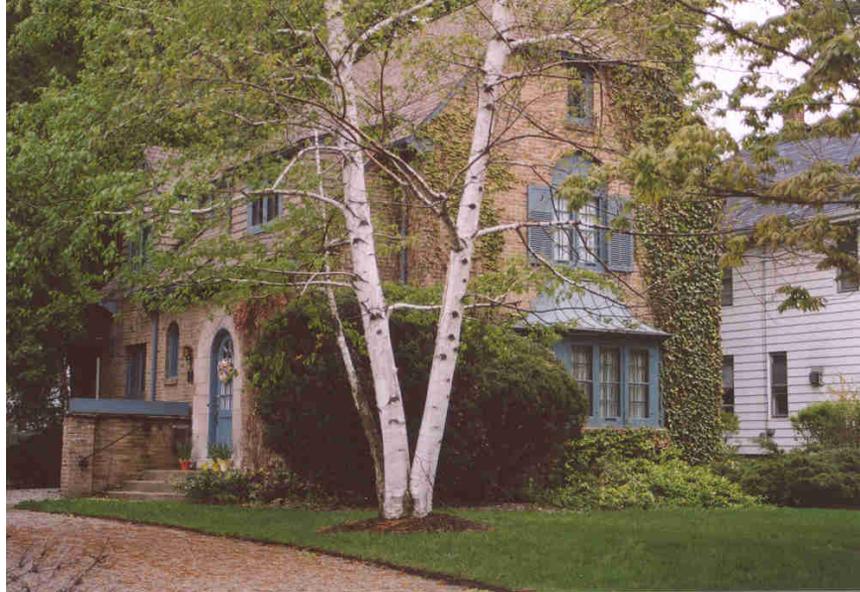
<p>DESCRIPTION: 2-1/2-story brick Tudor house with jerkinhead roof, projecting bay with flared roof, quoined half-round door surround. Property contains freestanding garage.</p>

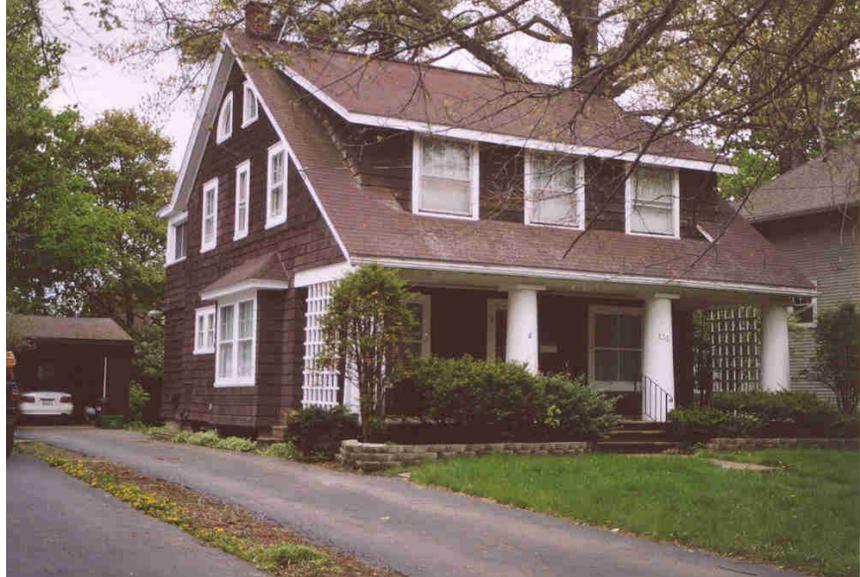
<p>ADDRESS: 132 Pierce Avenue</p>	<p>DATE OF CONSTRUCTION: ca. 1920</p>	<p>SIGNIFICANCE: S – Domestic architecture</p>

<p>DESCRIPTION: 1-1/2-story, side-gable wood frame Craftsman house with stained shingles featuring full-façade shed roof dormer and full-façade three-bay porch supported by full-height massive Tuscan columns.</p>

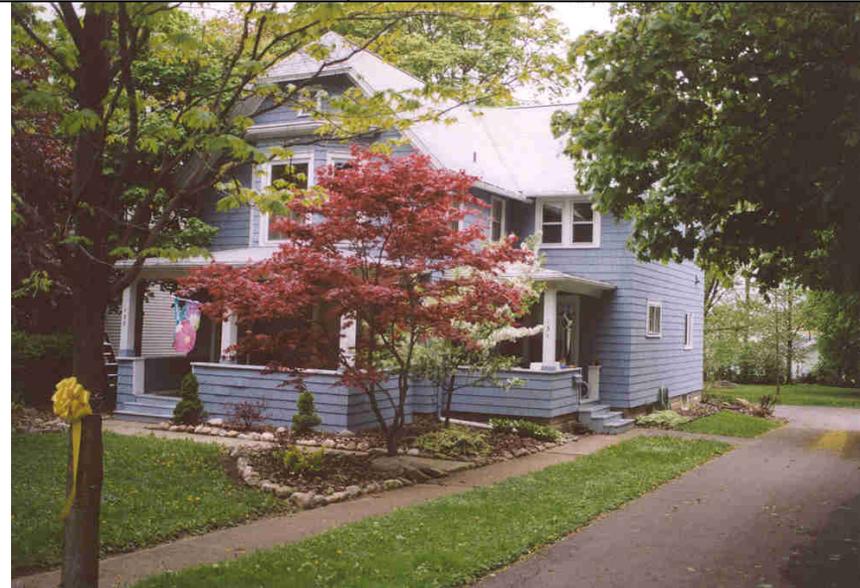
<p>DESCRIPTION: 2-1/2-story, cross plan wood frame Queen Anne house with a Jerkinhead roof. Second floor three-sided bay, wood shingle cladding and a wraparound porch supported by battered square posts set on a closed handrail.</p>

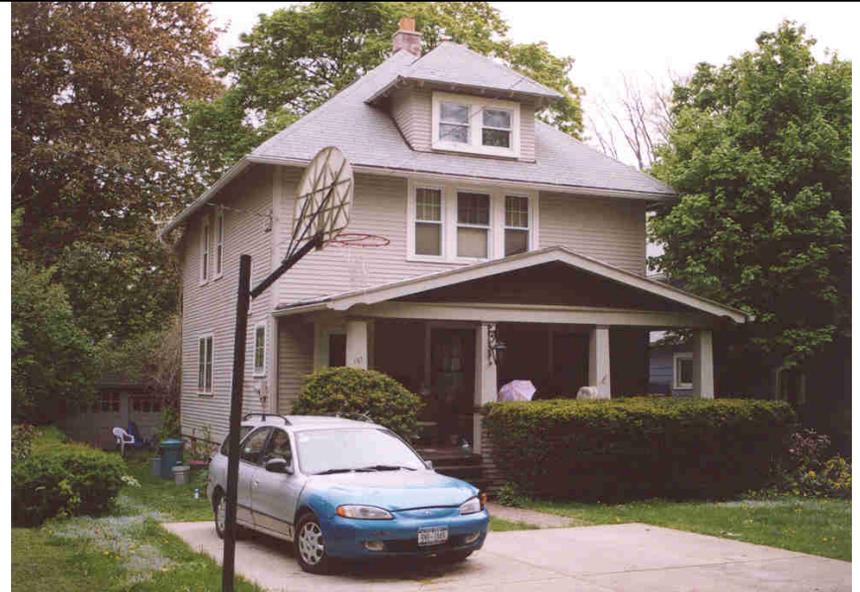
<p>ADDRESS: 137 Pierce Avenue</p>	<p>DATE OF CONSTRUCTION: ca. 1910</p>	<p>SIGNIFICANCE: C – Domestic architecture</p>

<p>DESCRIPTION: 2-1/2-story, hip-roof wood frame Craftsman house incorporating hip-roof dormer, flared eaves, exposed rafter tails, and a front-gable, three-bay porch supported by chamfered square posts set on a closed handrail.</p>

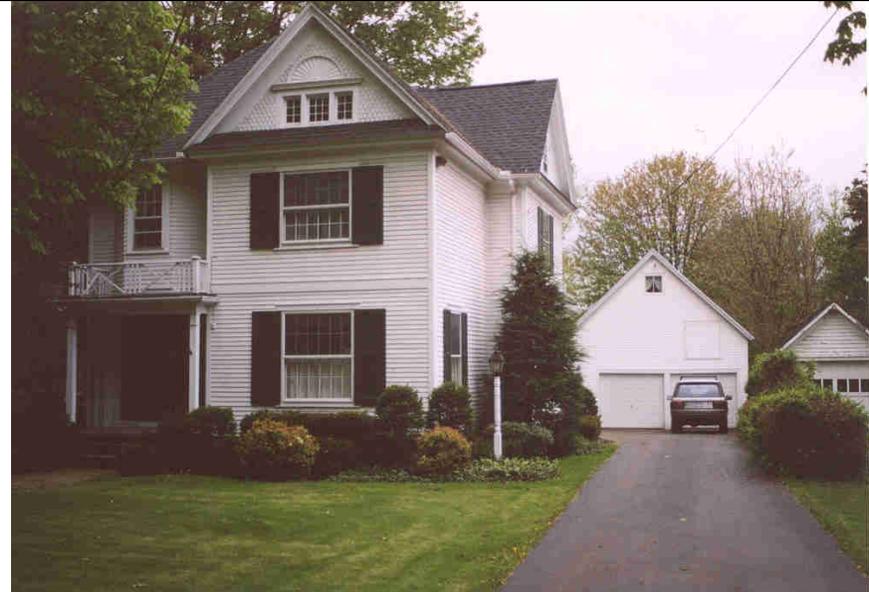
<p>ADDRESS: 147 Pierce Avenue</p>	<p>DATE OF CONSTRUCTION: ca. 1895</p>	<p>SIGNIFICANCE: C – Domestic architecture</p>

<p>DESCRIPTION: 2-1/2-story cross gable asymmetrical Queen Anne house featuring 45 degree roof pitch and closed gables. One-bay entrance porch supported by full-height square posts. A 1-1/2-story carriage barn is located at the rear of the property.</p>

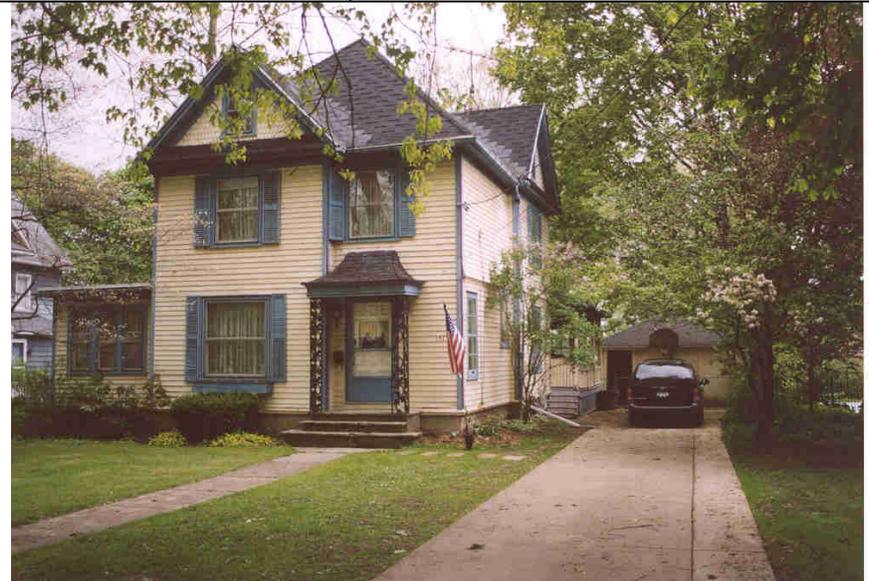
<p>ADDRESS: 151 Pierce Avenue</p>	<p>DATE OF CONSTRUCTION: ca. 1900</p>	<p>SIGNIFICANCE: C – Domestic architecture</p>

<p>DESCRIPTION: 2-1/2-story, hip-roof wood frame Queen Anne house featuring 45 degree roof pitch, closed gables and rock face concrete block foundation. The original porch has been replaced by a Colonial Revival flared roof porch dating from about 1950.</p>

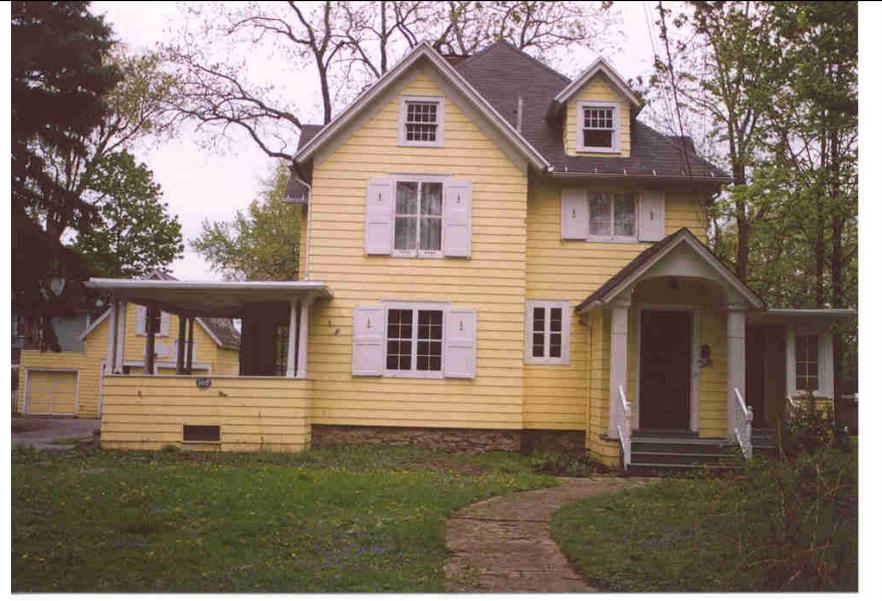
<p>DESCRIPTION: 2-1/2-story, hip-roof wood frame Queen Anne house altered in the Colonial Revival style in the 1920s. Queen Anne features include asymmetrical massing and complicated roof form. Colonial Revival features include cutout window shutters and front gable entrance. Side porch is an early 20th century addition. Property includes remodeled 1-1/2 story Colonial Revival barn.</p>

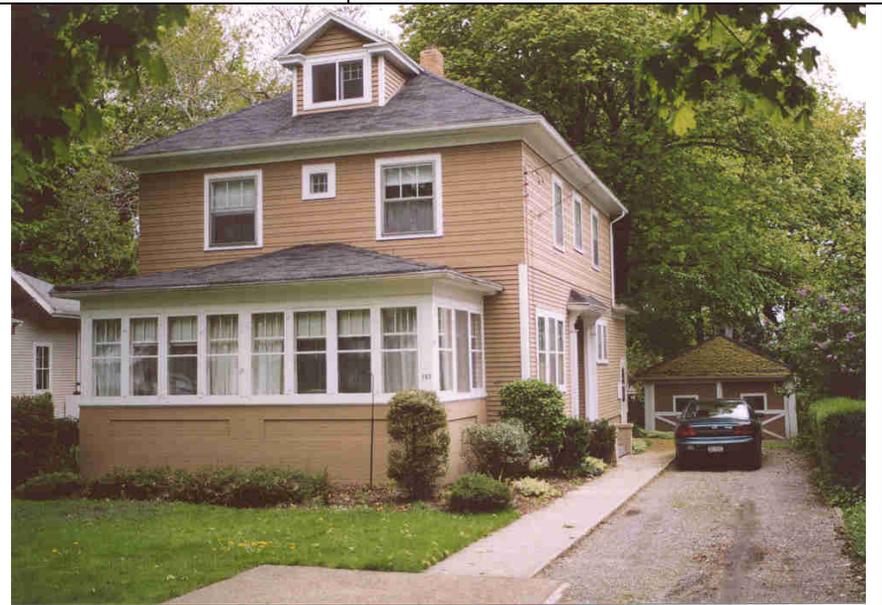
<p>ADDRESS: 167 Pierce Avenue</p>	<p>DATE OF CONSTRUCTION: ca. 1910</p>	<p>SIGNIFICANCE: C – Domestic architecture</p>

<p>DESCRIPTION: 2-1/2-story, hip-roof wood frame Four-square house with flared eaves, front-gable dormer, and enclosed full-facade porch.</p>

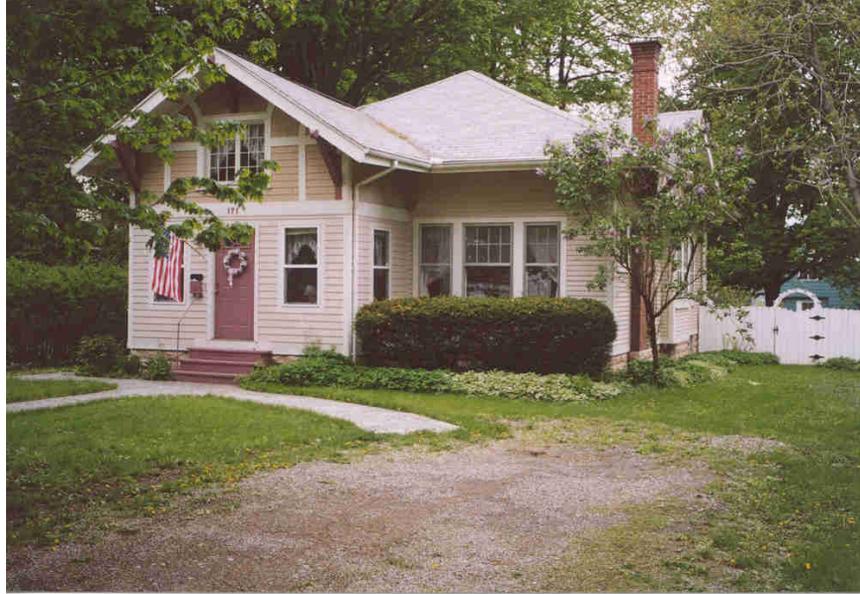
<p>DESCRIPTION: 1-1/2-story, hip roof wood frame Craftsman house featuring widely projecting eaves supported by triangular knee braces, half-timbering and rock faced concrete block foundation.</p>

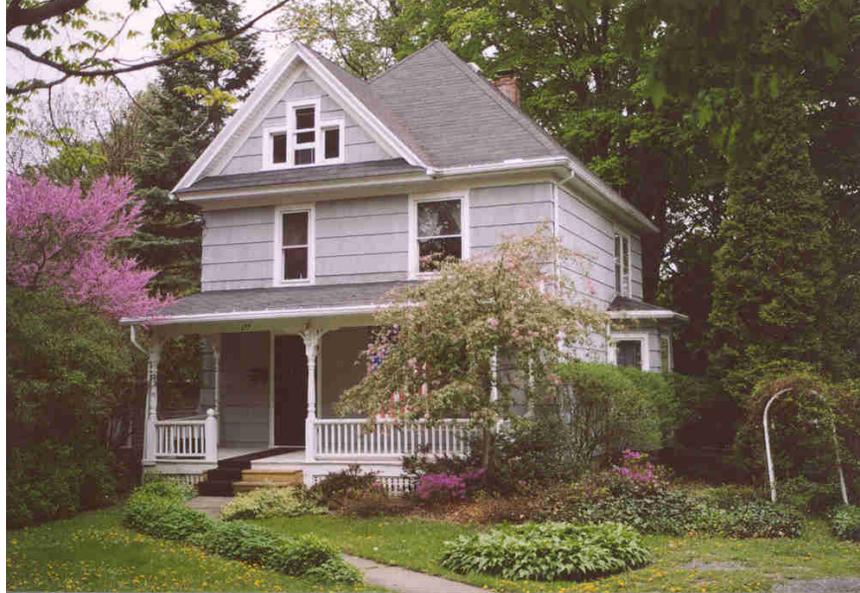
<p>DESCRIPTION: 2-1/2-story, hip-roof wood frame asymmetrical Queen Anne house featuring closed gable and full-façade two-bay porch supported by turned posts.</p>

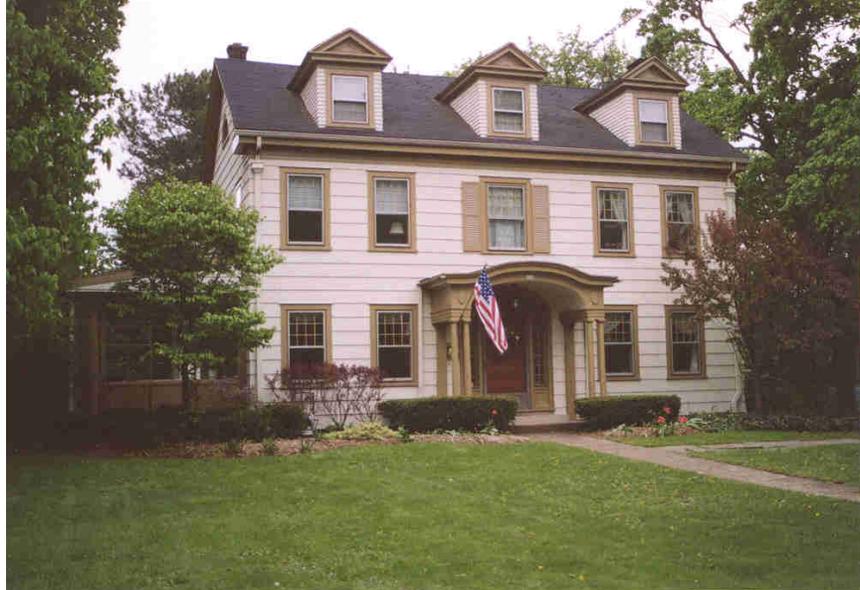
<p>ADDRESS: 182 Pierce Avenue</p>	<p>DATE OF CONSTRUCTION: ca. 1910</p>	<p>SIGNIFICANCE: S – Domestic architecture</p>

<p>DESCRIPTION: 2-1/2-story, side-gable wood frame symmetrical five-bay center entrance Colonial Revival house with pedimented dormers and entrance portico featuring segmental barrel vaulted roof.</p>

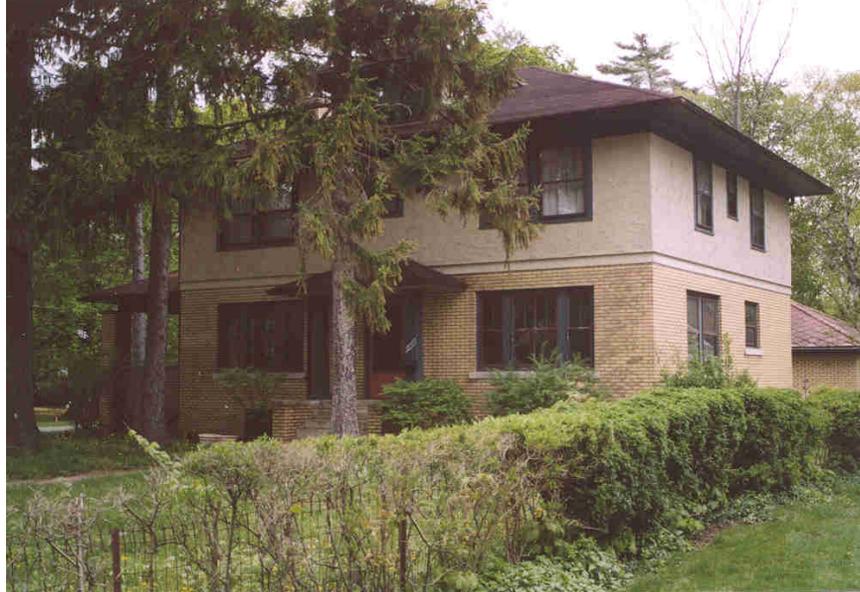
<p>ADDRESS: 200 Pierce Avenue</p>	<p>DATE OF CONSTRUCTION: ca. 1920</p>	<p>SIGNIFICANCE: S – Domestic architecture</p>

<p>DESCRIPTION: 2-1/2-story, hip-roof brick and stucco Prairie house featuring widely projecting eaves, side porch supported by full height brick piers and hip roof entrance portico supported by square posts.</p>

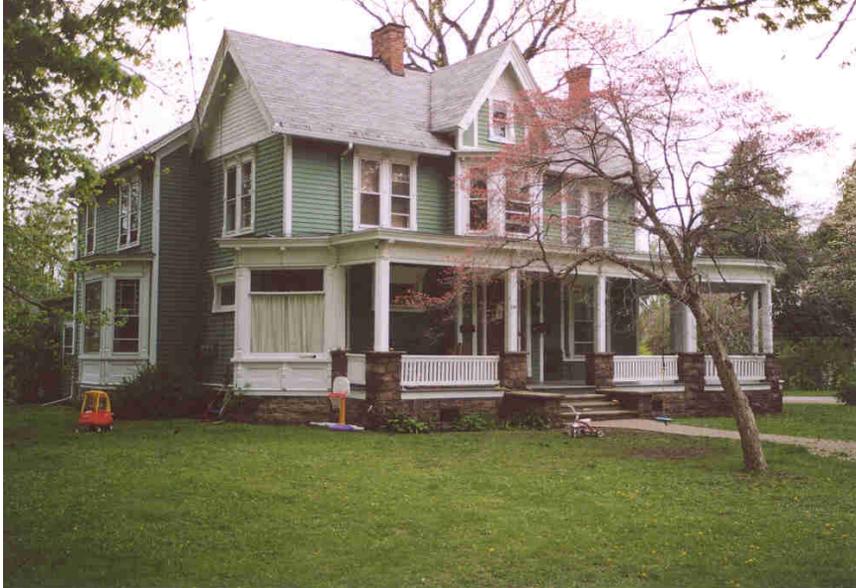
<p>ADDRESS: 201 Pierce Avenue</p>	<p>DATE OF CONSTRUCTION: ca. 1890</p>	<p>SIGNIFICANCE: S – Domestic architecture</p>

<p>DESCRIPTION: 2-1/2-story, side-gable wood frame Queen Anne house featuring steeply pitched roofs, patterned wood shingles in the gables, projecting three-sided bays, flat arch window surrounds supported by low relief Tuscan pilasters, rock face concrete block foundation and a wraparound porch supported by square posts.</p>

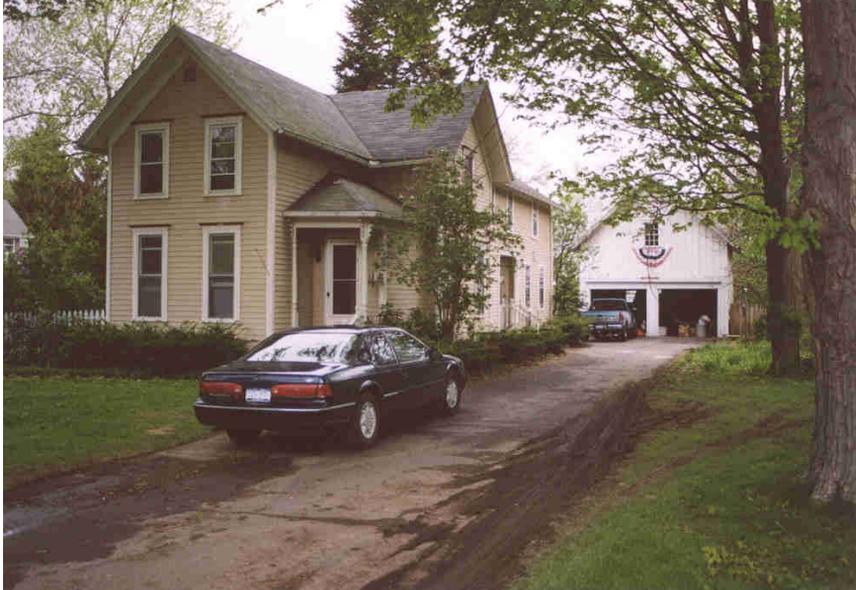
<p>ADDRESS: 205 Pierce Avenue</p>	<p>DATE OF CONSTRUCTION: ca. 1875</p>	<p>SIGNIFICANCE: C – Domestic architecture</p>

<p>DESCRIPTION: 2-1/2-story, cross-gable wood frame L-plan house featuring widely projecting eaves and one-bay entrance porch supported by turned posts. Property contains freestanding barn.</p>

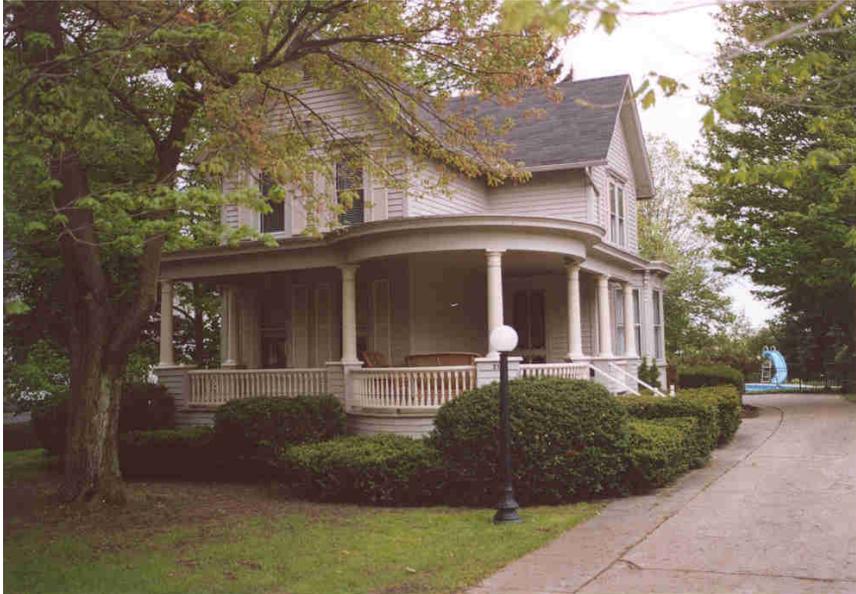
<p>ADDRESS: 211 Pierce Avenue</p>	<p>DATE OF CONSTRUCTION: ca. 1880</p>	<p>SIGNIFICANCE: S – Domestic architecture</p>

<p>DESCRIPTION: 2-1/2-story, tri-gable wood frame L-plan house with three-sided projecting bay featuring brackets and a wraparound Colonial Revival porch circa 1900 supported by 3/4-height Tuscan pilasters</p>

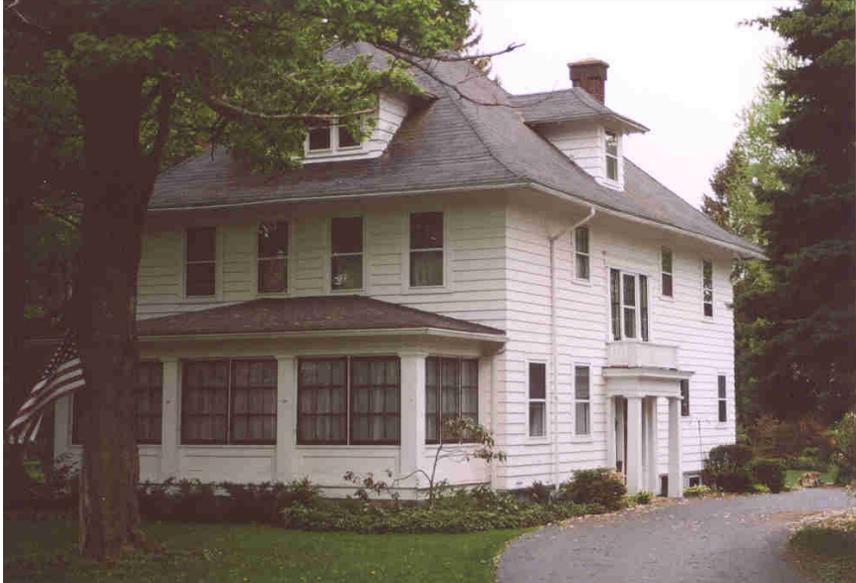
<p>ADDRESS: 221 Pierce Avenue</p>	<p>DATE OF CONSTRUCTION: ca. 1915</p>	<p>SIGNIFICANCE: C – Domestic architecture</p>

<p>DESCRIPTION: 2-1/2-story, hip roof wood frame Four-square house incorporating hip roof dormers, two-story bay, flared eaves with exposed rafter tails, grade level driveway entrance with portico supported by square posts and three-bay hip roof porch with closed handrail. Porch has been enclosed.</p>

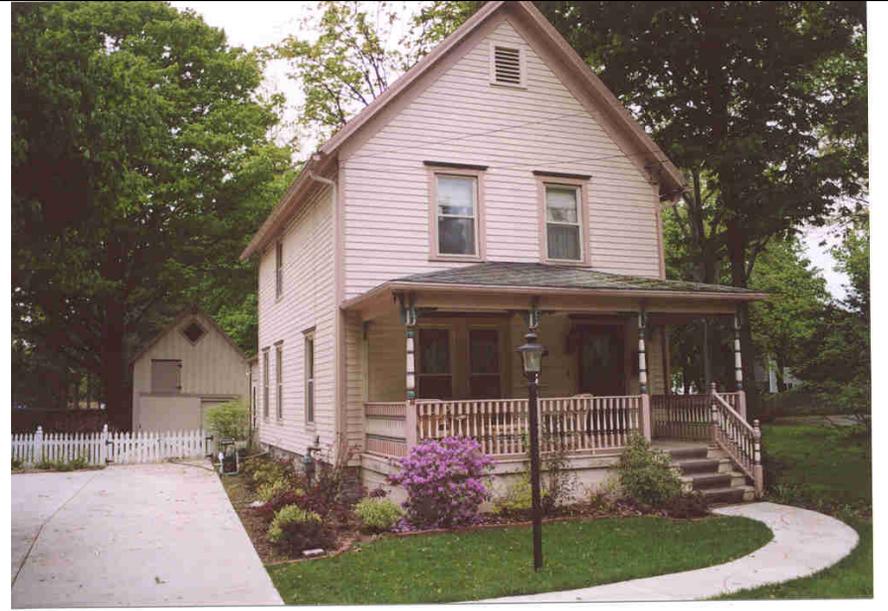
<p>DESCRIPTION: 2-1/2-story, front-gable wood frame Vernacular house featuring rock face concrete block foundation and three-bay full-façade porch supported by turned posts. One-and-one-half-story carriage barn is located at the rear of the property.</p>
