RECONNAISSANCE LEVEL SURVEY
OF HISTORIC RESOURCES

VILLAGE OF HAMBURG

Erie County, New York

Bero Architecture PC
32 Winthrop Street
Rochester, New York 14607

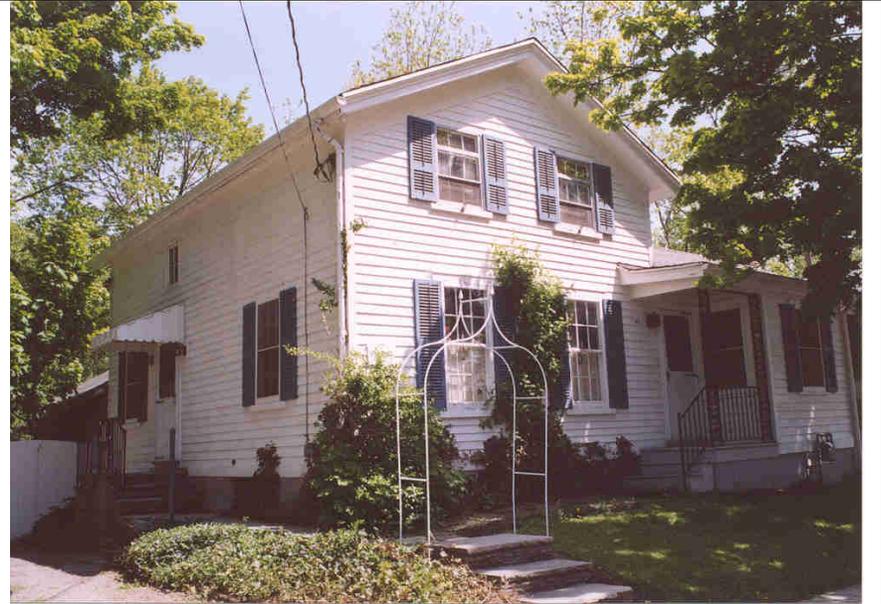
<p>DESCRIPTION: 2-1/2-story Front-gable house featuring projecting eaves, rock face concrete block foundation and twentieth-century entrance portico supported by decorative metalwork posts.</p>

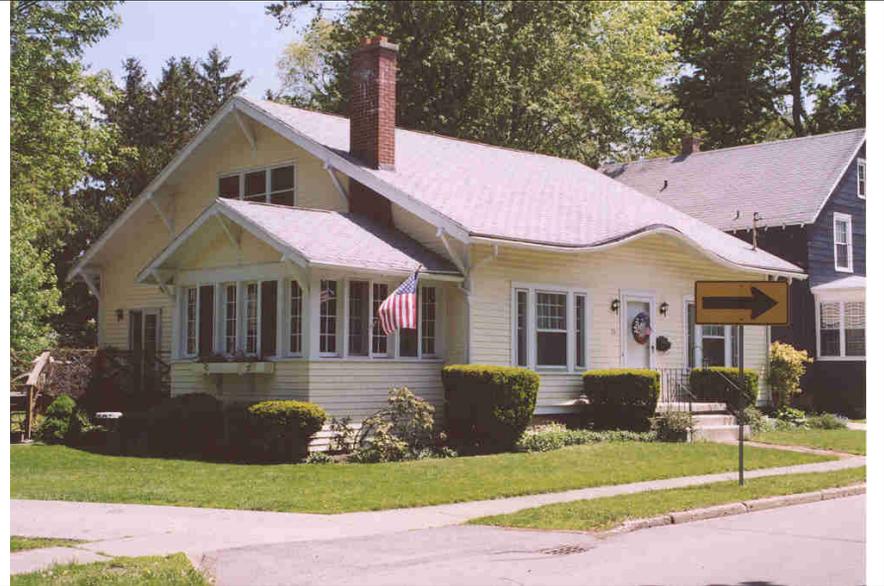
<p>DESCRIPTION: 1-1/2-story side-gable Craftsman bungalow featuring projecting eaves supported by triangular knee braces, curved roof imitating thatched roof and enclosed porch.</p>

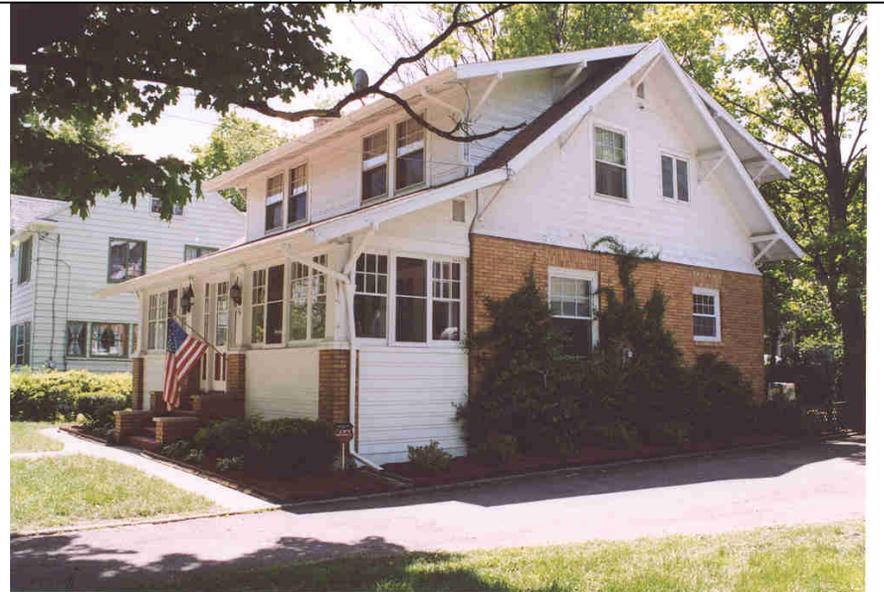
<p>ADDRESS: 26 Pleasant Avenue</p>	<p>DATE OF CONSTRUCTION: ca. 1920</p>	<p>SIGNIFICANCE: C – Domestic architecture</p>

<p>DESCRIPTION: 1-1/2-story side-gable brick and shingle Craftsman bungalow featuring full-façade shed roof dormers, projecting eaves supported by triangular knee braces and a three-bay full-façade porch supported by 3/4-height square posts which is now enclosed.</p>

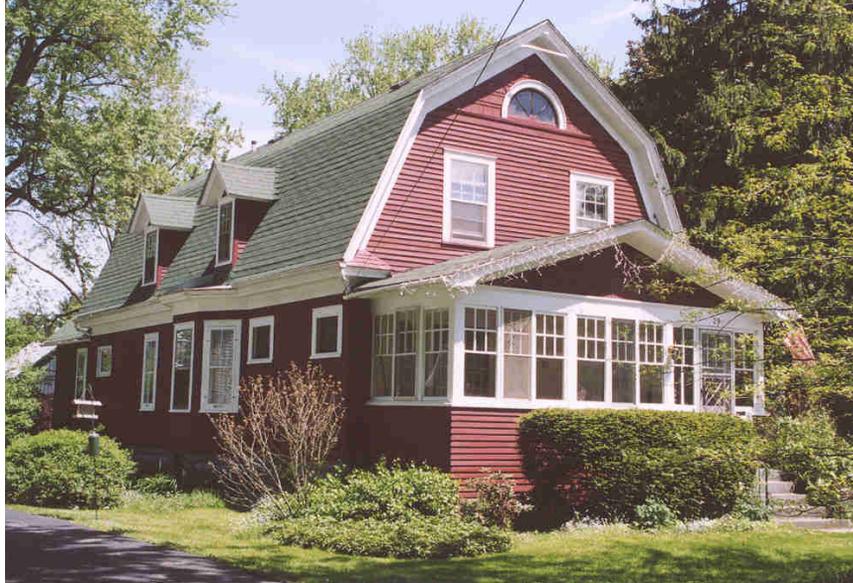
<p>ADDRESS: 29 Pleasant Avenue</p>	<p>DATE OF CONSTRUCTION: ca. 1905</p>	<p>SIGNIFICANCE: C – Domestic architecture</p>

<p>DESCRIPTION: 2-1/2-story gambrel roof Dutch colonial house featuring front-gable dormers, fanlight in gable and front-gable three-bay enclosed porch.</p>

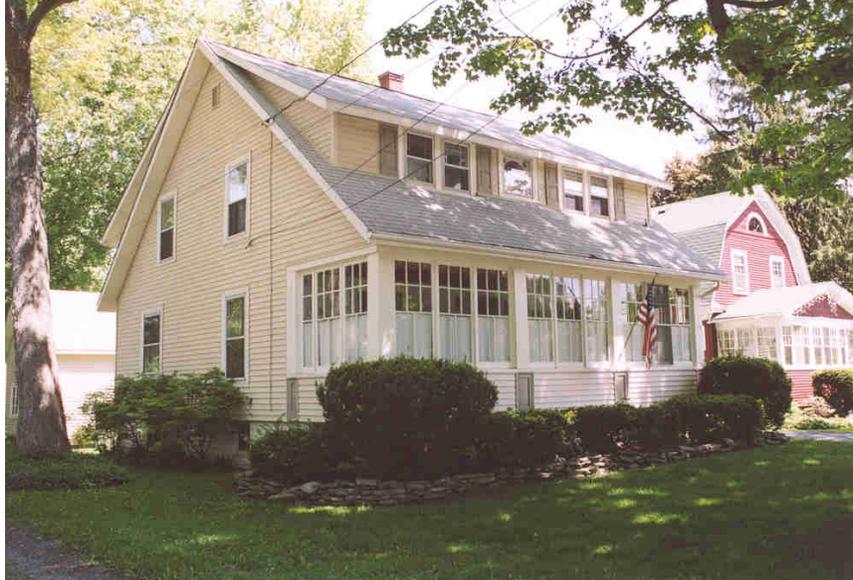
<p>ADDRESS: 35 Pleasant Avenue</p>	<p>DATE OF CONSTRUCTION: ca. 1920</p>	<p>SIGNIFICANCE: C – Domestic architecture</p>

<p>DESCRIPTION: 1-1/2-story side-gable Craftsman bungalow featuring full-façade shed roof dormers, rock-face concrete block foundation and an enclosed three-bay full-façade porch supported by square posts.</p>

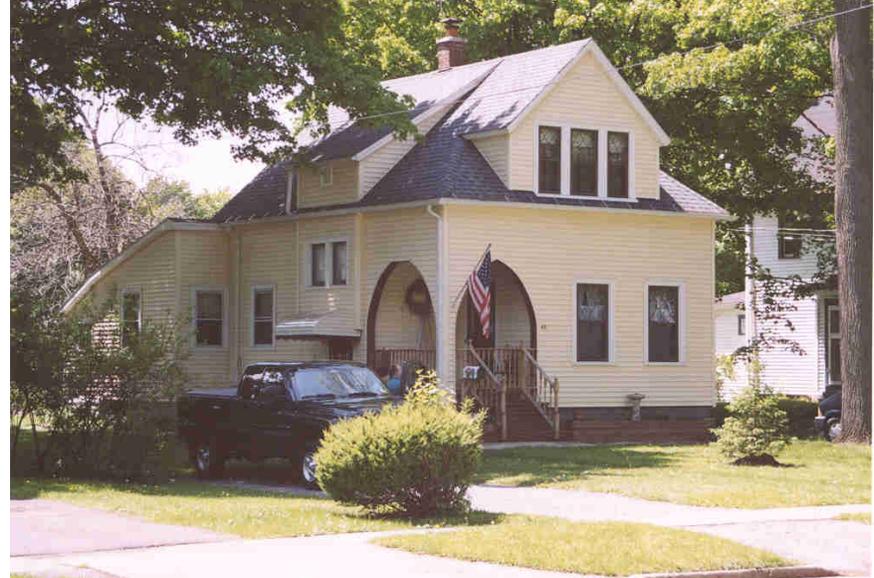
<p>DESCRIPTION: 1-1/2-story Colonial Revival house with recessed entrance porch incorporating pointed-arch openings.</p>

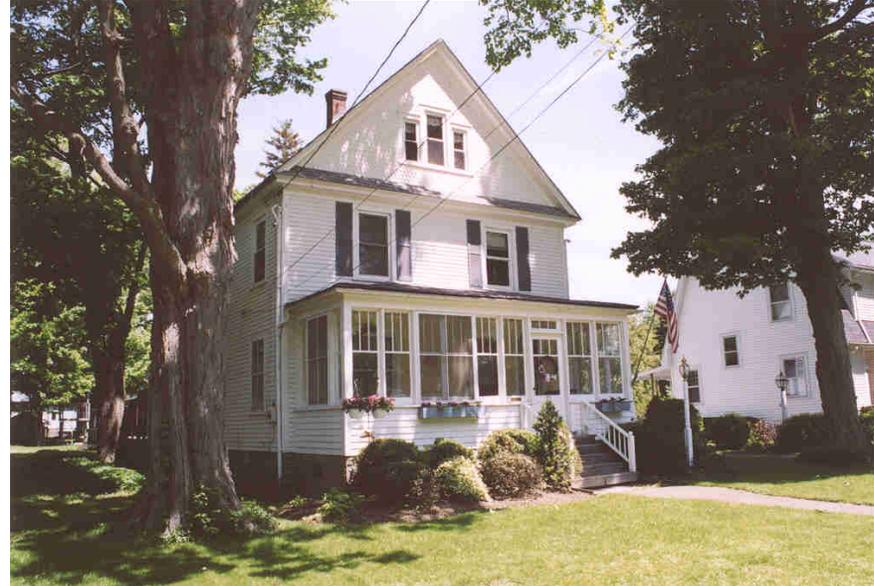
<p>DESCRIPTION: 2-1/2-story front-gable Four-square house with 45 degree roof slope and closed gable. Rock face concrete block foundation, and enclosed full-façade porch.</p>

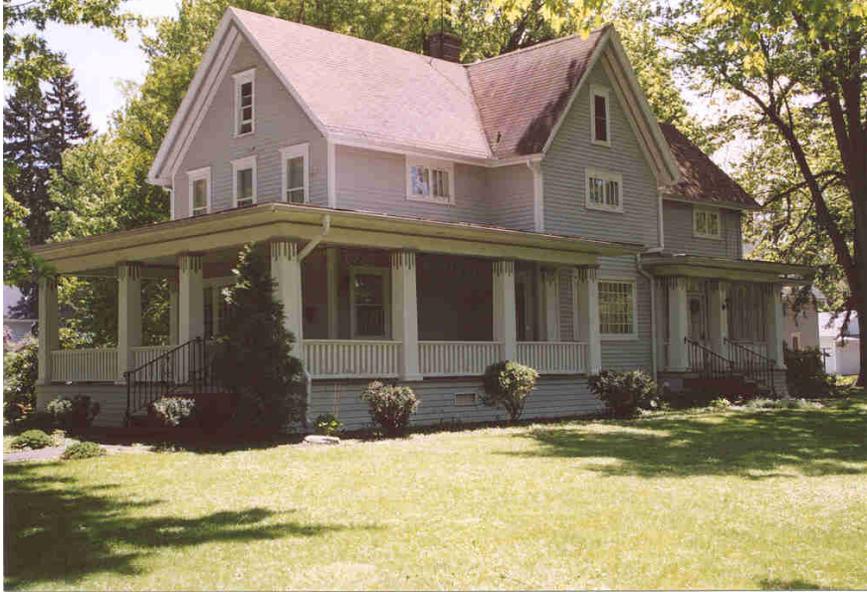
<p>DESCRIPTION: 2-1/2-story Cross-plan house featuring steeply pitched roofs and an early twentieth-century Prairie style wraparound porch supported by full-height square columns. Property contains a freestanding barn.</p>

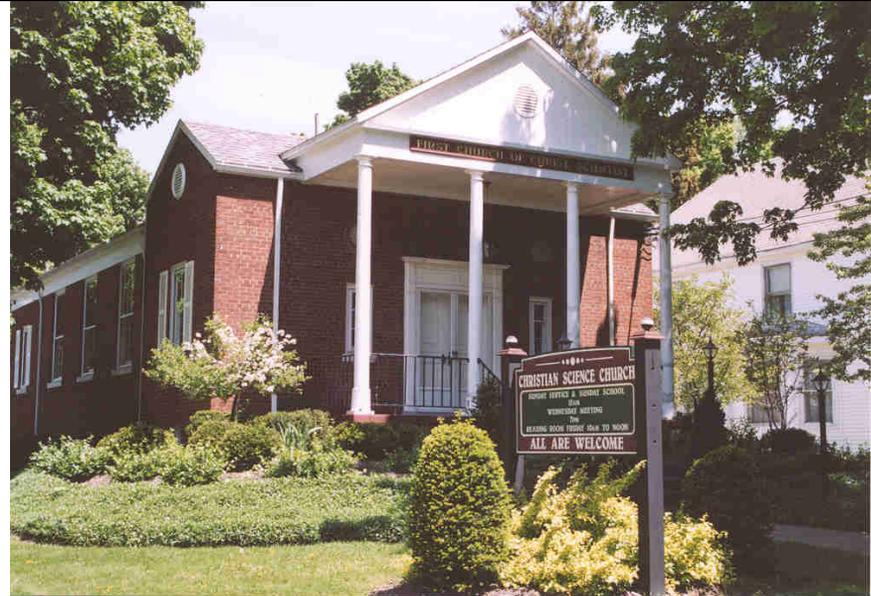
<p>ADDRESS: Church of Christ, Scientist, Pleasant Avenue</p>	<p>DATE OF CONSTRUCTION: 1932</p>	<p>SIGNIFICANCE: C – Ecclesiastical architecture</p>

<p>DESCRIPTION: 1-1/2-story side-gable brick Colonial Revival Church with pedimented entrance portico supported by slender Tuscan columns.</p>

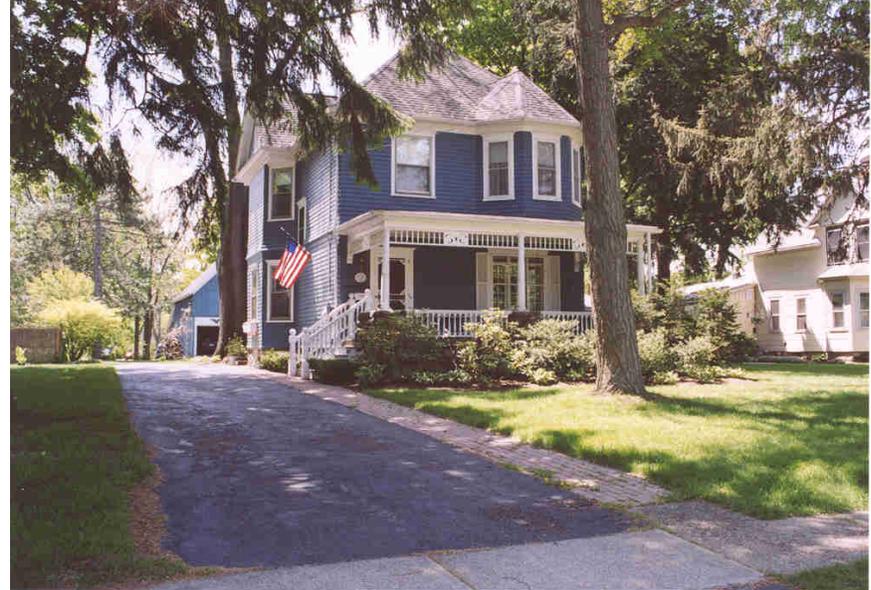
<p>DESCRIPTION: 2-1/2-story hip roof asymmetrical Queen Anne house featuring three-sided projecting bay with a faceted conical roof, rock face concrete block foundation and two-bay full-façade porch supported by slender Tuscan columns. One-and-one-half-story carriage barn is located at the rear of the property.</p>

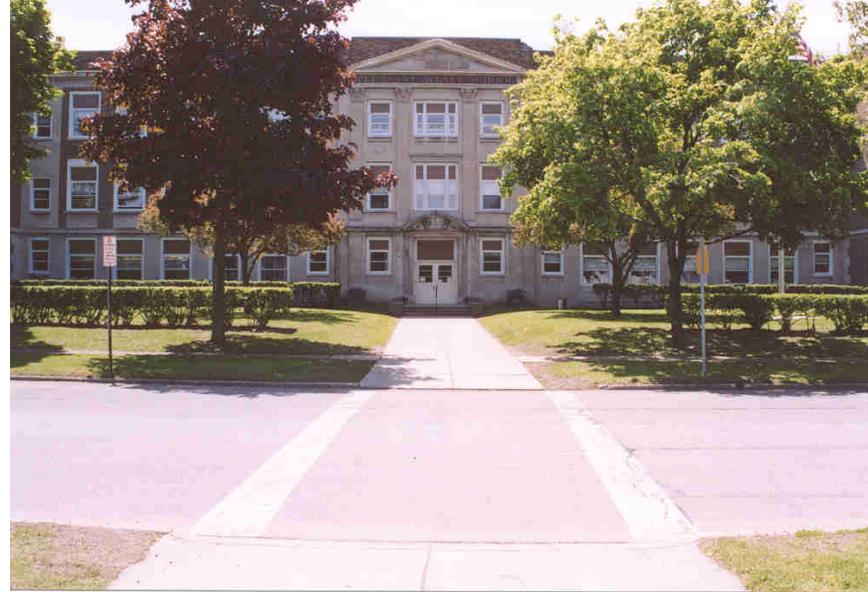
DESCRIPTION: 3-1/2-story side-gable Neoclassical building with stone base, brick and stone upper stories and quoined corners featuring three-bay central pedimented wing supported by double-height Corinthian pilasters sitting on single-story Tuscan pilasters. Entrance crowned by broken segmental arch resting on a stone frame. Building was originally Hamburg High School.

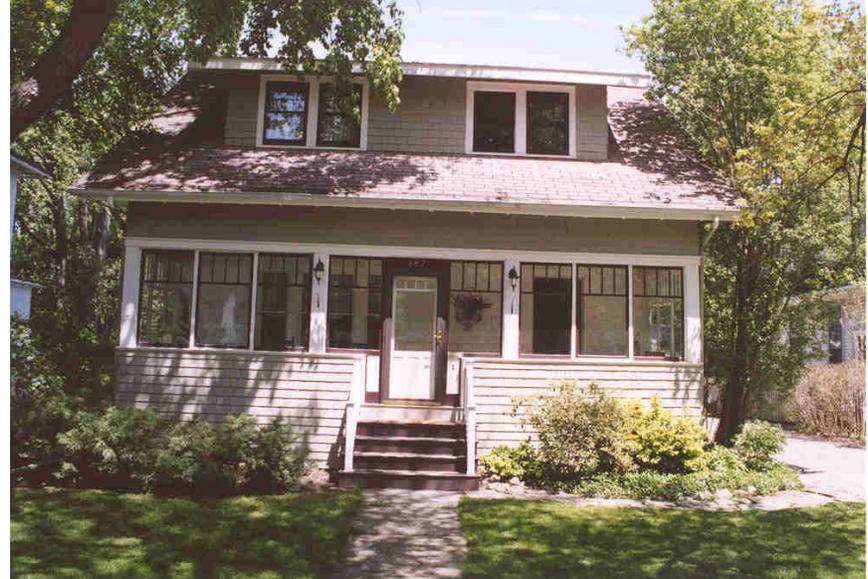
ADDRESS: 187 Pleasant Avenue	DATE OF CONSTRUCTION: ca. 1915	SIGNIFICANCE: C – Domestic architecture

DESCRIPTION: 1-1/2-story side-gable Craftsman bungalow featuring full-façade shed roof dormer and three-bay full-façade enclosed porch supported by 3/4-height square posts set on a closed handrail..

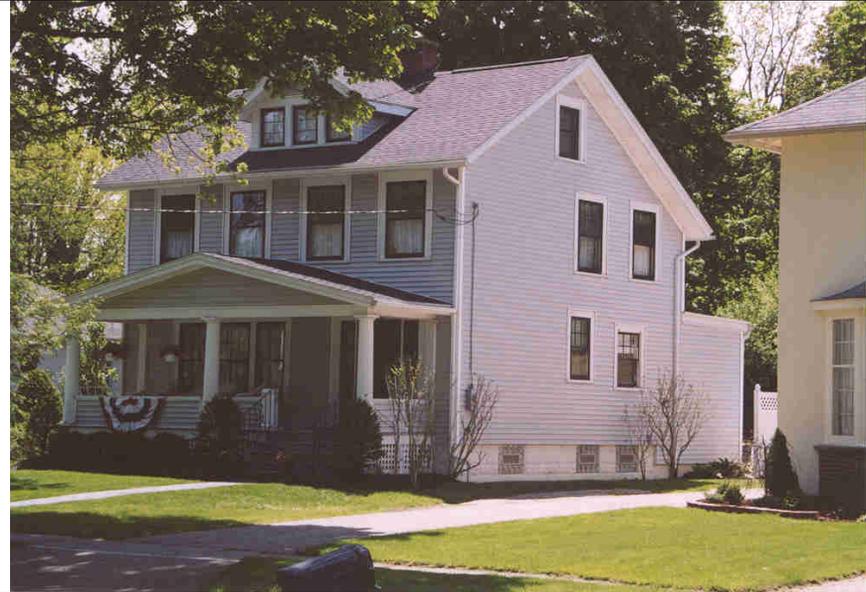
<p>ADDRESS: 198 Pleasant Avenue</p>	<p>DATE OF CONSTRUCTION: ca. 1920</p>	<p>SIGNIFICANCE: C – Domestic architecture</p>

<p>DESCRIPTION: 2-1/2-story, side-gable Craftsman house featuring front-gable dormer and front-gable two-bay full-façade porch supported by full-height Tuscan columns with a closed handrail.</p>

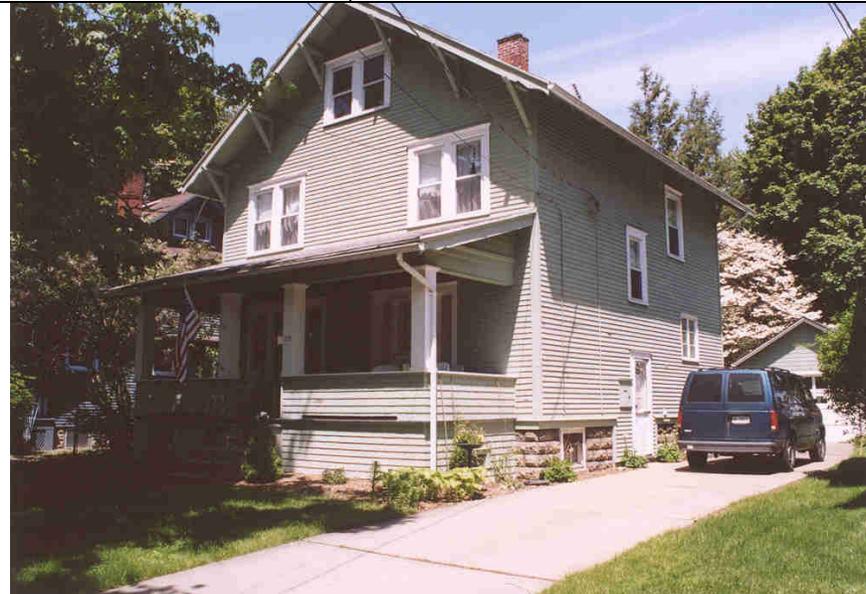
<p>DESCRIPTION: 2-1/2-story front-gable Craftsman house with 45 degree roof slope, broadly projecting eaves with exposed rafter tails, triangular knee brackets, rock-face concrete block foundation, and full façade three-bay porch supported by ¾-height square posts with closed handrail.</p>

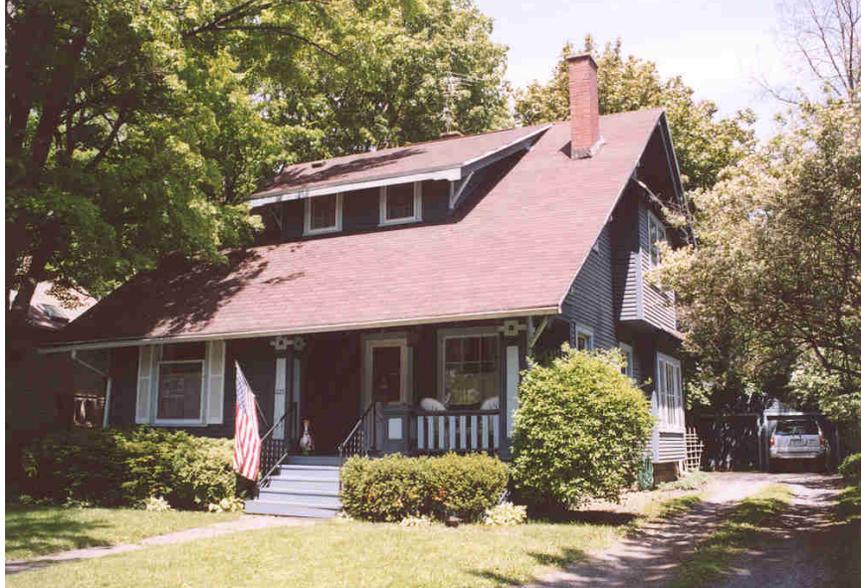
<p>DESCRIPTION: 1-1/2-story side-gable Craftsman bungalow featuring partial-façade shed roof dormer, projecting eaves with exposed rafter tails and one-bay partial-façade porch supported by full-height battered posts.</p>

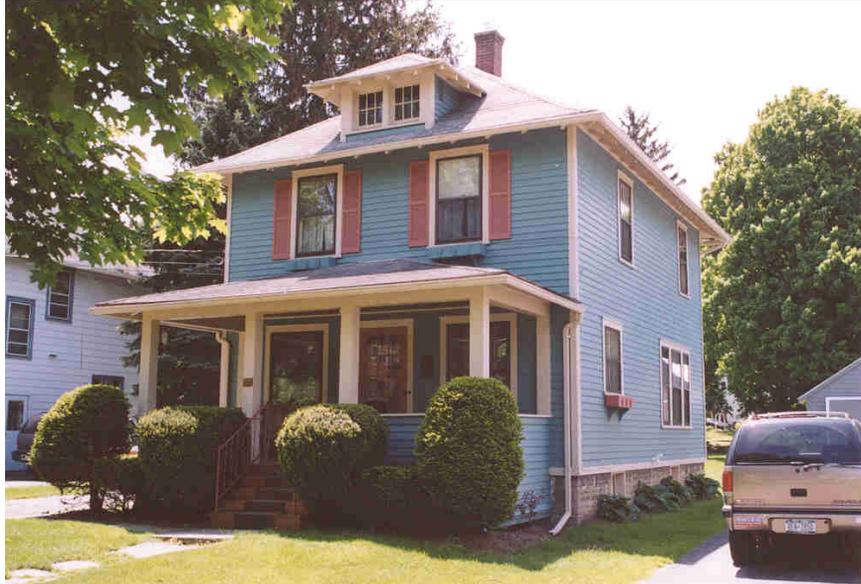
<p>ADDRESS: 232 Pleasant Avenue</p>	<p>DATE OF CONSTRUCTION: ca. 1910</p>	<p>SIGNIFICANCE: C – Domestic architecture</p>

<p>DESCRIPTION: 2-1/2-story hip roof Four-square house incorporating hip roof dormer. Flared eaves with exposed rafter tails, rock face concrete block foundation. Three-bay full façade porch supported by 3/4-height square posts with closed handrail.</p>

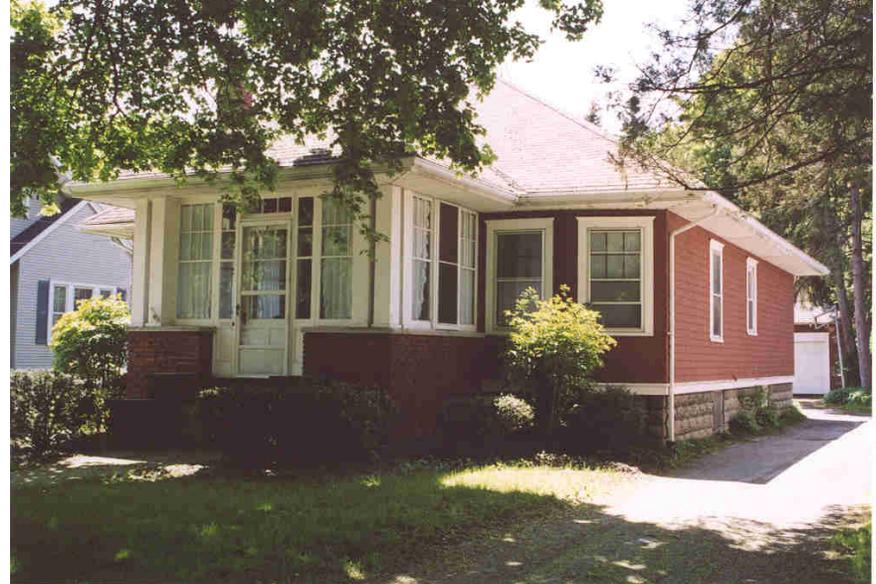
<p>DESCRIPTION: 1-1/2-story, symmetrical, hip-roof Vernacular house with hip-roof enclosed porch.</p>

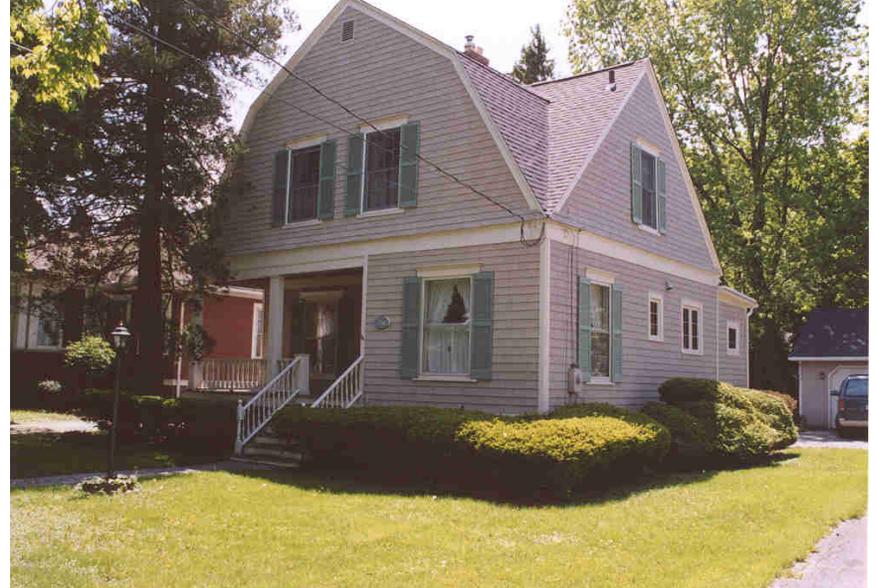
<p>ADDRESS: 256 Pleasant Avenue</p>	<p>DATE OF CONSTRUCTION: ca. 1905</p>	<p>SIGNIFICANCE: C – Domestic architecture</p>

<p>DESCRIPTION: 1-1/2-story gambrel roof Dutch Colonial house featuring façade gambrel, flush eaves, and recessed two-bay partial-façade porch supported by full-height square posts.</p>

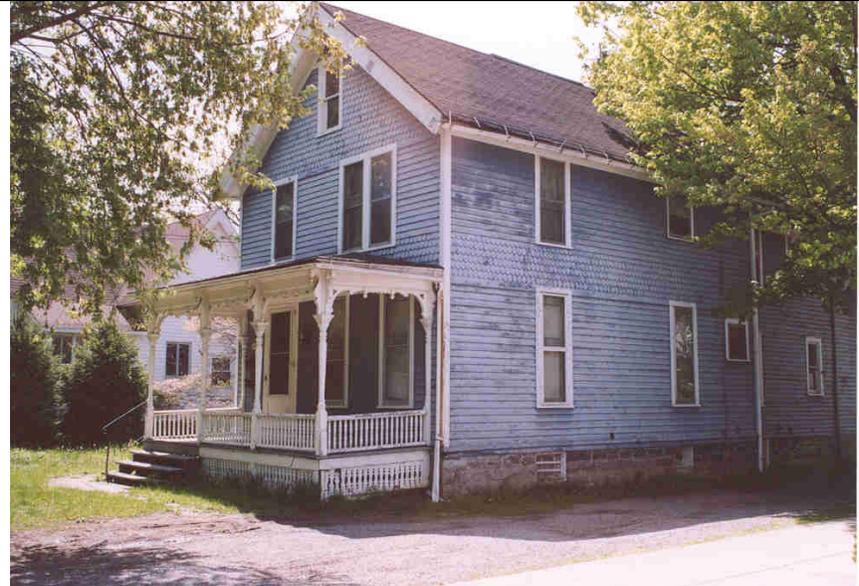
<p>ADDRESS: 304 Pleasant Avenue</p>	<p>DATE OF CONSTRUCTION: ca. 1885</p>	<p>SIGNIFICANCE: C – Domestic architecture</p>

<p>DESCRIPTION: 2-1/2-story front-gable wood-frame Queen Anne house featuring tall, thin windows, rock face concrete block foundation and a three-bay Queen Anne porch supported by turned posts.</p>

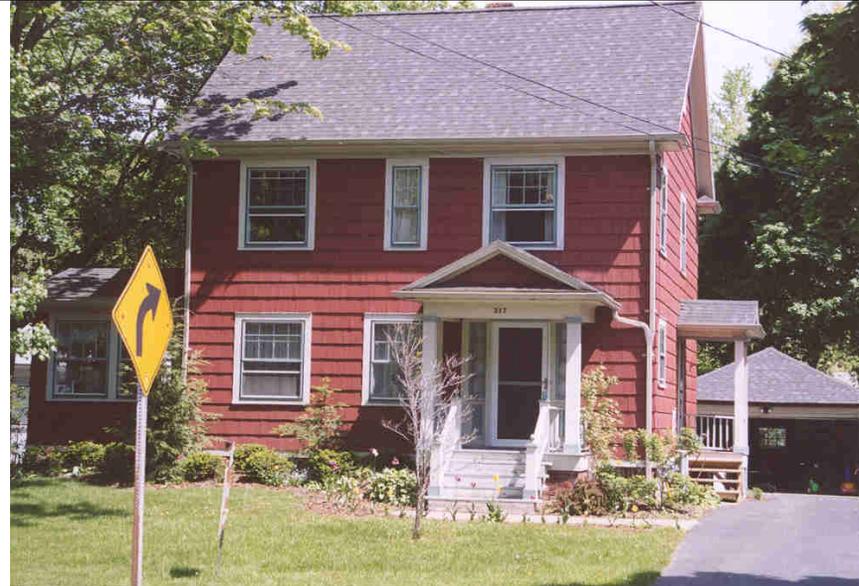
<p>ADDRESS: 317 Pleasant Avenue</p>	<p>DATE OF CONSTRUCTION: ca. 1925</p>	<p>SIGNIFICANCE: C – Domestic architecture</p>

<p>DESCRIPTION: 2-1/2-story side-gable Colonial Revival house with bands at cornice, pedimented single-bay entrance porch on front and side supported by square posts. Freestanding hip roof garage is located at the rear of the property.</p>

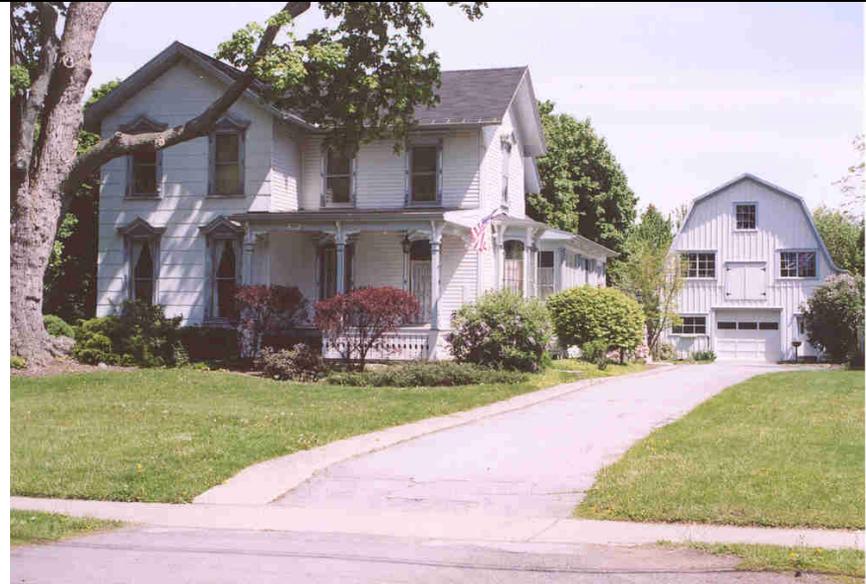
<p>ADDRESS: 339 Pleasant Avenue</p>	<p>DATE OF CONSTRUCTION: ca. 1875</p>	<p>SIGNIFICANCE: C – Domestic architecture</p>

<p>DESCRIPTION: 2-1/2-story gable and wing Italianate style house featuring tall, thin windows, broadly projecting eaves, pedimented windows and a two-bay partial-façade Queen Anne porch supported by full-height chamfered square posts . Property also contains an early twentieth-century gambrel-roof freestanding barn.</p>

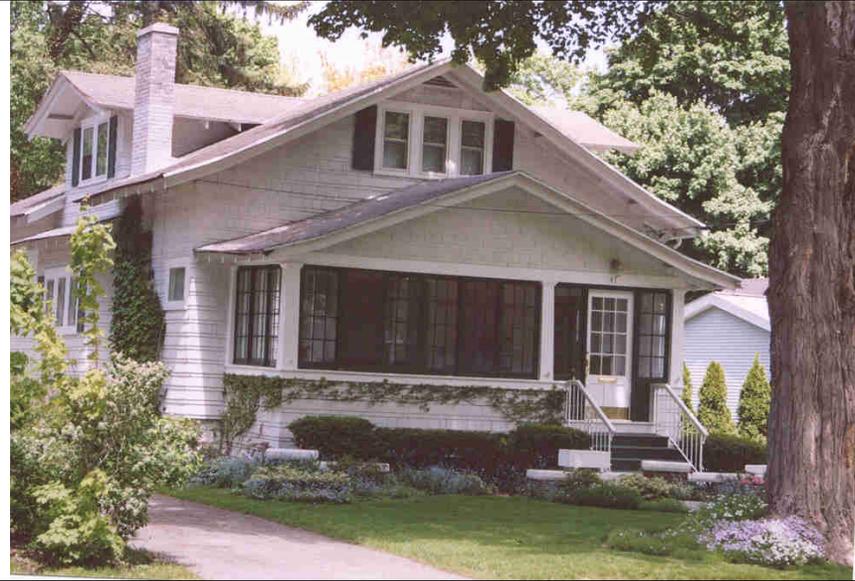
<p>ADDRESS: 47 Prospect Avenue</p>	<p>DATE OF CONSTRUCTION: ca. 1920</p>	<p>SIGNIFICANCE: C – Domestic architecture</p>

<p>DESCRIPTION: 1-1/2-story front-gable Craftsman house with gable-roof dormers, flared eaves, exposed rafter tails, and a two-bay full-façade enclosed porch supported by ¾-height square posts set on a closed handrail.</p>

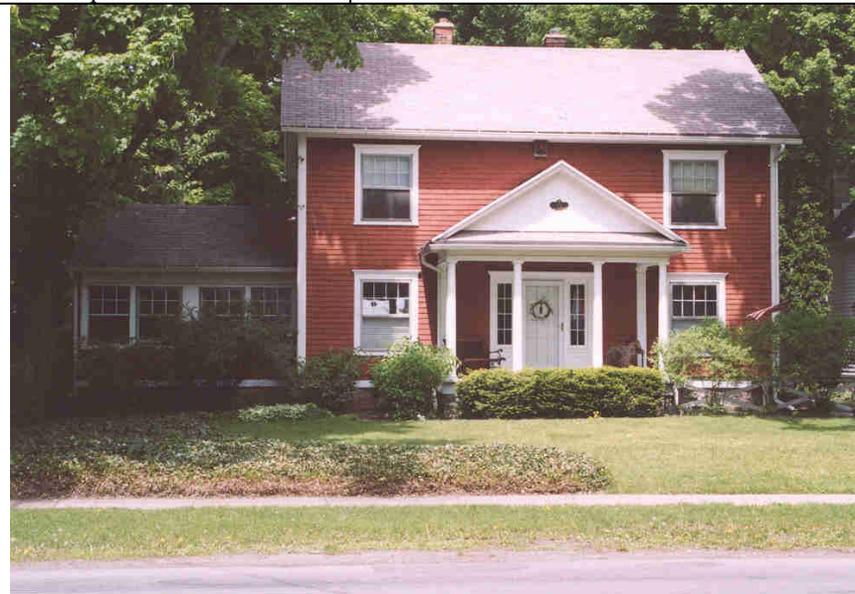
<p>ADDRESS: 69 Prospect Avenue</p>	<p>DATE OF CONSTRUCTION: ca. 1920</p>	<p>SIGNIFICANCE: C – Domestic architecture</p>

<p>DESCRIPTION: 2-1/2-story side-gable, center-entrance, symmetrical Colonial revival house featuring rock face concrete block foundation, enclosed side porch and three-bay closed-gable entry portico supported by full height Tuscan columns.</p>

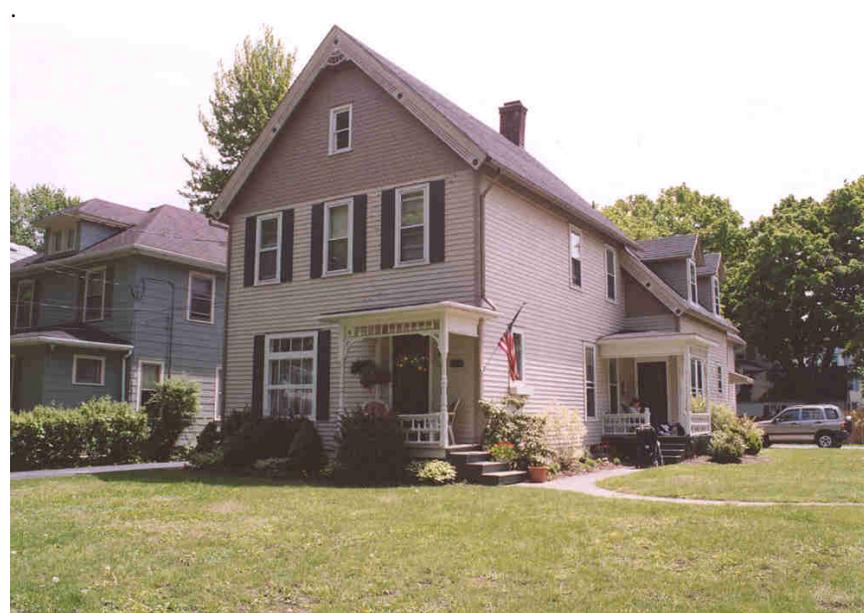
<p>DESCRIPTION: 2-1/2-story front-gable wood frame Queen Anne house with patterned wood shingles and spindlework in the gable, front-gable dormers and two one-bay entrance porticoes supported by turned posts</p>

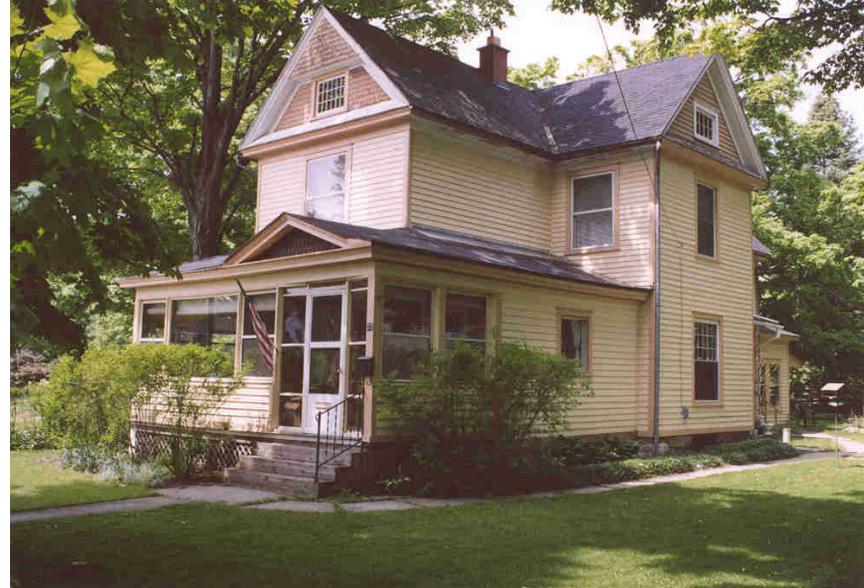
<p>ADDRESS: 77 Prospect Avenue</p>	<p>DATE OF CONSTRUCTION: ca. 1890</p>	<p>SIGNIFICANCE: C – Domestic architecture</p>

<p>DESCRIPTION: 2-1/2-story L-plan Queen Anne house featuring closed gables, patterned wood shingles, rock face concrete block foundation and a full-façade enclosed porch with a front-gable entrance.</p>

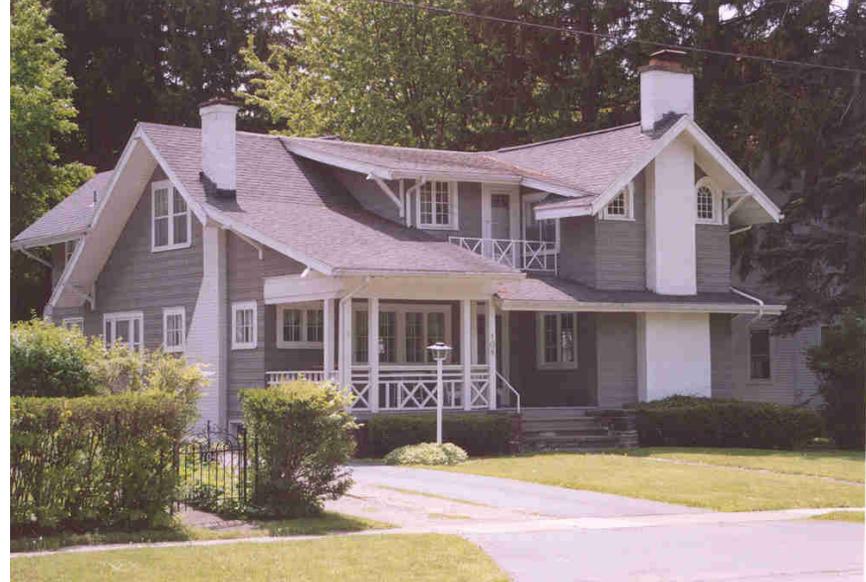
<p>ADDRESS: 108 Prospect Avenue</p>	<p>DATE OF CONSTRUCTION: ca. 1915</p>	<p>SIGNIFICANCE: S – Domestic architecture</p>

<p>DESCRIPTION: 1-1/2-story cross-gable wood frame Craftsman house featuring broadly projecting eaves supported by triangular knee brackets, partial-façade shed dormer, twin half-round windows, exterior chimneys and a two-bay partial-façade porch supported by grouped square posts.</p>

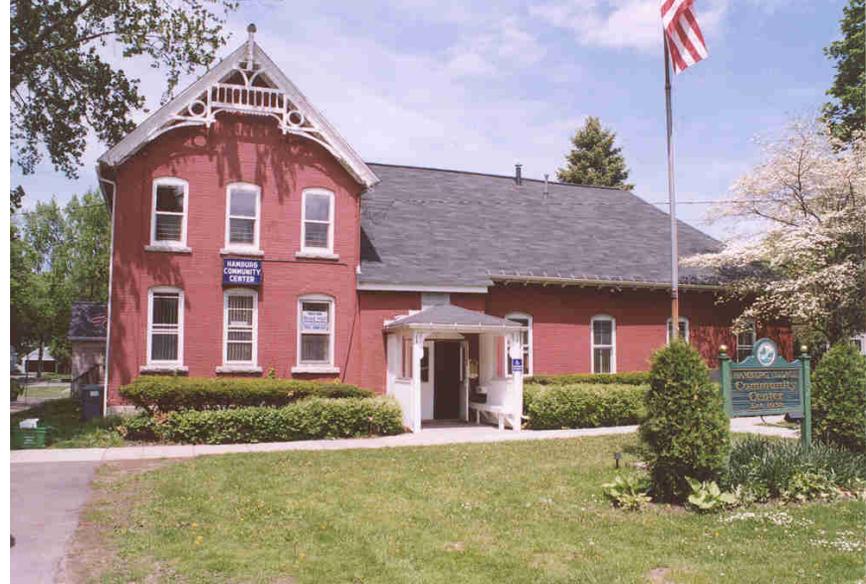
<p>ADDRESS: 107 Prospect Avenue Hamburg Community Center,</p>	<p>DATE OF CONSTRUCTION: ca. 1889</p>	<p>SIGNIFICANCE: S - Commercial Architecture</p>

<p>DESCRIPTION: 2-1/2-story, gable and wing brick Queen Anne building featuring an elaborate spindlework bargeboard in gable, tall, thin 1/1 segmental arch windows and one-bay hip roof entrance portico supported by full-height square posts. The building was built as pumping station for the Hamburg Water and Electric Light Company. The building has served as a community recreation center since the 1930s.</p>

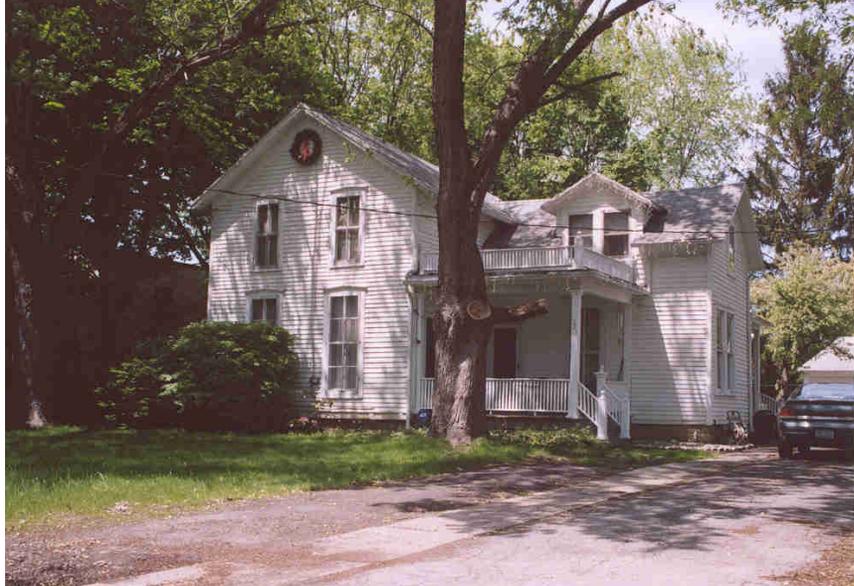
<p>ADDRESS: 321 Prospect Avenue</p>	<p>DATE OF CONSTRUCTION: ca. 1860</p>	<p>SIGNIFICANCE: C – Domestic architecture</p>

<p>DESCRIPTION: 2-1/2-story gable and wing Italianate house featuring tall, thin segmental arch windows, rock face concrete block foundation, front-gable dormer and ca. 1900 one-bay Colonial Revival porch supported by full-height square posts.</p>

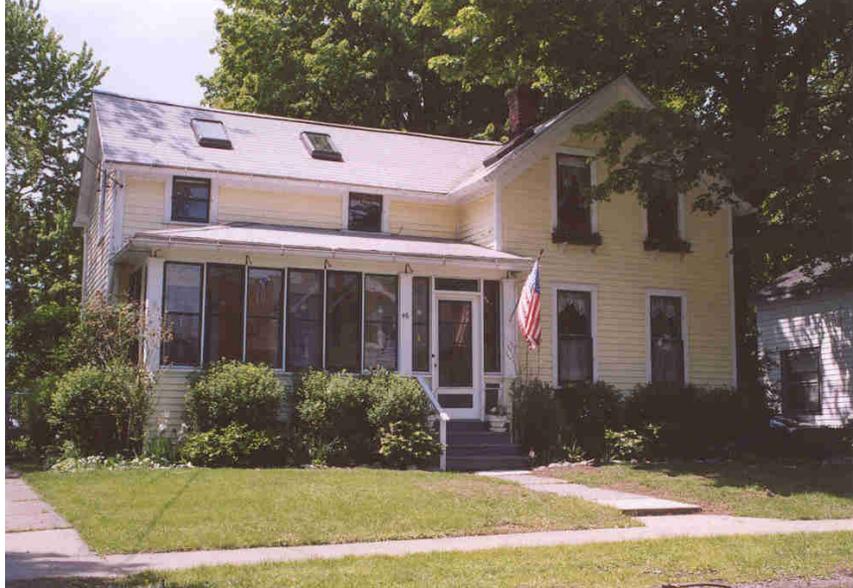
<p>ADDRESS: 46 Sickmon Avenue</p>	<p>DATE OF CONSTRUCTION: ca. 1860</p>	<p>SIGNIFICANCE: C – Domestic architecture</p>

<p>DESCRIPTION: 2-1/2-story Gable and wing house incorporating ca. 1910 two-bay partial-façade enclosed porch supported by ¾ square posts set on a closed handrail.</p>

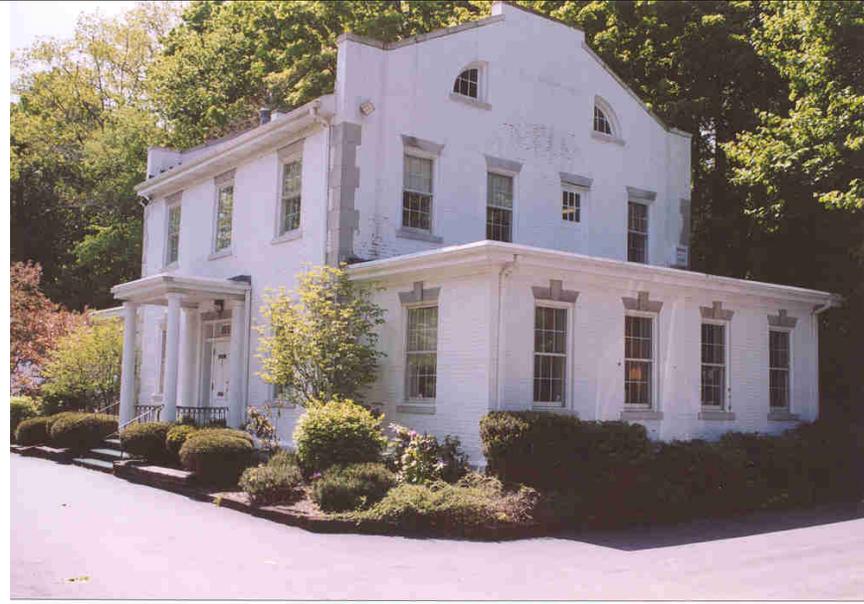
<p>ADDRESS: 97 South Buffalo St.</p>	<p>DATE OF CONSTRUCTION: ca. 1927</p>	<p>SIGNIFICANCE: S – Domestic architecture</p>

<p>DESCRIPTION: 2-1/2 story, three-bay Colonial Revival building with side-gable parapet roof and featuring quoins at corners, one-story flat roof wing and projecting entrance portico supported by full-height Tuscan columns. Former village filtration plant. Now occupied Hamburg Counseling Services.</p>

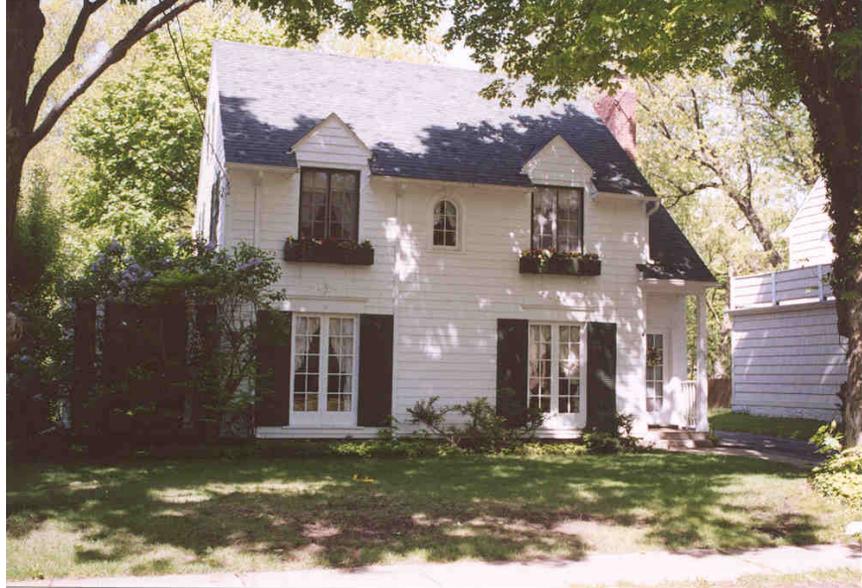
ADDRESS: 159 South Lake Street	DATE OF CONSTRUCTION: ca. 1925	SIGNIFICANCE: C – Domestic architecture

DESCRIPTION: 2-1/2-story side-gable French Eclectic house with nearly flush eaves, steeply pitched roof, front-gable through-the-cornice dormers, floor to ceiling windows, half-round window and one-bay entry porch supported by full-height square post.

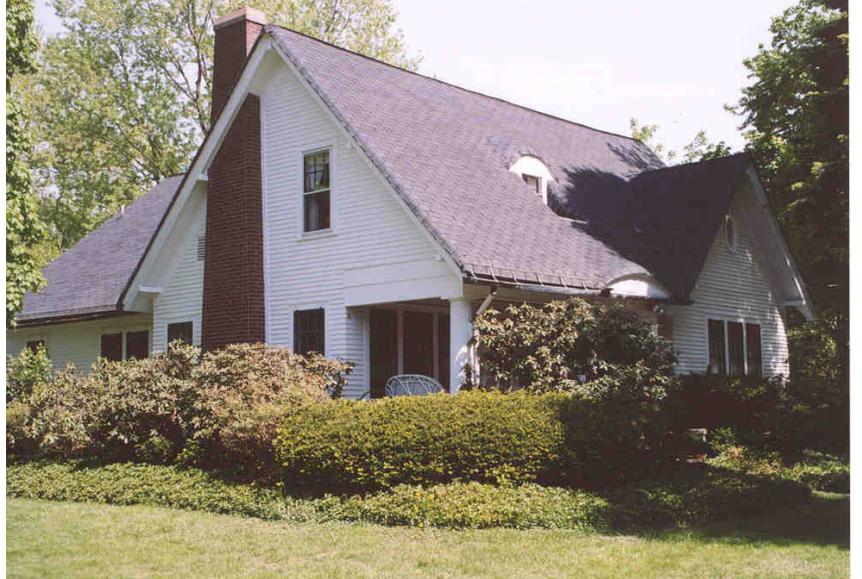
ADDRESS: 197 South Lake St.	DATE OF CONSTRUCTION: ca. 1925	SIGNIFICANCE: S – Domestic architecture

DESCRIPTION: 1-1/2-story side-gable Tudor house featuring inset dormer, projecting eaves with exposed rafter tails, steeply pitched roofs and one-bay porch supported by full-height thick Tuscan columns. Edges of roof plane are curled in imitation of a thatched roof. Recessed porch is supported by massive Tuscan columns.

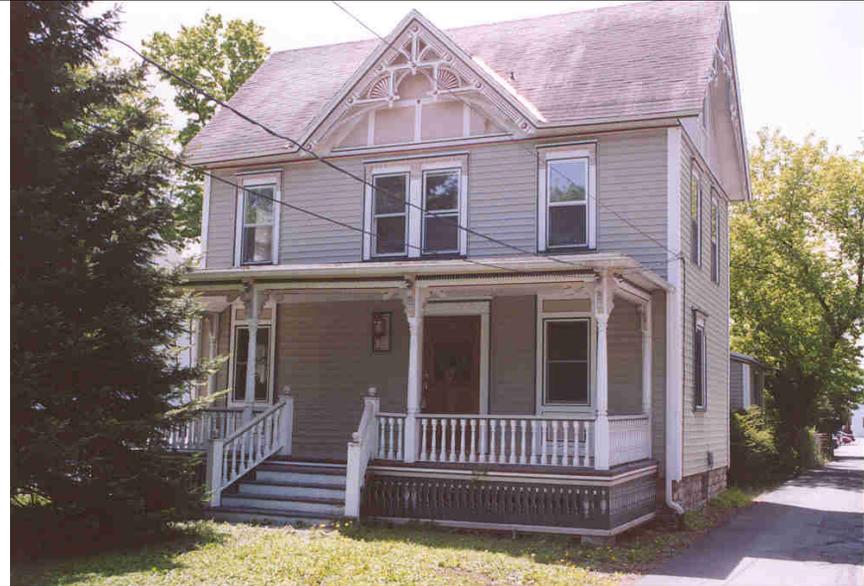
<p>ADDRESS: 40 Union Street</p>	<p>DATE OF CONSTRUCTION: ca. 1885</p>	<p>SIGNIFICANCE: C – Domestic architecture</p>

<p>DESCRIPTION: 2-1/2-story side-gable Queen Anne house featuring truss-style bargeboards, rock-face concrete block foundation, bracketed window surrounds and three-bay full-façade porch supported by turned posts.</p>

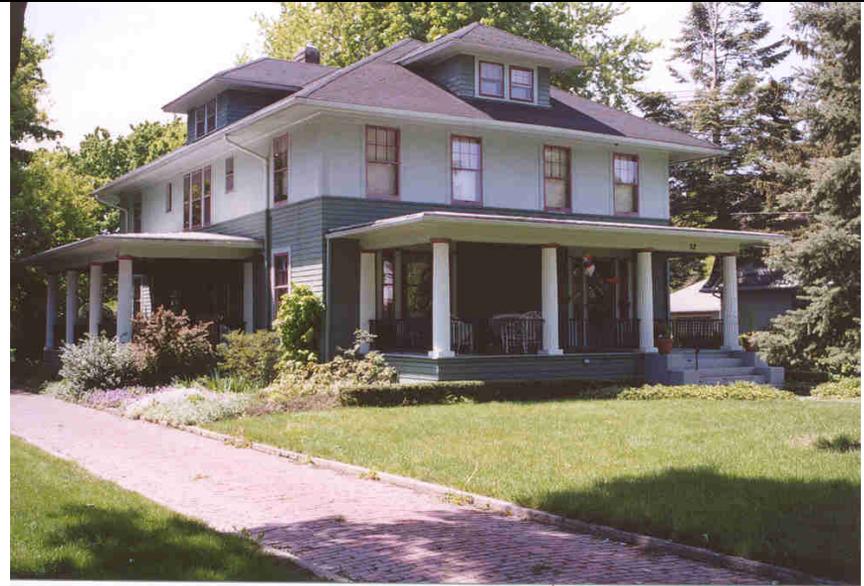
<p>ADDRESS: 52 Union Street</p>	<p>DATE OF CONSTRUCTION: ca. 1915</p>	<p>SIGNIFICANCE: S – Domestic architecture</p>

<p>DESCRIPTION: 2-1/2-story, hip-roof, wood-frame, Prairie house featuring broadly projecting eaves, hip roof dormers, contrasting cladding at the upper and lower stories and front and side three-bay hip roof porches supported by full-height fluted Tuscan columns.</p>

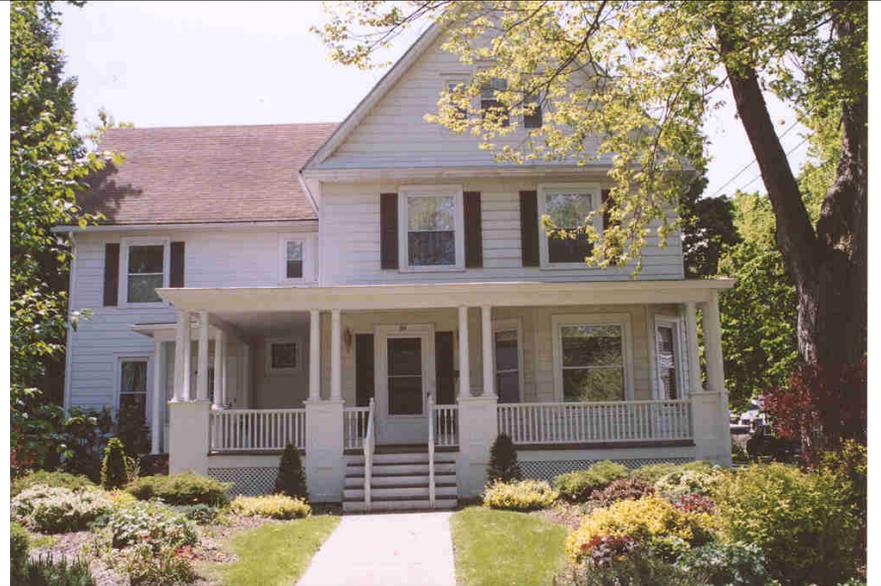
<p>ADDRESS: 84 Union Street</p>	<p>DATE OF CONSTRUCTION: ca. 1900</p>	<p>SIGNIFICANCE: C – Domestic architecture</p>

<p>DESCRIPTION: 2-1/2-story gable and wing Queen Anne house featuring closed gables and a wraparound porch supported by ¾-height grouped Tuscan columns sitting on piers. Altered by mid twentieth-century aluminum siding.</p>

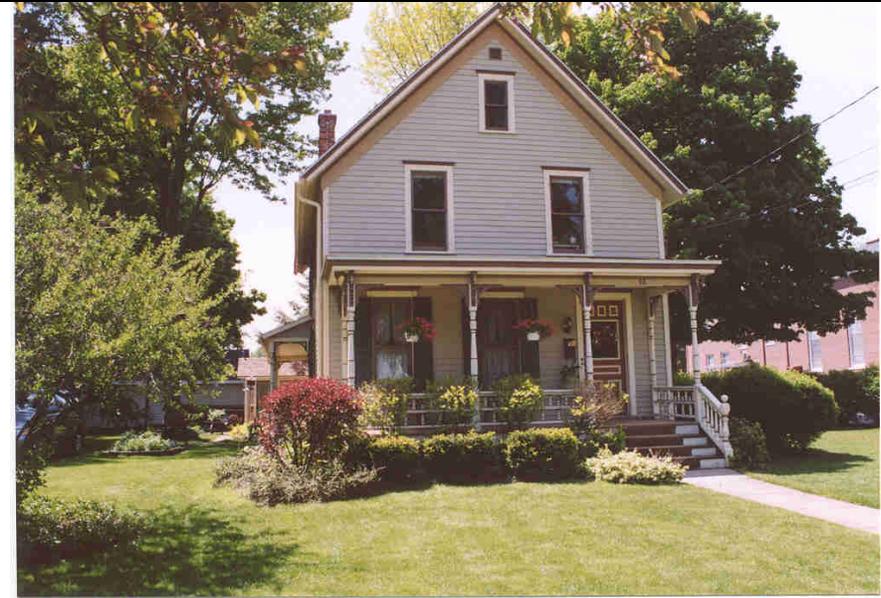
<p>ADDRESS: 98 Union Street</p>	<p>DATE OF CONSTRUCTION: ca. 1885</p>	<p>SIGNIFICANCE: C – Domestic architecture</p>

<p>DESCRIPTION: 2-1/2-story Front-gable house with steeply pitched roof and a three-bay full-façade Queen Anne porch supported by turned posts.</p>

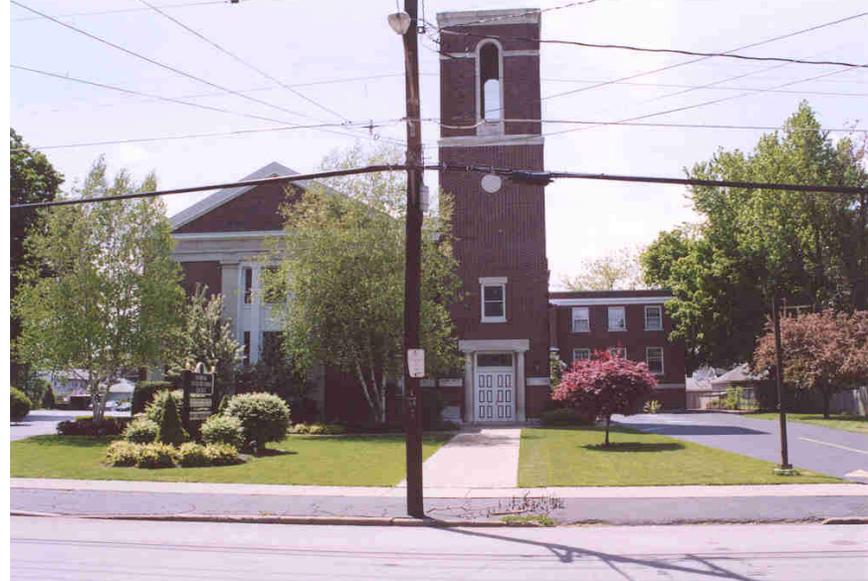
<p>ADDRESS: 116 Union Street Hamburg United Methodist Church,</p>	<p>DATE OF CONSTRUCTION: ca. 1928</p>	<p>SIGNIFICANCE: C – Ecclesiastical architecture</p>

<p>DESCRIPTION: Colonial Revival church replaced earlier building on same site. The church features a pedimented neoclassical façade, a square side tower, limestone trim, and an attached two-story school/community center building.</p>

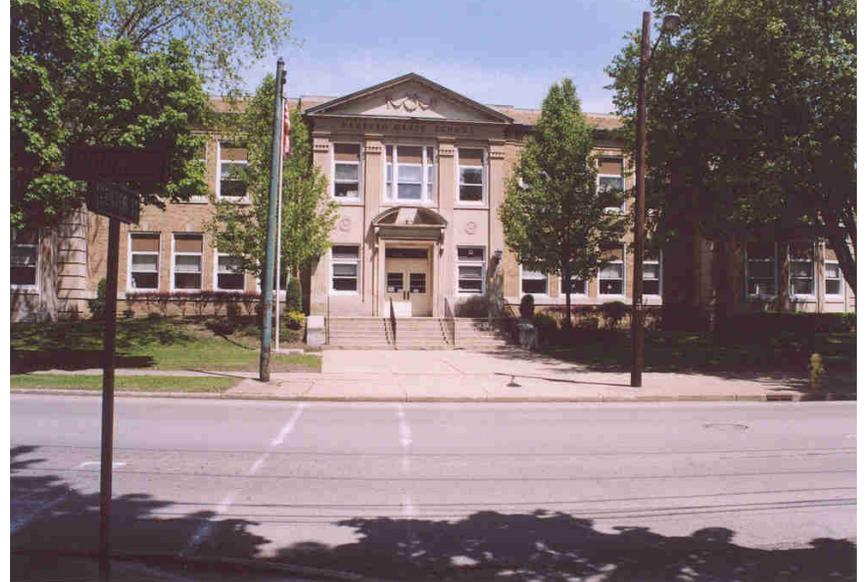
<p>ADDRESS: Hamburg Grade School, Union Street</p>	<p>DATE OF CONSTRUCTION: ca. 1940</p>	<p>SIGNIFICANCE: S – Civic architecture</p>

<p>DESCRIPTION: 2-1/2 story side gable Neoclassical brick school with quoined corners and pedimented stone central wing supported by fluted Doric columns. Entrance crowned by broken rounded pediment supported by brackets. Constructed as the Union Street grade school on the former site of the Hamburg Academy. This building is now connected to the old Pleasant Avenue high school building.</p>
