RECONNAISSANCE LEVEL SURVEY
OF HISTORIC RESOURCES

VILLAGE OF HAMBURG

Erie County, New York

Bero Architecture PC
32 Winthrop Street
Rochester, New York 14607

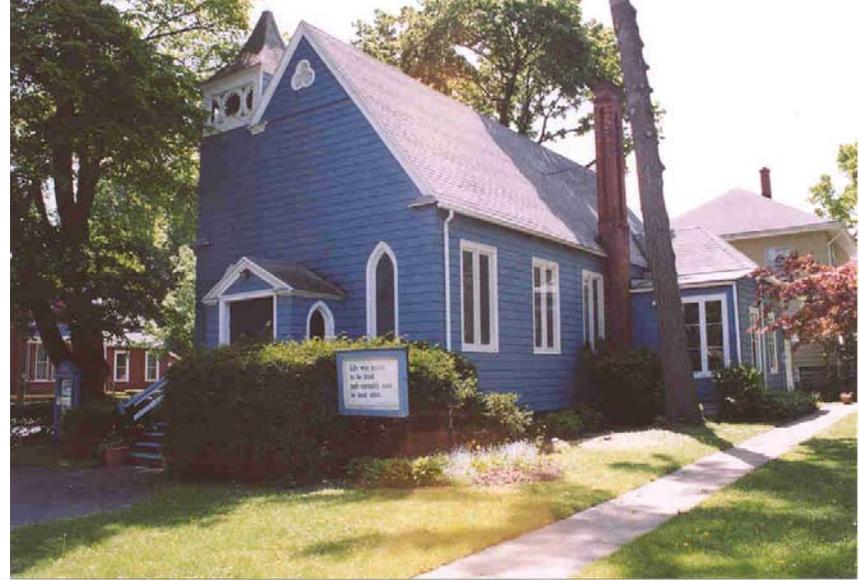
<p>ADDRESS: 142 Union Street Unitarian Universalist Church,</p>	<p>DATE OF CONSTRUCTION: 1892</p>	<p>SIGNIFICANCE: S – ecclesiastical architecture</p>

<p>DESCRIPTION: 1-1/2-story front-gable Shingle Style church with corner tower featuring flared pyramidal roof. Steeply pitched roof, tall, thin windows including pointed arch window, rock face concrete block foundation and single-story front-gable enclosed entrance portico. Built as Trinity Episcopal Church the building has been altered by the removal of a rose window at its front façade.</p>

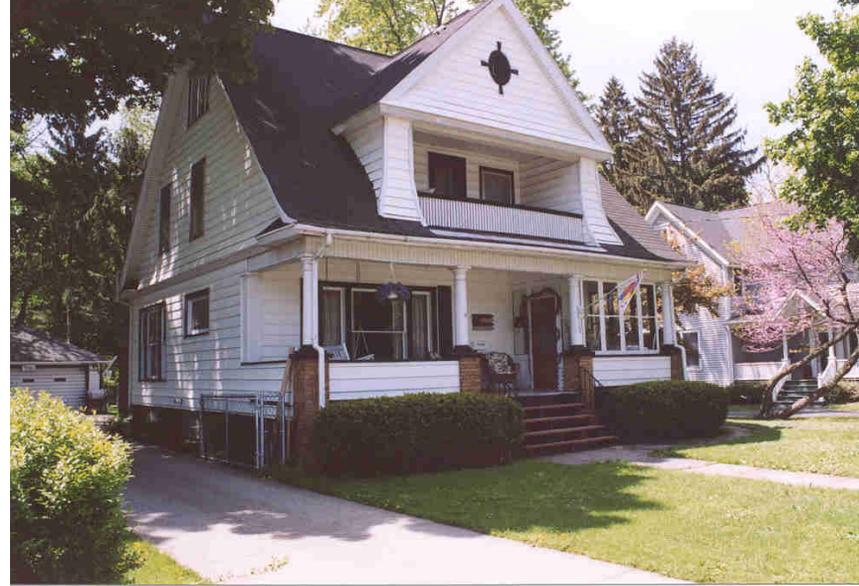
<p>ADDRESS: 150 Union Street</p>	<p>DATE OF CONSTRUCTION: ca. 1895</p>	<p>SIGNIFICANCE: C – Domestic architecture</p>

<p>DESCRIPTION: 2-1/2-story side-gable Shingle Style house featuring steeply pitched roofs, flared eaves, closed gables, recessed second-floor porch at dormer, rock-face concrete block foundation and three-bay full-façade porch supported by 3/4-height Tuscan columns sitting on a closed handrail. Altered by vinyl siding.</p>

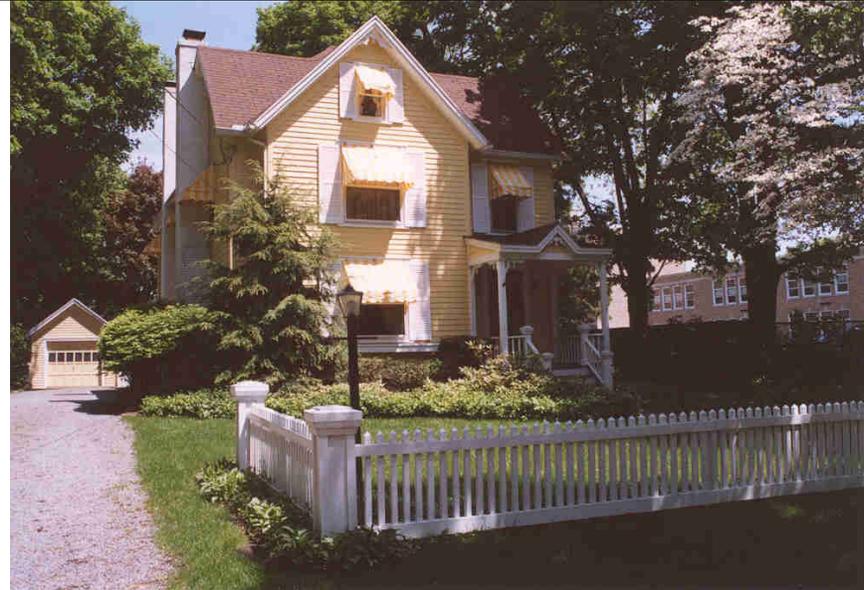
<p>ADDRESS: 161 Union Street</p>	<p>DATE OF CONSTRUCTION: ca. 1890</p>	<p>SIGNIFICANCE: C – Domestic architecture</p>

<p>DESCRIPTION: 2-1/2-story cross gable Queen Anne house with gable bargeboard, rock-face concrete block foundation and a one-bay entrance porch supported by full-height square posts. The porch is embellished with decorative scrolls and spindle work in the gable.</p>

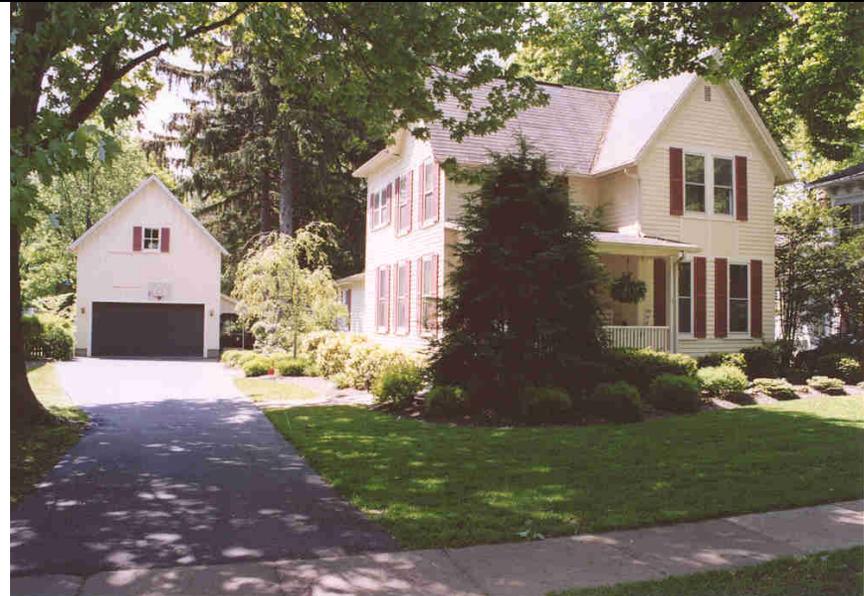
<p>ADDRESS: 164 Union Street</p>	<p>DATE OF CONSTRUCTION: ca. 1880</p>	<p>SIGNIFICANCE: C – Domestic architecture</p>

<p>DESCRIPTION: 2-1/2-story Stick Style Gable and wing house featuring steeply pitched roofs, stick work trim at exterior walls, tall, thin 1/1 windows, and a one-bay Colonial Revival porch supported by full-height square posts. Property includes freestanding barn.</p>

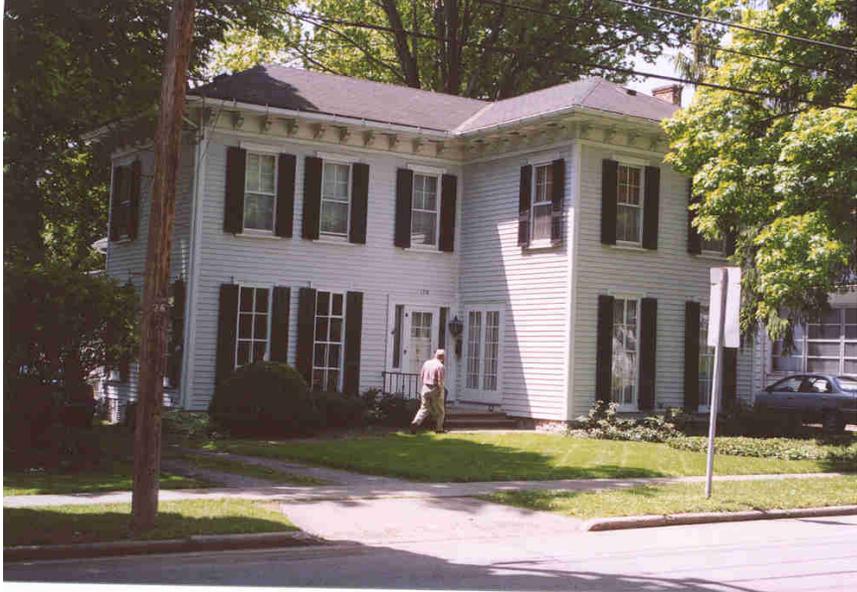
<p>ADDRESS: 170 Union Street</p>	<p>DATE OF CONSTRUCTION: ca. 1860</p>	<p>SIGNIFICANCE: S – Domestic architecture</p>

<p>DESCRIPTION: 2-1/2-story hip roof Italianate house featuring widely overhanging eaves supported by decorative brackets, tall, thin windows with drip-molded window surrounds and a rock face concrete block foundation.</p>

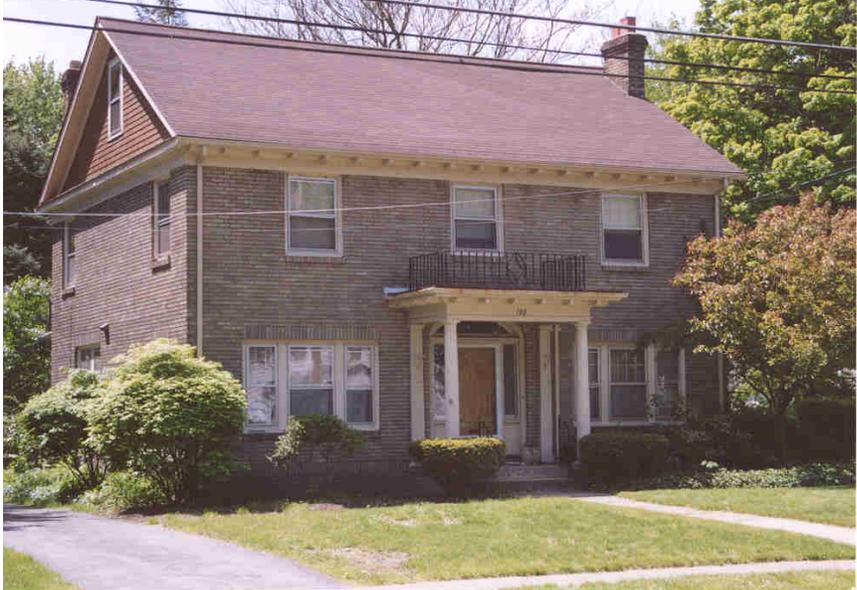
<p>ADDRESS: 180 Union Street</p>	<p>DATE OF CONSTRUCTION: ca. 1920</p>	<p>SIGNIFICANCE: C – Domestic architecture</p>

<p>DESCRIPTION: 2-1/2-story side-gable three-bay symmetrical brick Colonial Revival house featuring closed gables containing stained wood shingles, denticulated cornice and a one-bay central entrance portico with full entablature supported by full height Tuscan columns.</p>

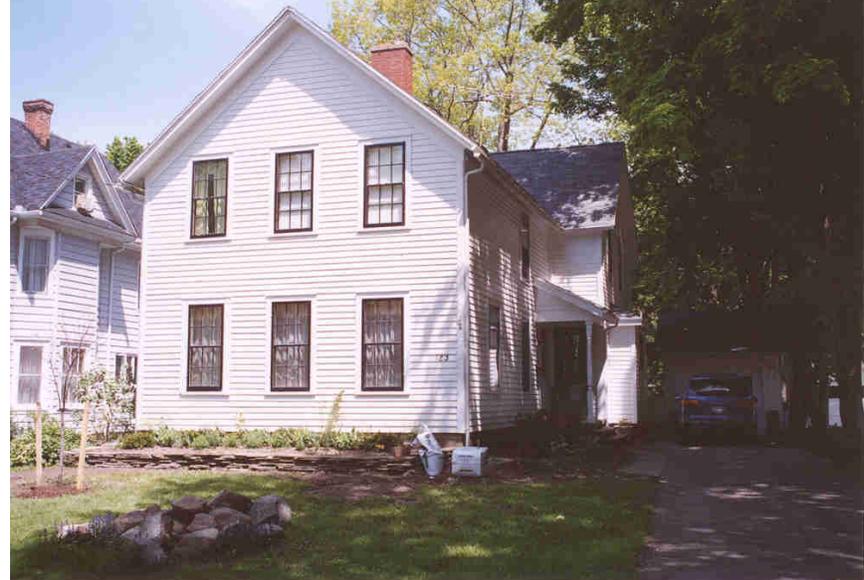
<p>ADDRESS: 183 Union Street</p>	<p>DATE OF CONSTRUCTION: ca. 1860</p>	<p>SIGNIFICANCE: C – Domestic architecture</p>

<p>DESCRIPTION: 2-1/2-story three-bay Front-gable house featuring one-bay entrance portico supported by turned posts.</p>

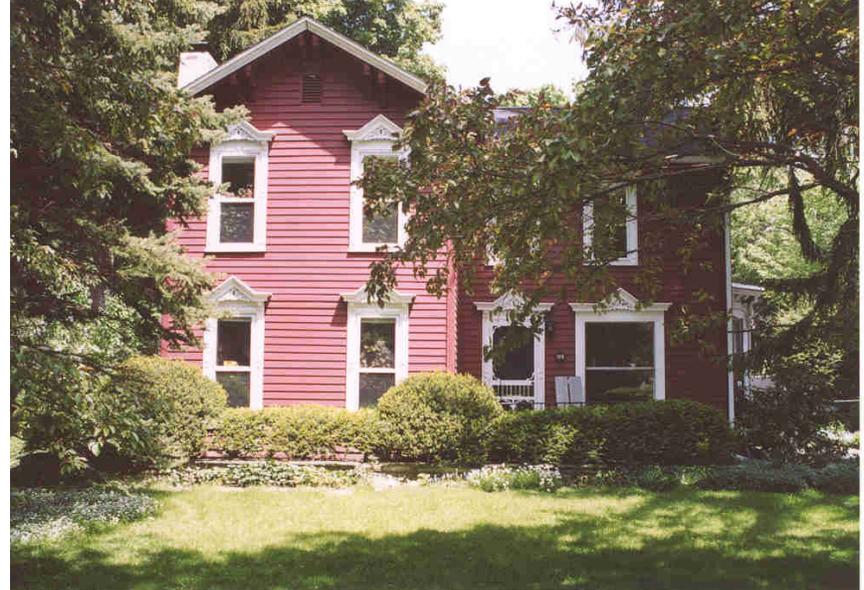
<p>ADDRESS: 189 Union Street</p>	<p>DATE OF CONSTRUCTION: ca. 1875</p>	<p>SIGNIFICANCE: C – Domestic architecture</p>

<p>DESCRIPTION: 2-1/2-story gable and wing Italianate house featuring paired brackets in the gables, pedimented windows and a rock face concrete block base. Porch has been removed.</p>

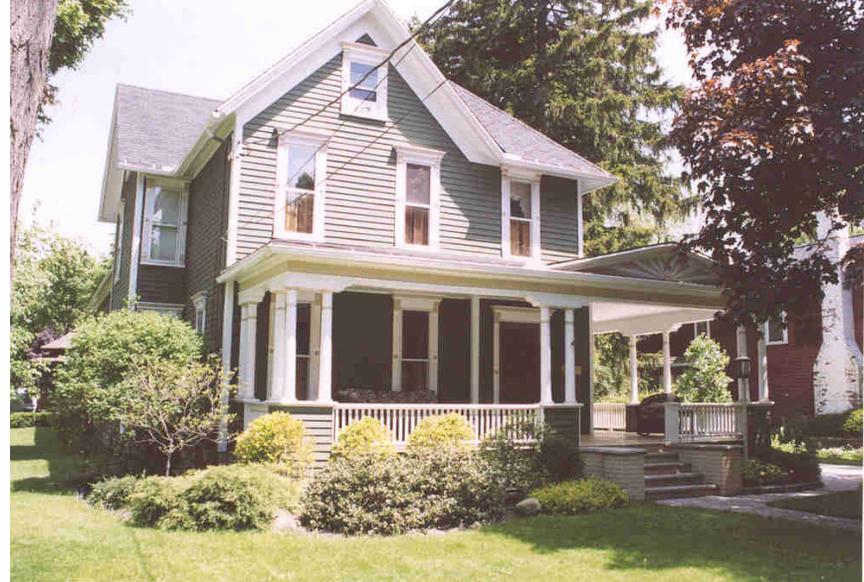
<p>ADDRESS: 197 Union Street</p>	<p>DATE OF CONSTRUCTION: ca. 1880</p>	<p>SIGNIFICANCE: C – Domestic architecture</p>

<p>DESCRIPTION: 2-1/2-story cross-gable Queen Anne house with tall, thin 1/1 windows and a wraparound porch supported by 3/4-height paired Tuscan columns set on clapboard clad piers.</p>

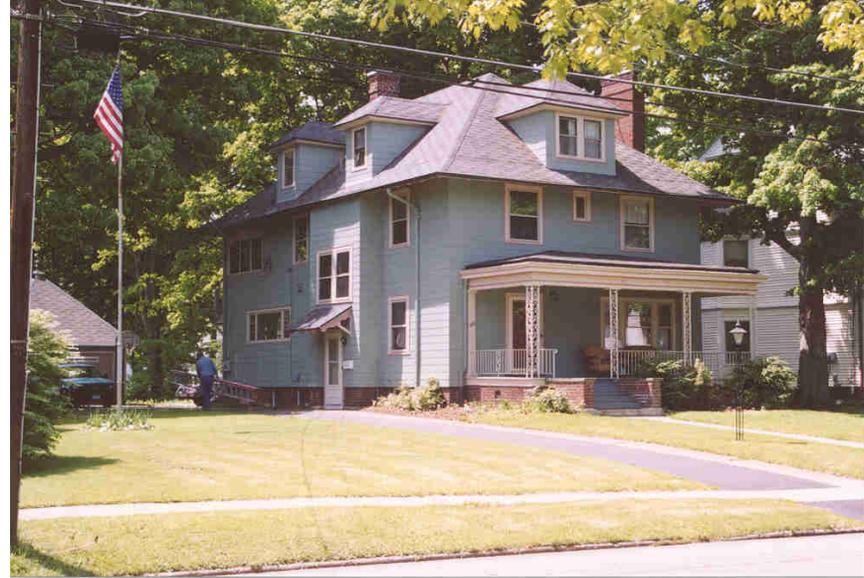
<p>ADDRESS: 198 Union Street</p>	<p>DATE OF CONSTRUCTION: ca. 1910</p>	<p>SIGNIFICANCE: C – Domestic architecture</p>

<p>DESCRIPTION: 2-1/2-story hip roof Prairie house incorporating hip roof dormers. Grade level driveway entrance, brick-faced foundation. Three-bay full façade porch supported by ca. 1955 decorative metalwork posts.</p>

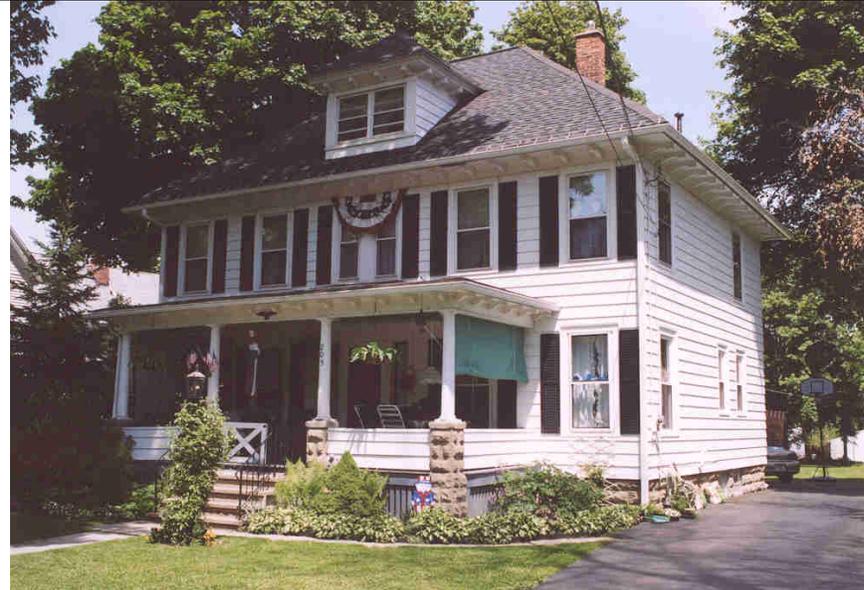
<p>ADDRESS: 205 Union Street</p>	<p>DATE OF CONSTRUCTION: ca. 1905</p>	<p>SIGNIFICANCE: C – Domestic architecture</p>

<p>DESCRIPTION: 2-1/2-story hip roof five-bay symmetrical Colonial Revival house incorporating hip roof dormer, rock face concrete block foundation and three-bay porch supported by 3/4-height Tuscan columns set on a concrete block piers.</p>

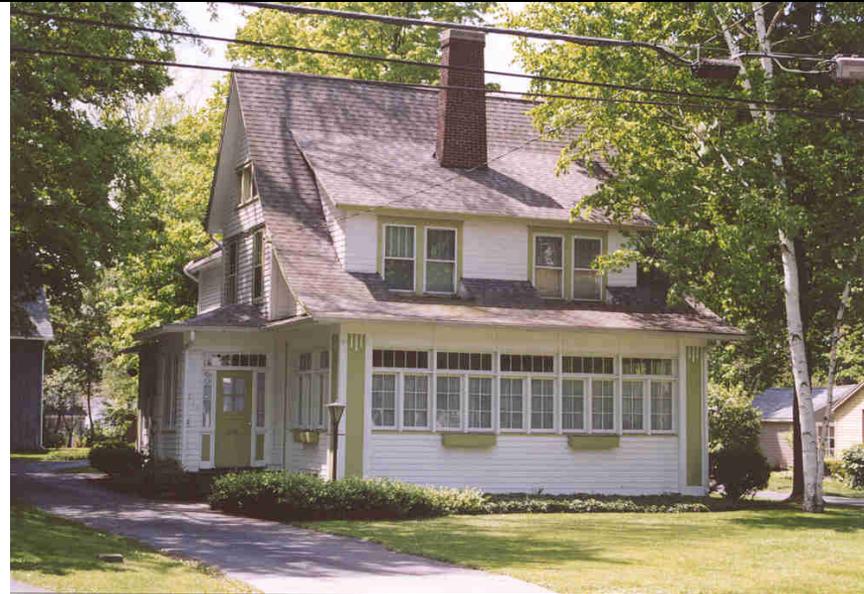
<p>ADDRESS: 210 Union Street</p>	<p>DATE OF CONSTRUCTION: ca. 1920</p>	<p>SIGNIFICANCE: C – Domestic architecture</p>

<p>DESCRIPTION: 2-1/2-story side-gable Craftsman house with steeply pitched roofs, flared eaves and full-façade shed roof dormer. Enclosed front porch incorporates Prairie pilasters.</p>

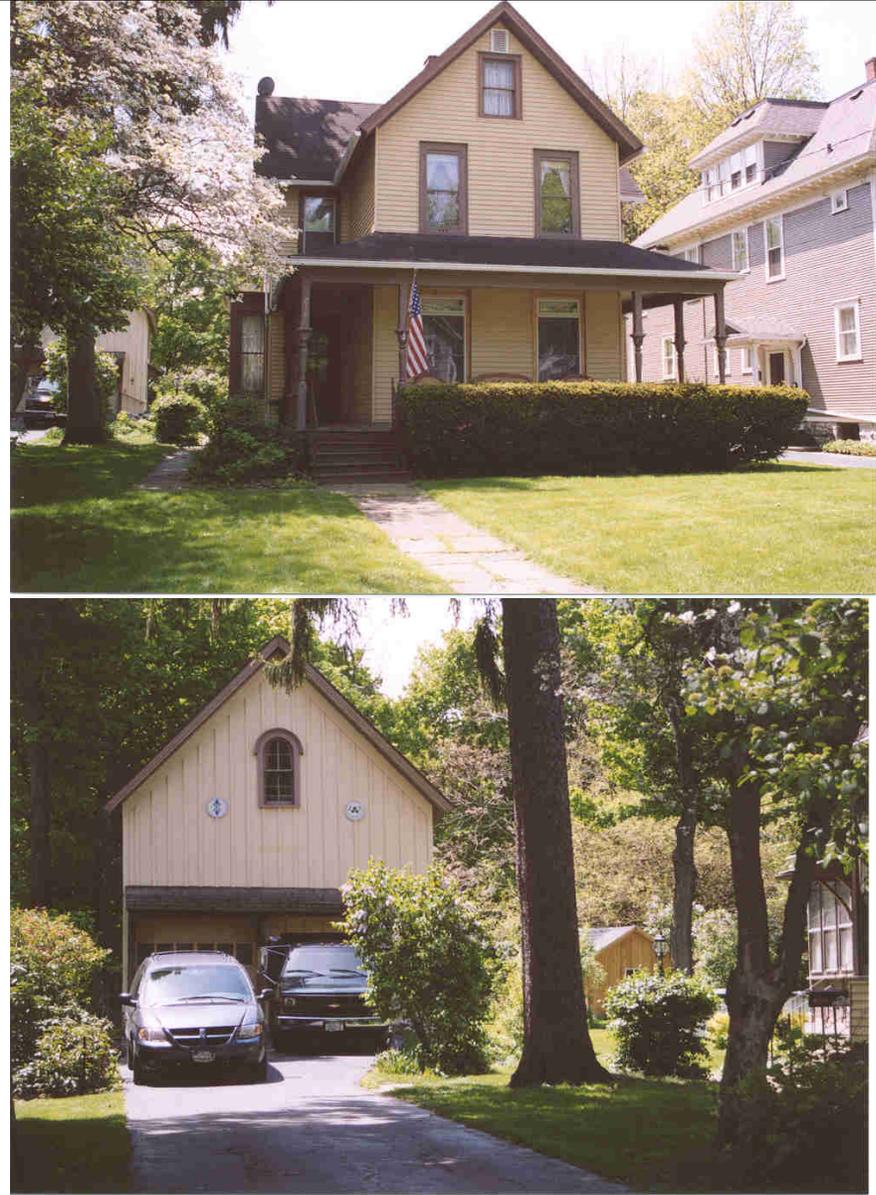
<p>ADDRESS: 217 Union Street</p>	<p>DATE OF CONSTRUCTION: ca. 1880</p>	<p>SIGNIFICANCE: C – Domestic architecture</p>

<p>DESCRIPTION: 2-1/2-story cross plan house featuring a Queen Anne porch supported by turned posts. Property contains a freestanding front-gable barn with half-round arched window.</p>

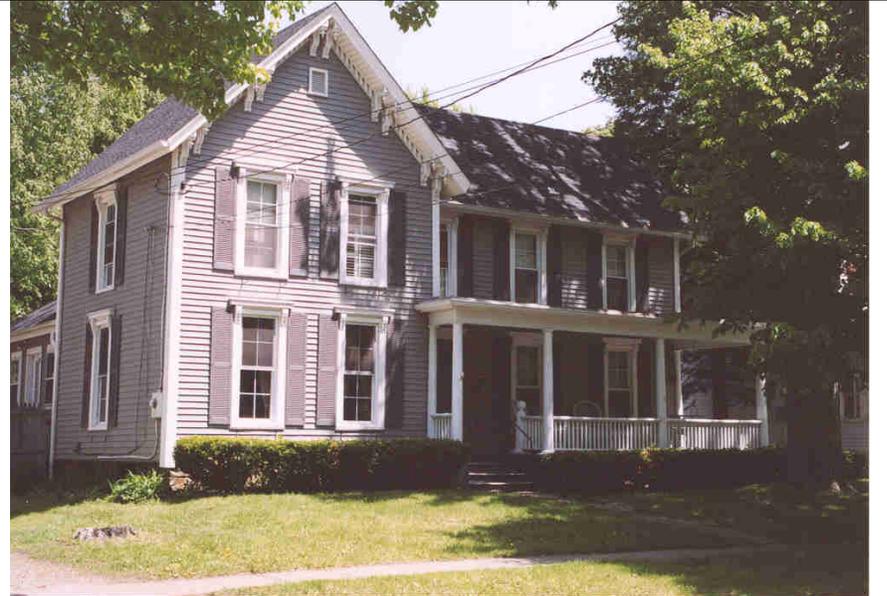
<p>ADDRESS: 222 Union Street</p>	<p>DATE OF CONSTRUCTION: ca. 1910</p>	<p>SIGNIFICANCE: C – Domestic architecture</p>

<p>A two-story house with a gable roof and a porch. The house has a steeply pitched roof with decorative brackets under the eaves. The porch is supported by columns. The house is surrounded by trees and a lawn.</p>		<p>DESCRIPTION: 2-1/2-story gable and wing Italianate house with paired brackets in gable, steeply pitched roof and tall, thin windows. Three-bay partial-façade Colonial Revival porch supported by full-height Tuscan columns.</p>

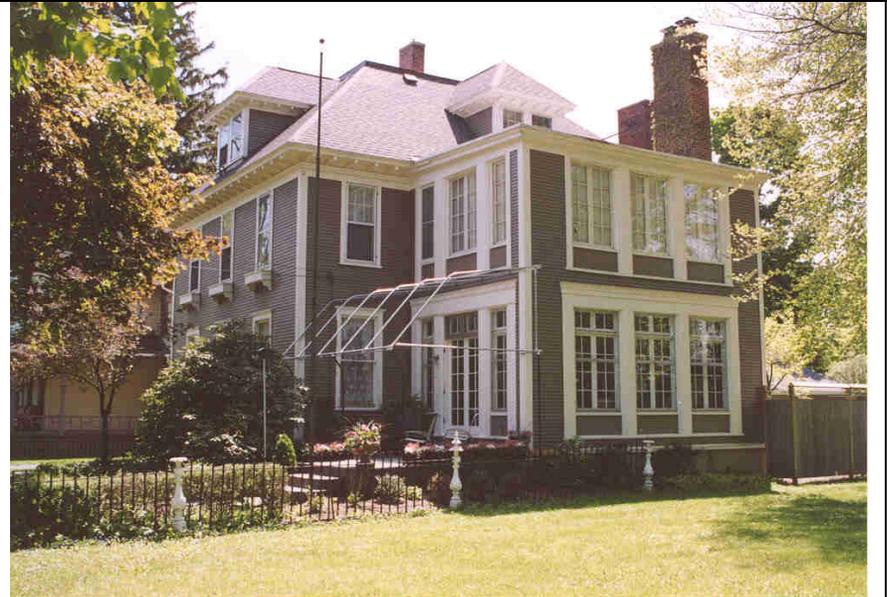
<p>ADDRESS: 223 Union Street</p>	<p>DATE OF CONSTRUCTION: ca. 1890</p>	<p>SIGNIFICANCE: C – Domestic architecture</p>

<p>A two-story house with a hip roof and a side porch. The house has a neoclassical cornice and a rock face concrete block foundation. The porch is supported by square piers. The house is surrounded by trees and a lawn.</p>		<p>DESCRIPTION: 2-1/2-story hip roof Colonial Revival house with hip roof dormers, widely overhanging eaves with neoclassical cornice, rock face concrete block foundation and grouped windows separated by square piers. Original front porch has been removed. Two story side porch appears to be a later addition.</p>

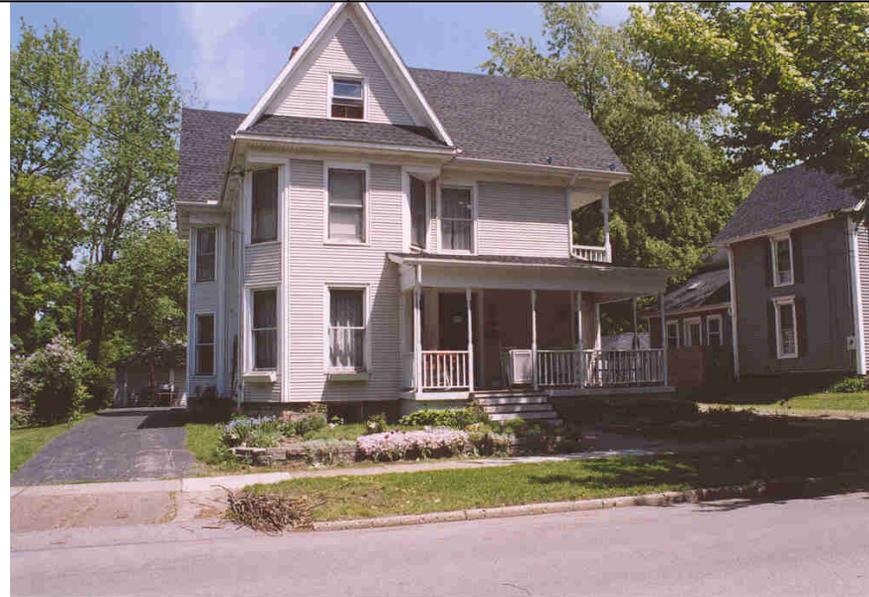
<p>ADDRESS: 231 Union Street</p>	<p>DATE OF CONSTRUCTION: ca. 1930</p>	<p>SIGNIFICANCE: C – Domestic architecture</p>

<p>DESCRIPTION: 2-1/2-story cross gable asymmetrical Queen Anne house with closed gables, steeply pitched roofs, tall, thin windows, rock face concrete block foundation and wraparound porch supported by turned posts. Altered by vinyl siding and modern porch handrail and posts.</p>

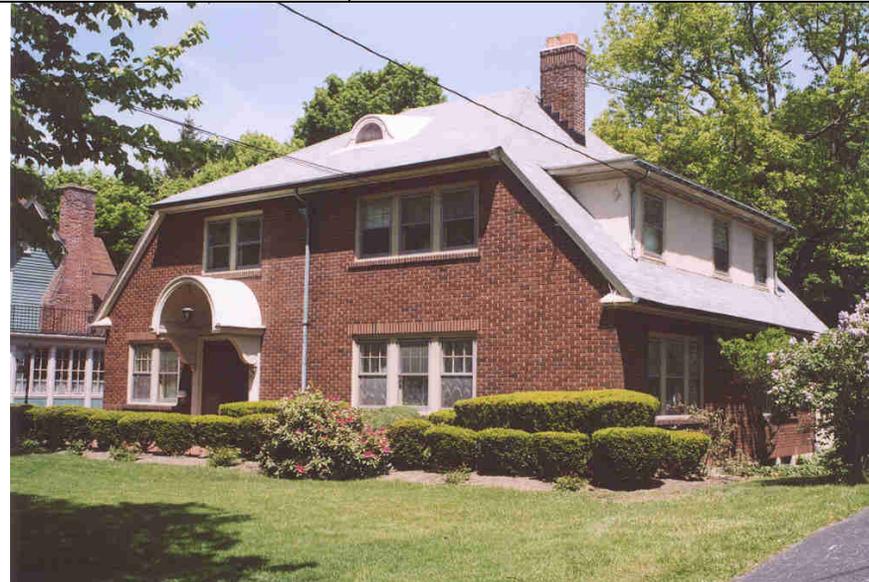
ADDRESS: 350 Union Street	DATE OF CONSTRUCTION: ca. 1900	SIGNIFICANCE:

<p>DESCRIPTION: 2-1/2-story Jerkinhead roof brick Tudor house with full façade side shed dormer, eyebrow dormer and barrel vaulted entrance portico supported by brackets.</p>

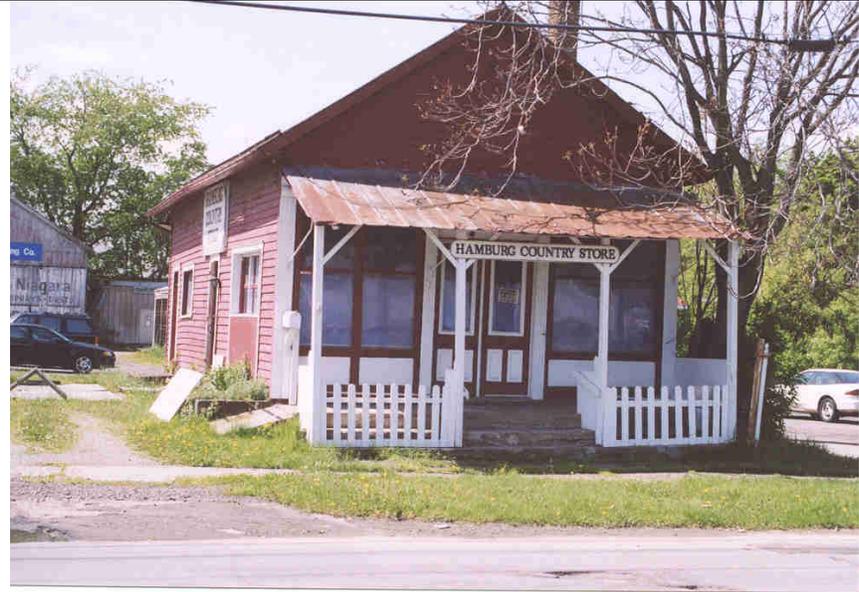
ADDRESS: 50 West Avenue, Erie County D.O.T. Complex	DATE OF CONSTRUCTION: ca. 1920	SIGNIFICANCE: C – Industrial/commercial

DESCRIPTION: 1-1/2 story front-gable mid 19 th century commercial building retaining original storefront. Built as office for the Drummer Coal Yard. Originally located across the street.

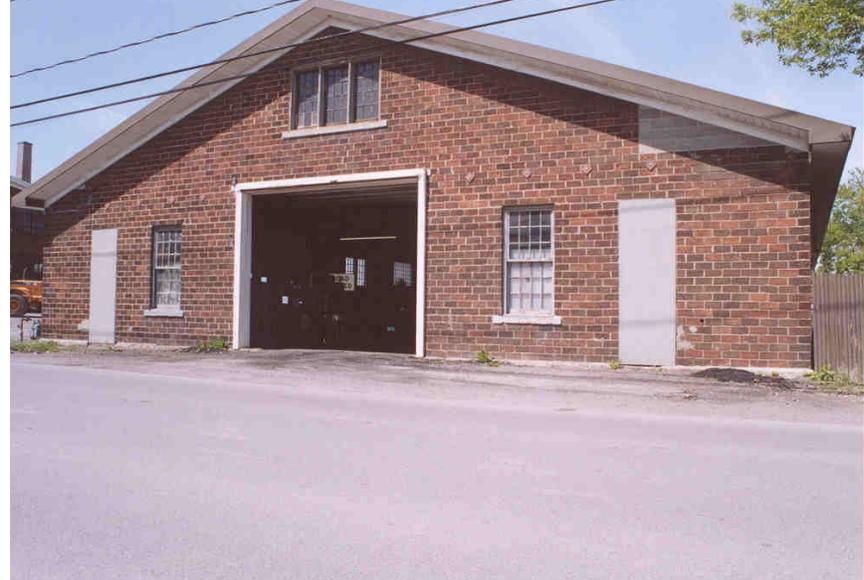
<p>ADDRESS: 16 Woodview Court</p>	<p>DATE OF CONSTRUCTION: ca. 1940</p>	<p>SIGNIFICANCE: C – Domestic architecture</p>

DESCRIPTION: 1-1/2 story front gable early 20 th century garage constructed with structural clay tile.

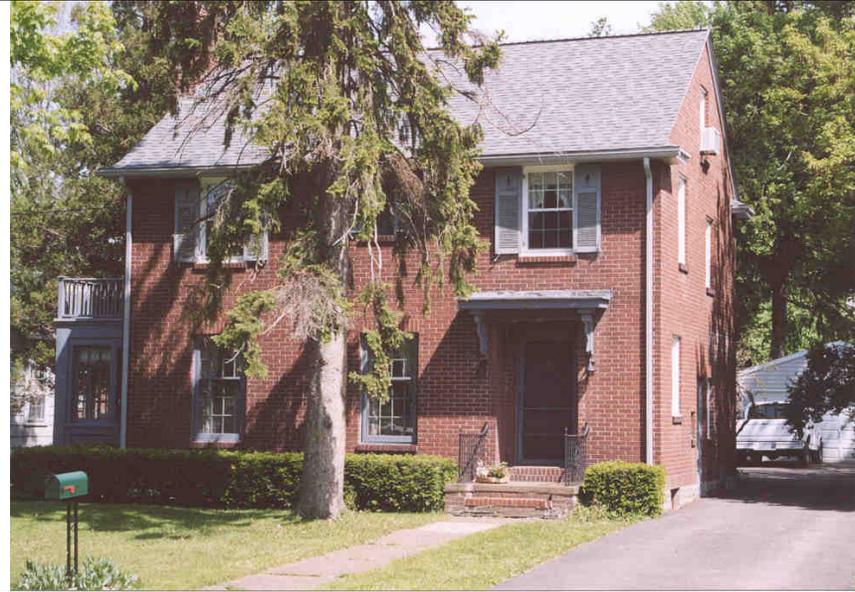
<p>ADDRESS: 19 Woodview Court</p>	<p>DATE OF CONSTRUCTION: ca. 1930</p>	<p>SIGNIFICANCE: C – Domestic architecture</p>

<p>DESCRIPTION: 2-1/2 story brick three-bay side-gable Colonial Revival house featuring cutout shutters, concrete block foundation and front entrance with flat arch roof supported by brackets.</p>

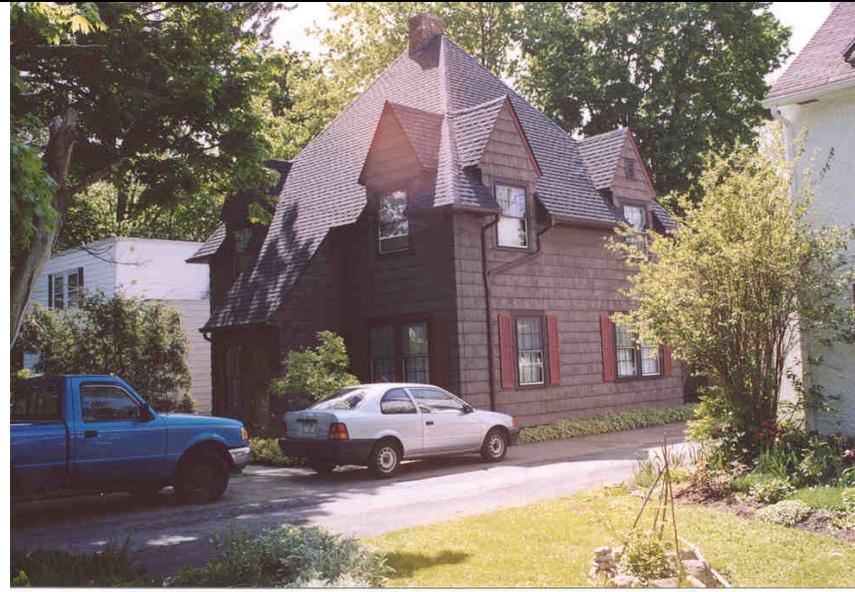
<p>DESCRIPTION: 2-1/2 story hip roof Tudor house with steeply pitched roofs and front-gable wall dormers.</p>

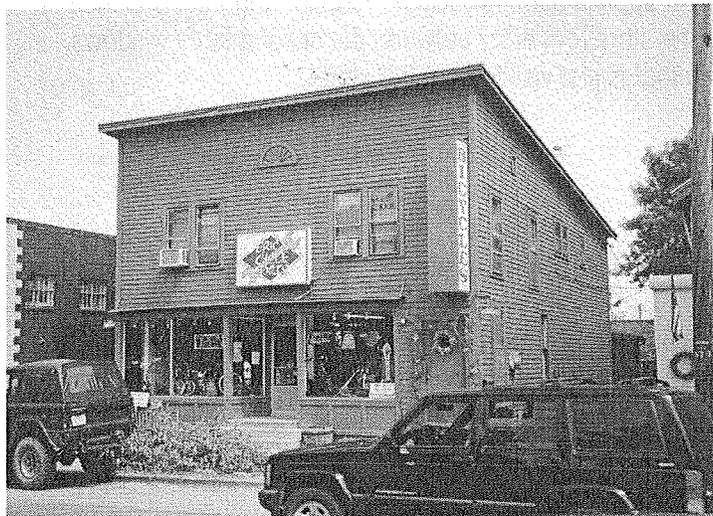
Photo:

The altered plate glass storefront has a recessed center entry with a door to the upper floors located at the east side. The storefront entry doors are elevated several steps above the sidewalk and simple replacement panels fill the space below the display windows. The second floor has two pairs of paired double-hung windows symmetrically placed, and centered at the attic level is an applied sunburst pattern lunette. Signage is placed at the east corner of the second story and centered over the storefront entry between the second story windows. There is a one story addition to the north of the building that is just visible from the street.

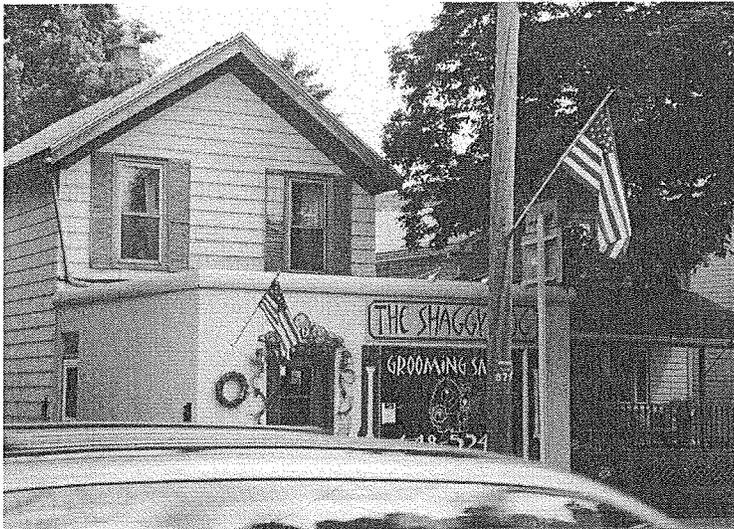
Photo:

The main building has a moderately sloped roof with asphalt shingles and replacement wood shingle siding. The second story replacement windows on the south façade have louvered shutters. A flat-roof, one-story concrete-block and brick storefront has been added to the south of the main block. The addition has a single plate glass display window to the east side of the façade with the entry to the west.

16 E. Main Street has been compromised by replacement windows and siding, and the concrete block storefront addition. Due to age and alterations the building is not architecturally significant, but it contributes to the scale, historic development pattern, and pedestrian oriented character of Hamburg's central business district. With time and if the existing design is conserved, the storefront addition will gain historic significance in its own right as an example of the Spartan, utilitarian decoration of Modern commercial blocks. This building is the transition point on this side on Main Street between residential and commercial functions.

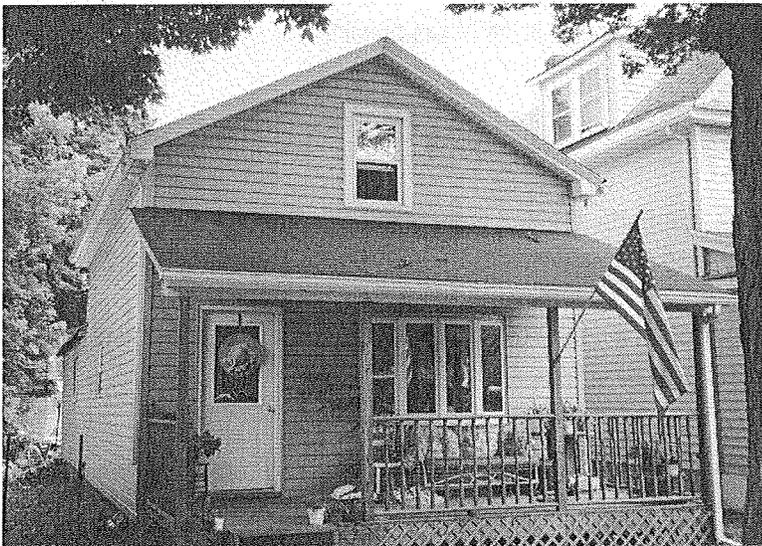
Photo:

Alterations, if known: vinyl siding, replacement windows, porch alterations Date: _____

The building's low-sloped roof and gable front orientation indicate Greek revival influence, though vinyl siding and aluminum cladding hides all original finishes. A one story shed roof porch extends across the front façade and shelters the front door and a bay window. The half story has a single one-over-one window centered in its width. All windows are replacements. A one story addition extends to the north of the building.

The building illustrates the denser patterns of streetcar suburbs created in the first half of the twentieth century but has been compromised by the added front porch, replacement windows, and vinyl and aluminum cladding.

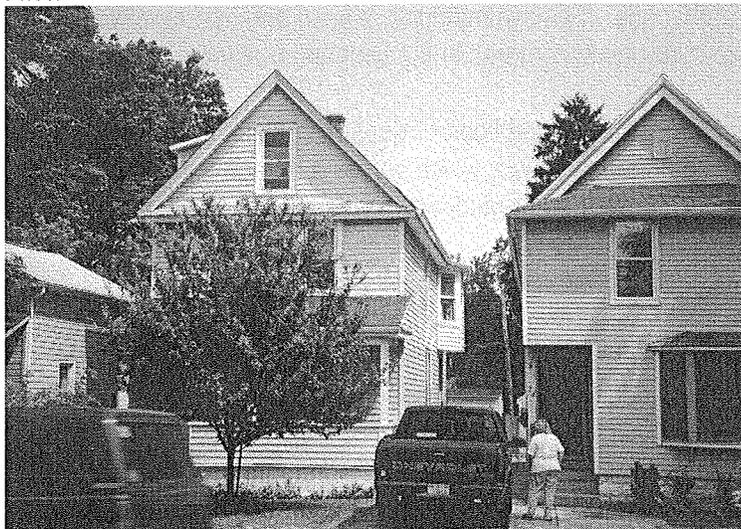
Photo:

Alterations, if known: vinyl siding, replacement windows, porch alterations Date: _____

At that rear of the east sidewall a bay window projects from the second floor. It does not extend below to accommodate the narrow drive between this and the neighboring house, which serves a garage for each. The house has been clad in vinyl and aluminum and has vinyl replacement windows.

The building illustrates the denser patterns of streetcar suburbs created in the first half of the twentieth century but has been compromised by the replacement windows and the vinyl and aluminum cladding.

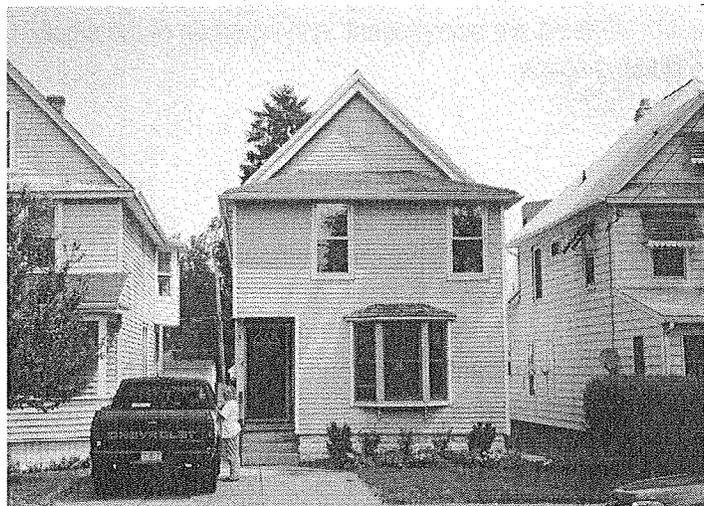
Photo:

Alterations, if known: vinyl siding, replacement windows, façade alterations Date: _____

The original gable-front house is almost completely obscured by a two-story, hip-roof addition added across the entire front facade. The recessed front door is located to the west side with a bay window centered in the remainder of the first floor wall. Two replacement windows are placed asymmetrically at the second story of the enclosed porch. Vinyl windows, vinyl siding, and aluminum cladding are also present, and a portion of the small front yard has been paved with concrete to convert it to parking space.

Due to replacement windows, vinyl siding, and the large addition, this building no longer meets National Register eligibility criteria.

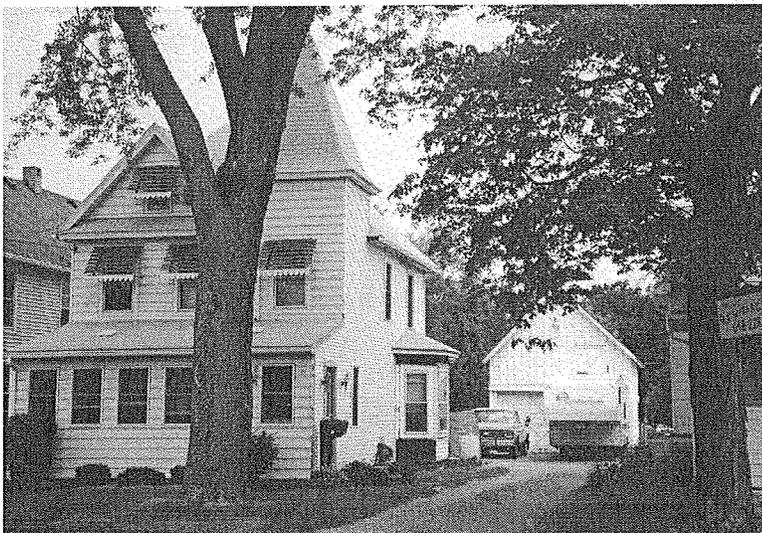
Photo:

Alterations, if known: replacement windows, vinyl siding, porch enclosure Date: _____

The building has a hip-roof with a cross gable facing the street on the west side of the front façade and a pyramidal-roof tower occupying the east side. Also on the front façade is an enclosed, one-story, full-width porch with a shed roof. Toward the rear of the east side of the house a one story bay window projects. The building has replacement windows, an altered front porch, and vinyl or aluminum covering.

Due to replacement windows, porch alterations, and vinyl and aluminum cladding, this building no longer meets National Register eligibility criteria.

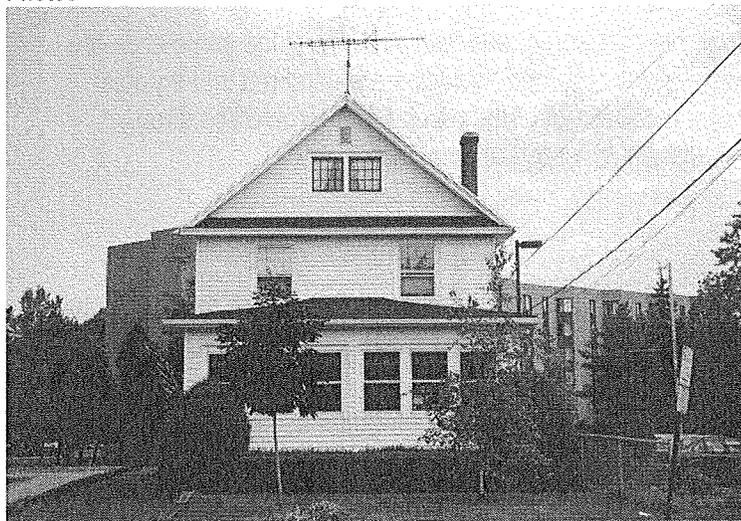
Photos

This two-and-one-half-story, gable-front house sits between Pine and Buffalo Streets on the north side of E. Main St. The building is a simple turn of the century eclectic style house with original detailing obscured by replacement siding. The front façade is separated from the sidewalk by a small square of tree planted lawn. The house is separated from its neighbors on either side by driveways.

The building has been compromised by replacement windows and vinyl and aluminum cladding, but it still reflects the simplified vernacular design of turn of the century domestic architecture.

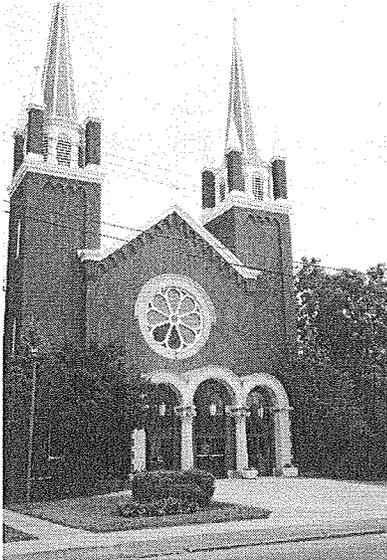
Photo:

SS Peter and Paul Church is significant as an intact example of the early twentieth century eclectic blending of Romanesque and Gothic architecture. Its large size and central location make it an important landmark in Hamburg's center.

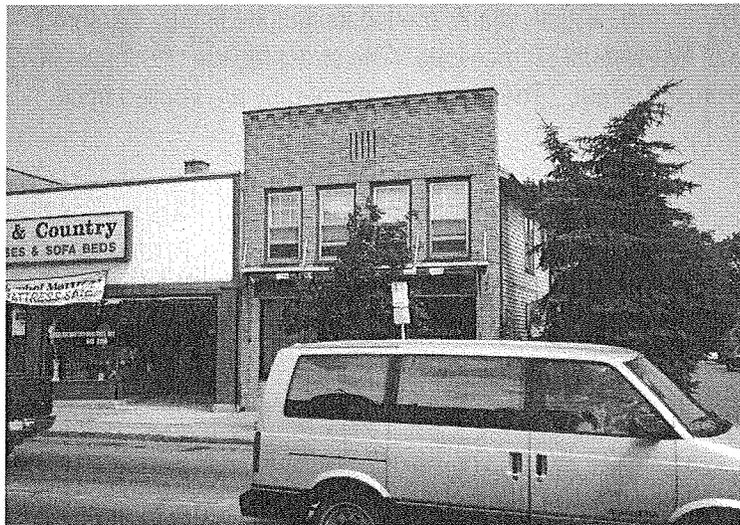
Photo:

This late nineteenth-century, two-and-one-half-story, wood-frame gable-roof building is faced with ca. 1925 brick-clad masonry façade. The symmetrical façade is clad with buff brick laid in running bond. At the first floor is a three-bay storefront with a recessed center entrance. The original storefront glazing has been replaced with a bronze anodized aluminum-frame glazing system. Above the storefront is a retractable canvas awning. At the second floor is a row of four regularly spaced six-over one double-hung windows. The window openings are spanned with concealed steel windows. A soldier row of brick visually marks the location of the lintel. Centered in the field of the wall above the windows is a group of five vertical slit recesses. The street façade terminates in a parapet which conceals the building's gable roof from the street. The parapet is capped by a corbelled brick cornice covered with metal coping..

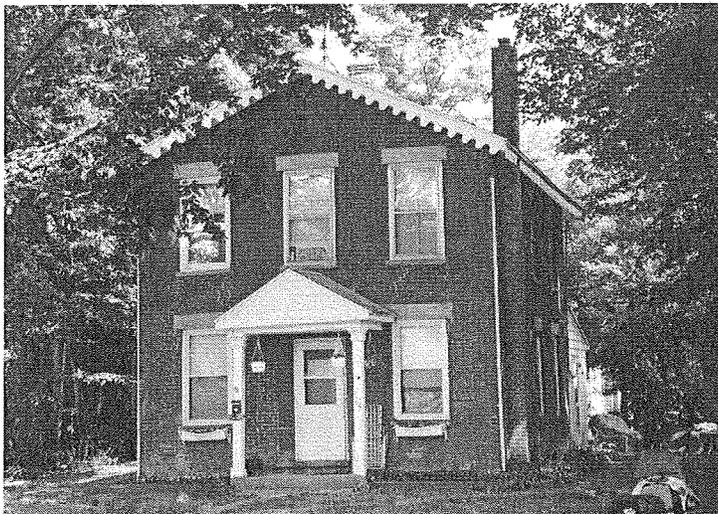
Photo:

Alterations, if known: replacement windows, porch/entry alterations Date: _____

This symmetrical three-bay, front-gable, brick, building has the massing, fenestration pattern and roof slope typical of the Greek Revival style. The eaves of the building are cut in a decorative nebule pattern. The three-bay front façade features a center entrance with a small front-gable entrance porch. The door and porch appear to be late twentieth-century replacements of earlier features. The outline of paint on brick adjacent to the door preserves the outline of massive columns from a past porch. Nineteenth-century two-over-two double-hung sashes remain at the second-floor windows while contemporary replacement windows have been installed at the first floor. The window and door openings have limestone sills and lintels. A one-story shed roofed addition has been added to the rear of the building.

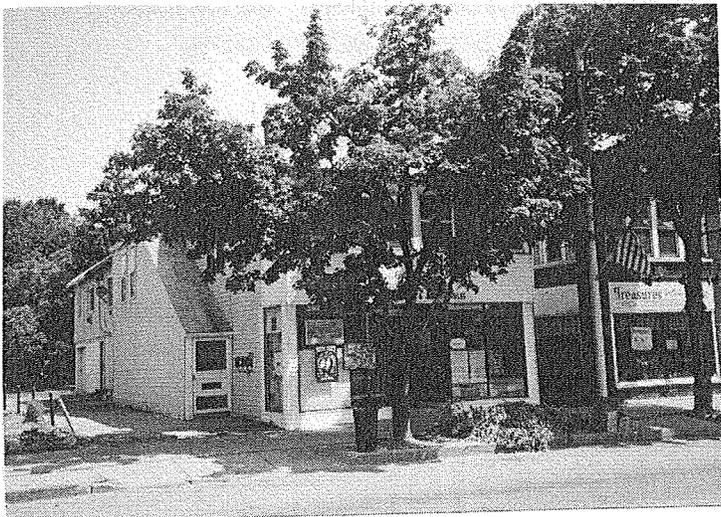
Photo:

This late nineteenth-century, two-and-one-half-story, wood-frame vernacular building has been adapted to retail use by an early twentieth-century addition which created a storefront with large display windows and a recessed entrance at the street façade. The second floor has six one-over-one replacement windows across its façade. To the west of the building, an enclosed stairway, which accesses the upper floor, has been added. A two-story addition to the north extends for approximately the same distance as the original building. The lower floor of the addition has two garage doors on its west side. The whole building has been clad with vinyl siding.

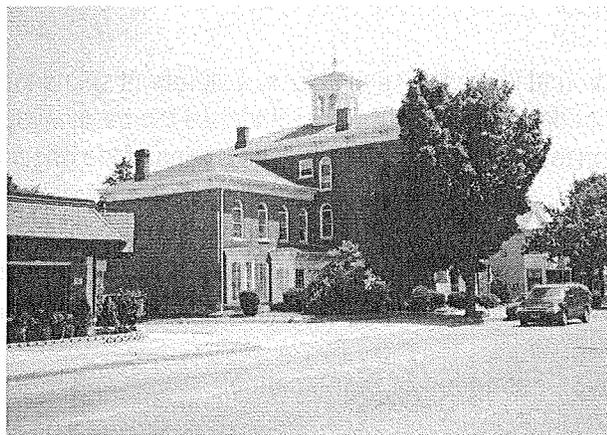
Photos:

This asymmetrical, brick, hip-roof, Italianate incorporates a three-and-one-half-story commercial block with a two-and-one-half-story side wing housing a residence. The stone foundation is capped with a cut-stone watertable. At the upper floors of the building fenestration consists of tall, narrow, half-round, one-over-one, double-hung windows with limestone window sills. Both sections of the building have a gently pitched hip roof with broad projecting eaves supported by paired scroll brackets. The roof of the main block is surmounted by a four-sided cupola. Paired half-round double-hung windows are located at each side of the cupola. The cupola is embellished by modillions and brackets at its cornice and a decorative metal finial which rises from the peak of its hipped roof.

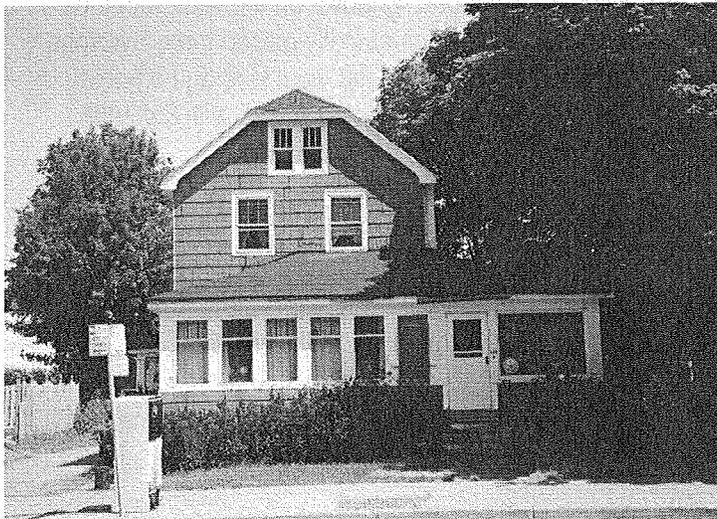
Photo:

Alterations, if known: porch, replacement siding Date: _____

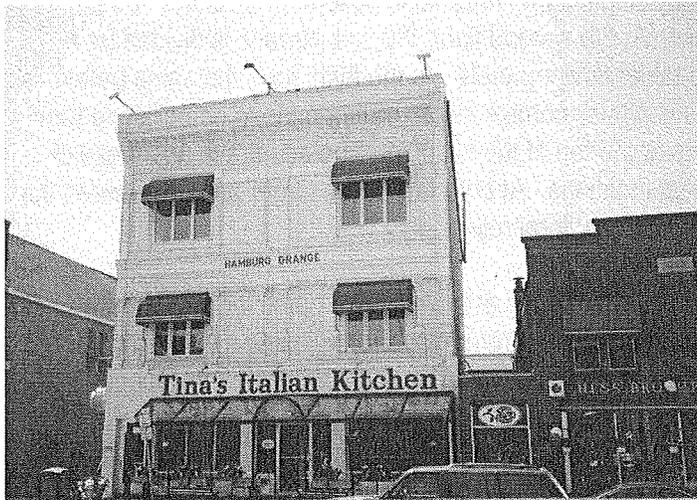
Photo:

Alterations, if known: storefront, window replacements Date: _____

At both the second and third stories a large window opening is located in the end quarter of the front façade. The original double-hung windows have been replaced by single-light, three-sash casement windows. Fixed modern fabric awnings are mounted above each window. At the second floor, the wall surface is divided by a series of engaged Corinthian columns set on piers with tablet flower panels. At the third floor, the same pattern is repeated with Tuscan pilasters. Between the two floors is a thick cornice incorporating a frieze embellished with a swag relief. A bracketed more massive cornice occurs at the top of the building. The architrave and frieze of the cornice are embellished with sunburst relief and pellet moldings. At both floors, the larger panels between the engaged columns and pilasters are embellished with an intricate floral relief.

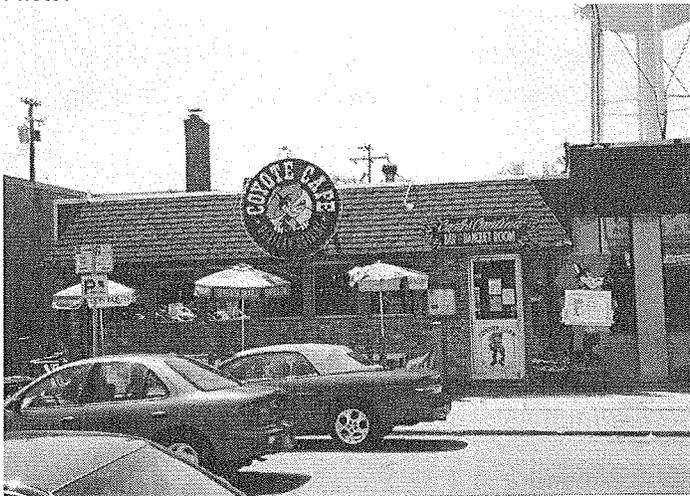
Photo:

This building is an example of the rustic commercial style of design which became popular during the 1970's, particularly in suburban settings. Because the building is not architecturally distinguished and is less than fifty years old, it is not National Register eligible.
